1997 - 1998 Corvette: Chevrolet Pro Service News: Water Leak Repair Guide

Source: Chevrolet Pro Service News

Date: June 1998, Volume 7, Issue Number 6

Subject: Corvette Water Leak Repair

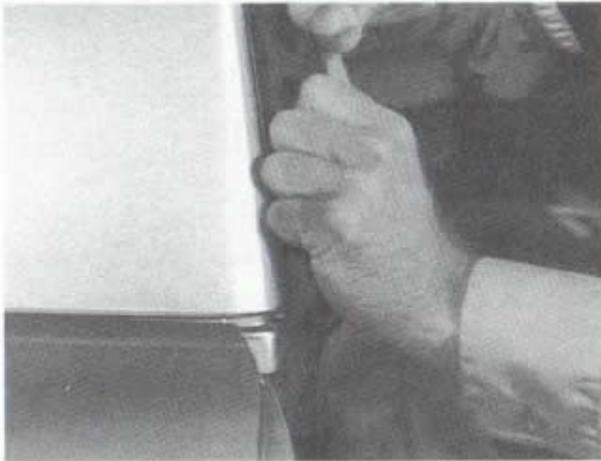
A leak at the rear edge of either door window results from a lack of contact pressure between the window and the roof bow weatherstrip. To correct it, firmly grasp the roof bow side glass weatherstrip at its midway point up the glass. Then stretch the lower portion of the weatherstrip down in its retainer, forming a slight bulge near the bottom.

Stretching lower portion of weatherstrip downward

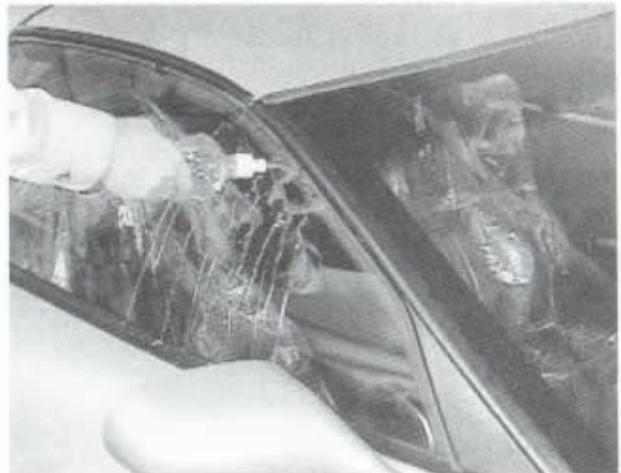
Window tip-in adjustments can also affect leaks at the front edge of the door glass. A confirmed leak along the windshield weatherstrip means you'll need to increase tip-in at the front of the window, ahead of the blow-out clip.

Leaks ahead of the blow-out clip require tip-in adjustment.
