1997 - 1998 Corvette: Chevrolet Pro Service News: Water Leak Repair Guide

Source: Chevrolet Pro Service News

Date: June 1998, Volume 7, Issue Number 6

Subject: Corvette Water Leak Repair

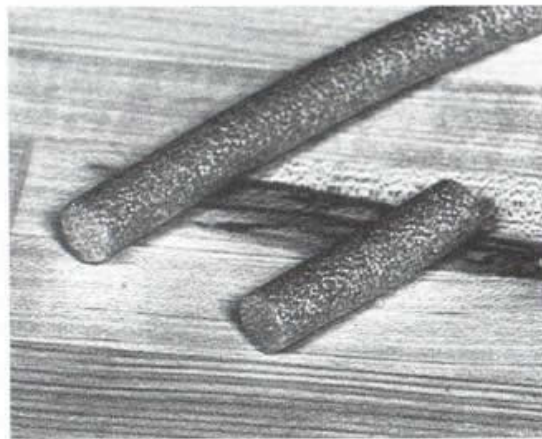
Closed-cell foam weatherstrip, 1/2 inch in diameter, 1-1/2 inches long

Complaints of leaks from the bottom of the windshield A-pillar onto the door trim panel are due to a collapsing door weatherstrip pocket. The collapsed pocket results in a lack of contact pressure between the windshield and door weatherstrips. After water-testing, remove the fir tree fastener at the front lip of the door weatherstrip. Then obtain a piece of closed-cell foam weatherstripping, about 1/2 inch in diameter by 1-1/2 inches long (12mm x 62mm). Rubber hose will also work. The insert stuffer simply needs to be water-resistant and moderately resilient.
