1997 - 1998 Corvette: Chevrolet Pro Service News: Water Leak Repair Guide

Date: June 1998, Volume 7, Issue Number 6

Subject: Corvette Water Leak Repair

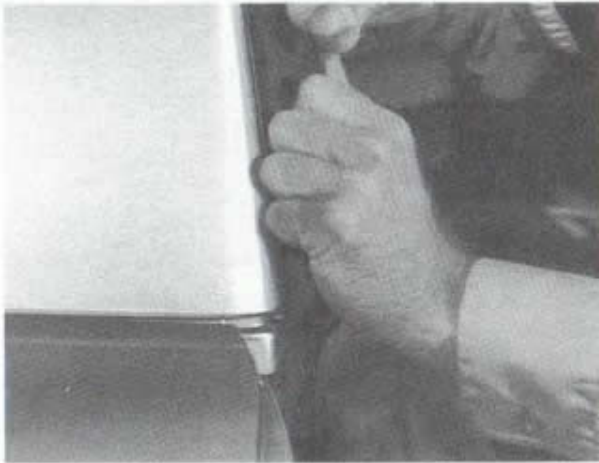
A leak at the rear edge of either door window results from a lack of contact pressure between the window and the roof bow weatherstrip. To correct it, firmly grasp the roof bow side glass weatherstrip at its midway point up the glass. Then stretch the lower portion of the weatherstrip down in its retainer, forming a slight bulge near the bottom.

Stretching lower portion of weatherstrip downward
