1997 - 1998 Corvette: Chevrolet Pro Service News: Water Leak Repair Guide

Source: Chevrolet Pro Service News

Date: June 1998, Volume 7, Issue Number 6

Subject: Corvette Water Leak Repair

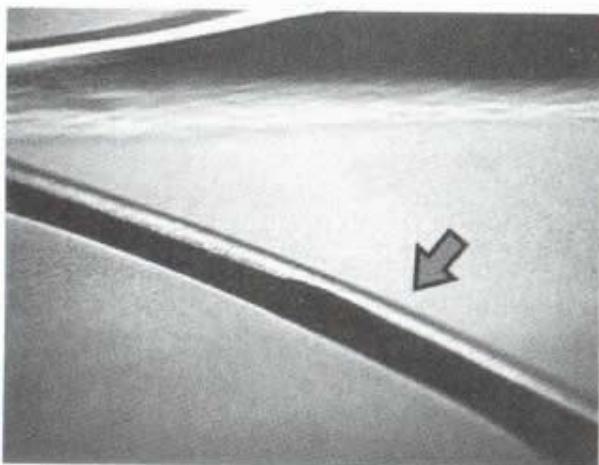
Rolled roof bow weatherstrip

A drip from either rear corner of the roof panel is generally the simplest to correct. First, confirm the leak. Then check to see whether the forward edge of the roof weatherstrip has rolled rearward and overlaps the rear weatherstrip edge. The condition is caused during incorrect roof panel installation, where the customer lays the roof panel flat, and slides it into place from the front to the rear.

To correct it, remove the panel and position the rear dowel pins first. Use the dowel pins as pivots to lower the front of the panel onto its seal, then secure the roof latches.

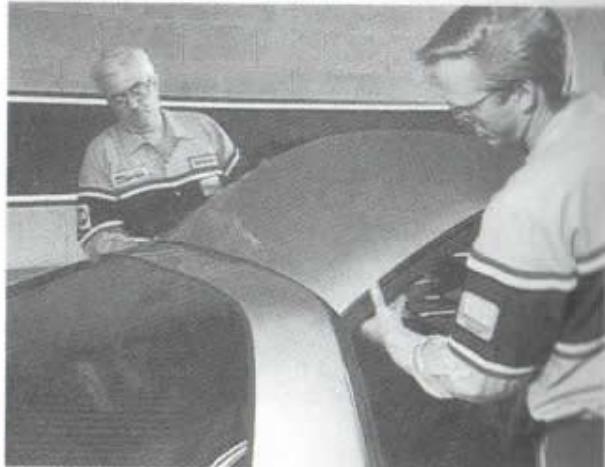
Pivoting roof panel on dowel pins

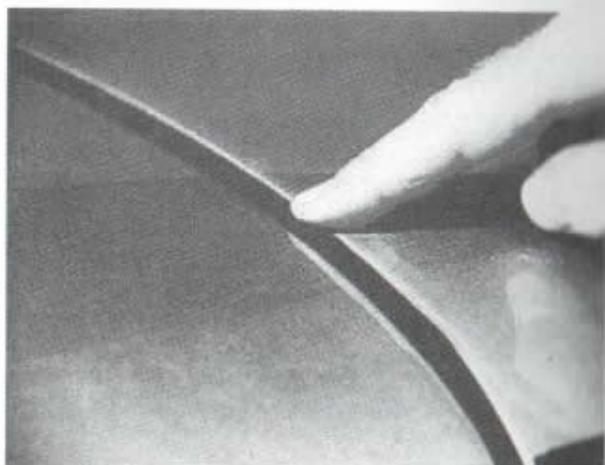
Smooth rear weatherstrip seal edge

Confirm that only the smooth edge of the rear weatherstrip seal is visible with the roof panel installed. You can prevent comebacks for this condition by demonstrating proper roof panel installation to the customer.

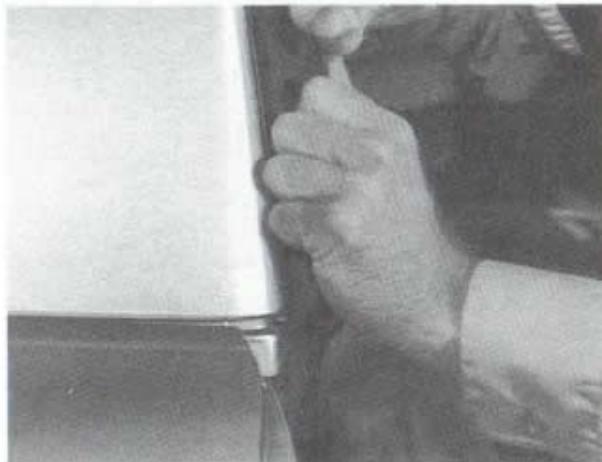
A leak at the rear edge of either door window results from a lack of contact pressure between the window and the roof bow weatherstrip. To correct it, firmly grasp the roof bow side glass weatherstrip at its midway point up the glass. Then stretch the lower portion of the weatherstrip down in its retainer, forming a slight bulge near the bottom.

Stretching lower portion of weatherstrip downward

Continue holding the center of the weatherstrip in place, and stretch its upper portion snug against the roof weatherstrip. If the area still leaks, rear window tip-in adjustment is necessary to increase pressure between the door glass and the roof bow weatherstrip.

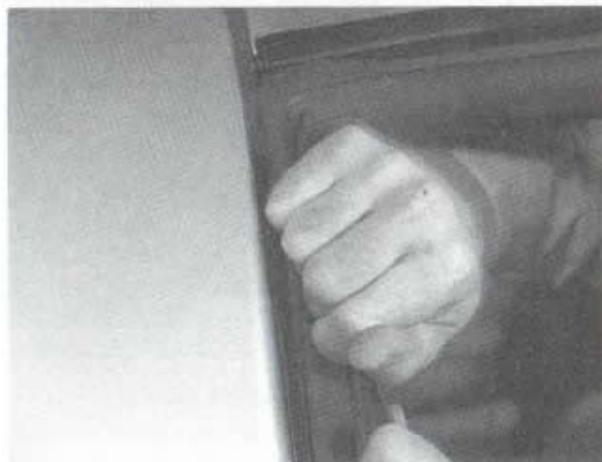
Stretching upper portion of weatherstrip upward

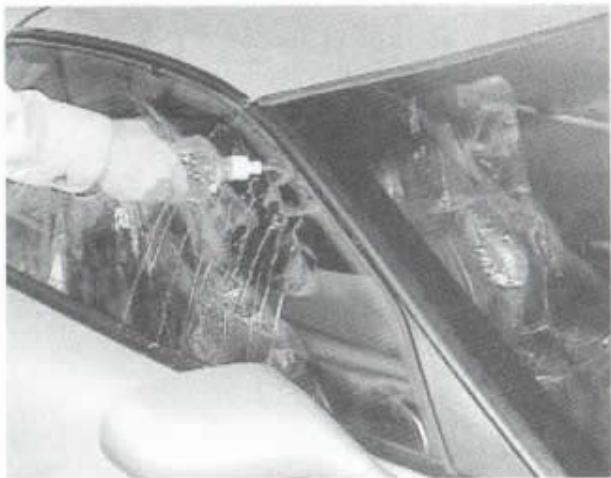
Window tip-in adjustments can also affect leaks at the front edge of the door glass. A confirmed leak along the windshield weatherstrip means you'll need to increase tip-in at the front of the window, ahead of the blow-out clip.

Leaks ahead of the blow-out clip require tip-in adjustment.

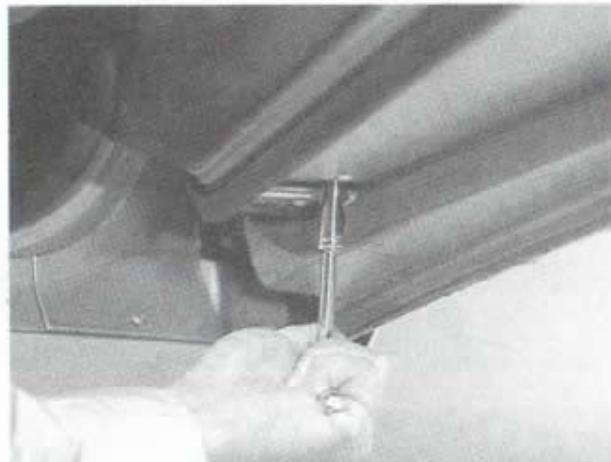
Loosening front lower regulator nut

Start front tip-in adjustments by removing the front lower access plug from the door. Loosen the front lower regulator nut inside the door, slide the regulator outboard and retighten the nut. Reinstall the lower access plug.

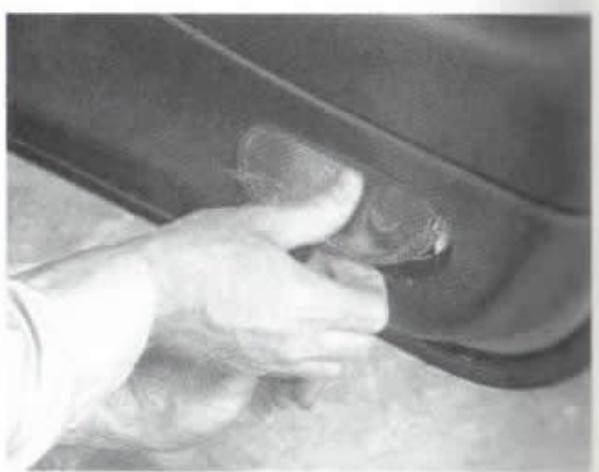
Removing reflector

If rear window tip-in is necessary, remove the reflector from the door after removing the front plug and loosening the regulator nut. Loosen the jack screw jam nut, and turn the jack screw counterclockwise to increase rear tip-in pressure. Finish by locking down the jam nut and re-installing the door reflector.

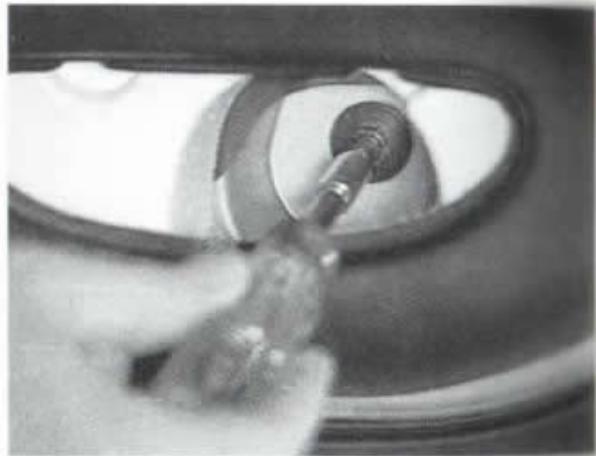
Jack screw is located behind reflector.

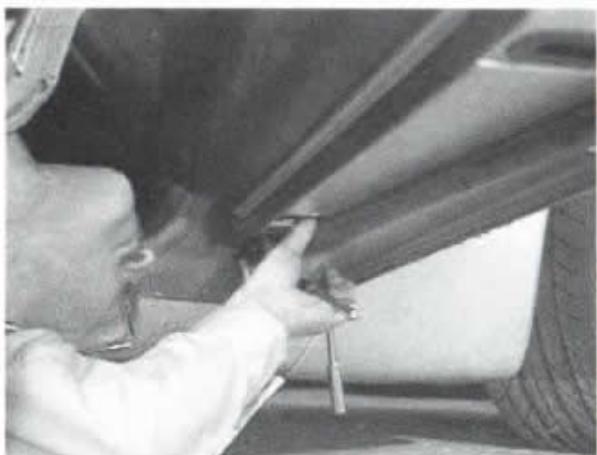
Sliding regulator outboard

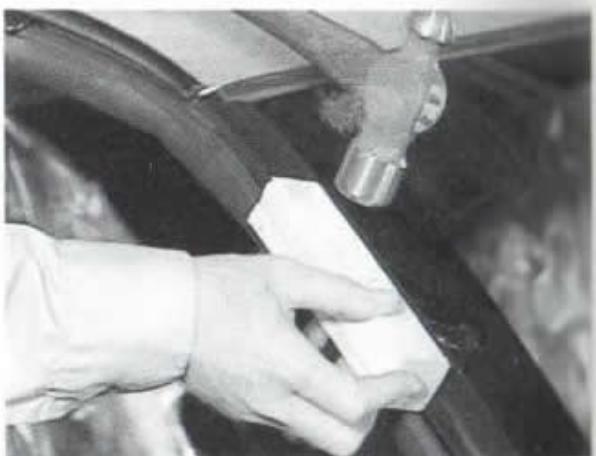
Bending windshield weatherstrip retainer downward

If door glass front edge leaks persist following tip-in adjustment, place a block of wood along the lip of the windshield weatherstrip retainer. Tap the block with a hammer to bend the retainer slightly downward toward the window.

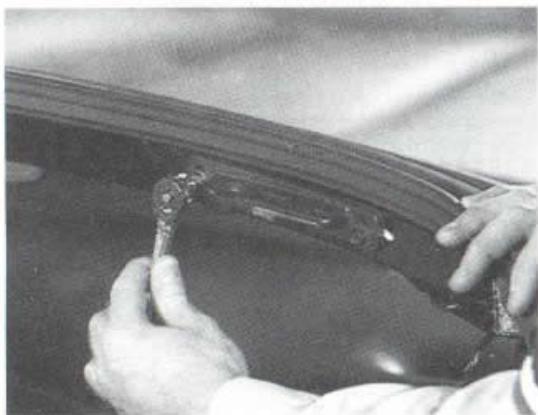
Leaks from the roof at the upper corner of the A-pillar are caused by a lack of contact pressure between the roof panel and the windshield weatherstrip. This condition requires a roof latch adjustment. After water-testing, remove the roof panel, upper garnish trim and sunshades. Then loosen the latch striker bolts on each side. Adjust the strikers downward to increase the contact pressure of the roof panel to the windshield weatherstrip. Retighten the bolts, reinstall the roof panel and water-test to confirm the fix, and reinstall the garnish trim and sunshades.

Loosening latch striker bolts

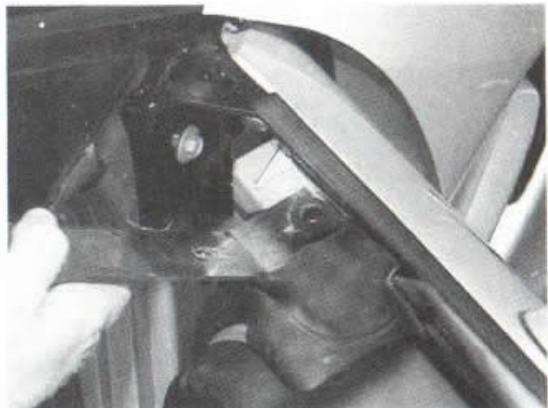
Fir tree fastener at front lip of door weatherstrip

Complaints of leaks from the bottom of the windshield A-pillar onto the door trim panel are due to a collapsing door weatherstrip pocket. The collapsed pocket results in a lack of contact pressure between the windshield and door weatherstrips. After water-testing, remove the fir tree fastener at the front lip of the door weatherstrip. Then obtain a piece of closed-cell foam weatherstripping, about 1/2 inch in diameter by 1-1/2 inches long (12mm x 62mm). Rubber hose will also work. The insert stuffer simply needs to be water-resistant and moderately resilient.

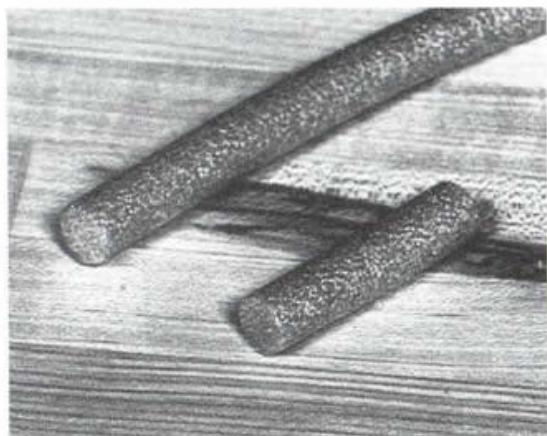
Closed-cell foam weatherstrip, 1/2 inch in diameter, 1-1/2 inches long

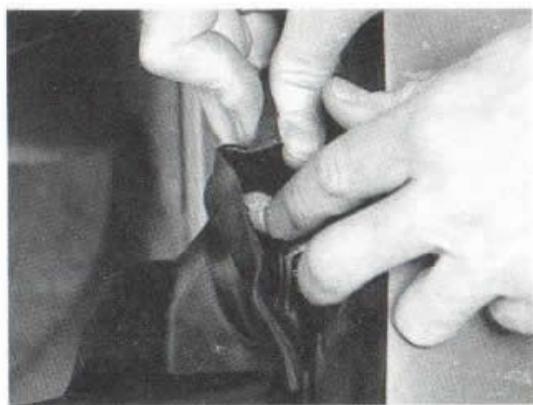
Inserting stuffer into door weatherstrip pocket

Push the stuffer into the door weatherstrip pocket until it just reaches the edge of the door trim panel. The stuffer increases contact pressure between the weatherstrips inboard of the A-pillar weatherstrip drain. It also prevents the collapse of the door weatherstrip under pressure.
