1997 - 2000 Corvette: Chevrolet Pro Service News: Corvette Windnoise

Source: Chevrolet Pro Service News

Date: September 1998, Volume 7, Issue #9

CORVETTE WINDNOISE

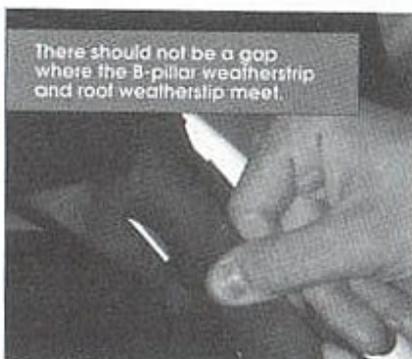
Windnoise also may occur where the B-pillar weatherstrip overlaps the roof weatherstrip. If there is a gap, slide the B-pillar weatherstrip upward in the retainer so it tightly contacts the roof weatherstrip.

There should not be a gap where the B-pillar weatherstrip and roof weatherstrip meet.

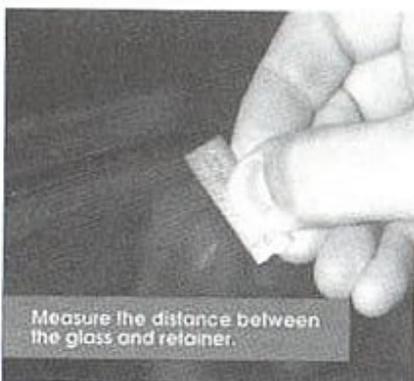
but are integral in diagnosing and correcting windnoise conditions. If you detect windnoise from around the glass, check the distance between the glass and the retainer. You can accomplish this by pushing the edge of the weatherstrip under the glass before measuring. The distance between the two should measure

between 4 mm and 8 mm. The distance from the rear edge of the glass to the retainer should be 7 mm to 9 mm.

Measure the distance between the glass and retainer.

The glass shoes on the door allow you to move the glass up, down, fore or aft to adjust the door glass to the desired position.

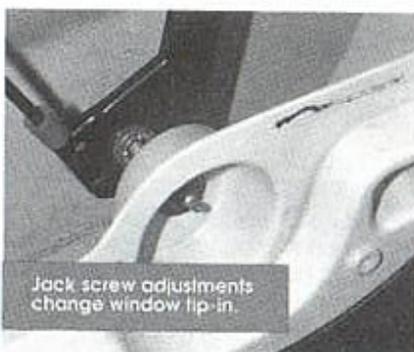
If you have a leak coming from the

Jack screw adjustments change window tip-in.

rear of the door glass, you may need to adjust the window tip-in. The glass should be flush, to 2 mm under flush, to the B-pillar retainer.

You can adjust the tip-in using the jack screw. A counterclockwise adjustment increases tip-in, and clockwise decreases. Refer to the service manual for more information on tip-in

If the glass doesn't roll up easily after adding tip-in, loosen the front lower regulator attachment, lower the glass, and tighten the lower front attachment.
