1997 - 2000 Corvette: Chevrolet Pro Service News: Corvette Windnoise

Source: Chevrolet Pro Service News

Date: September 1998, Volume 7, Issue #9

CORVETTE WINDNOISE

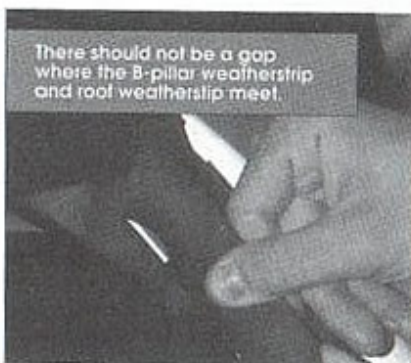
Windnoise also may occur where the B-pillar weatherstrip overlaps the roof weatherstrip. If there is a gap, slide the B-pillar weatherstrip upward in the retainer so it tightly contacts the roof weatherstrip.

There should not be a gap where the B-pillar weatherstrip and roof weatherstrip meet.

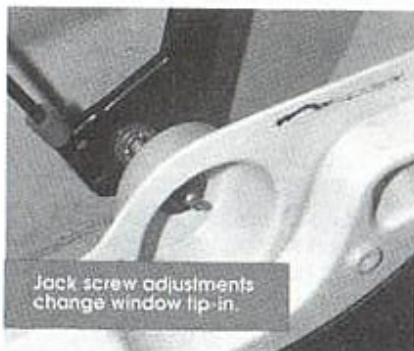
If you have a leak coming from the

Jack screw adjustments change window tip-in.

rear of the door glass, you may need to adjust the window tip-in. The glass should be flush, to 2 mm under flush, to the B-pillar retainer.

You can adjust the tip-in using the jack screw. A counterclockwise adjustment increases tip-in, and clockwise decreases. Refer to the service manual for more information on tip-in

If the glass doesn't roll up easily after adding tip-in, loosen the front lower regulator attachment, lower the glass, and tighten the lower front attachment.
