2012 - 2013 Corvette: GM Techlink Article: Instrument Panel Tweeter Noise

Source: GM TechLink

Date: August 2012

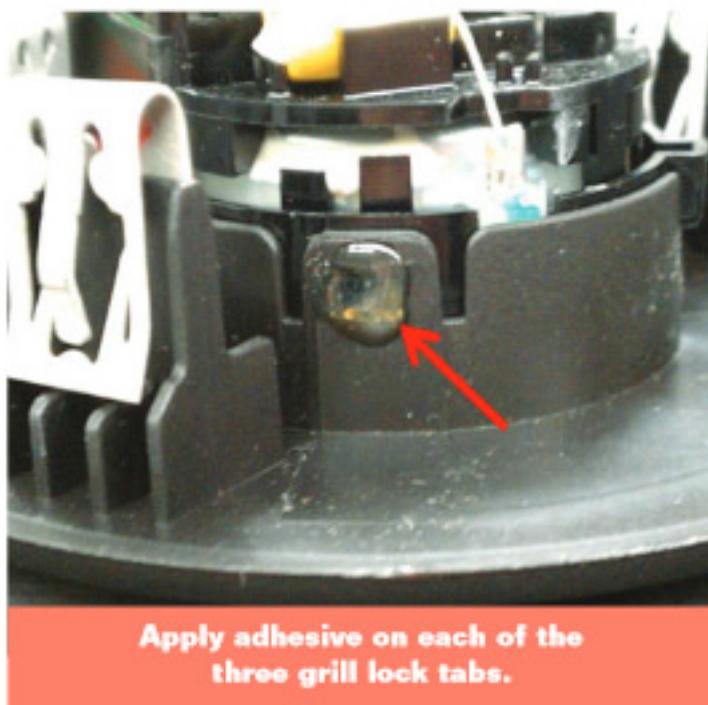
A rattle noise in left side of the instrument panel may be heard on some 2012-2013 Corvettes. The noise may be caused by the tweeter not being secured to the tweeter grill. The curvature of the instrument panel causes the rattle to appear to be on the left side.

**Apply adhesive on each of the
three grill lock tabs.**

Remove the tweeter assembly from the instrument panel. Secure the tweeter in the grill by applying a small dot of hot melt adhesive on each of the three lock tabs. Only apply enough glue to fill each tab window. Reinstall the speaker assembly to the vehicle and confirm the repair.
