2012 - 2013 Corvette: GM Techlink Article: Instrument Panel Tweeter Noise

Source: GM TechLink

Date: August 2012

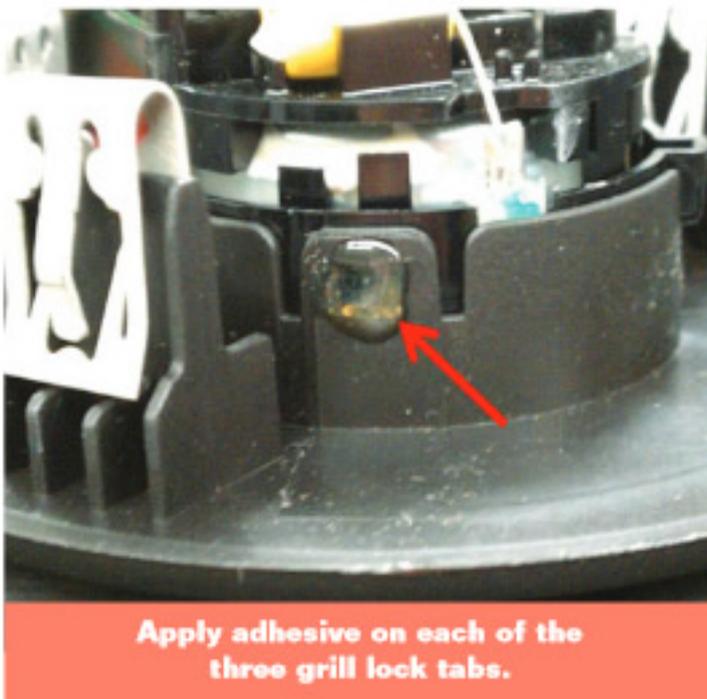
A rattle noise in left side of the instrument panel may be heard on some 2012-2013 Corvettes. The noise may be caused by the tweeter not being secured to the tweeter grill. The curvature of the instrument panel causes the rattle to appear to be on the left side.

Remove the tweeter assembly from the instrument panel. Secure the tweeter in the grill by applying a small dot of hot melt adhesive on each of the three lock tabs. Only apply enough glue to fill each tab window. Reinstall the speaker assembly to the vehicle and confirm the repair.

Apply adhesive on each of the three grill lock tabs.
