# 2012 - 2013 Corvette: GM Techlink Article: Instrument Panel Tweeter Noise

**Source:** GM TechLink

**Date:** August 2012

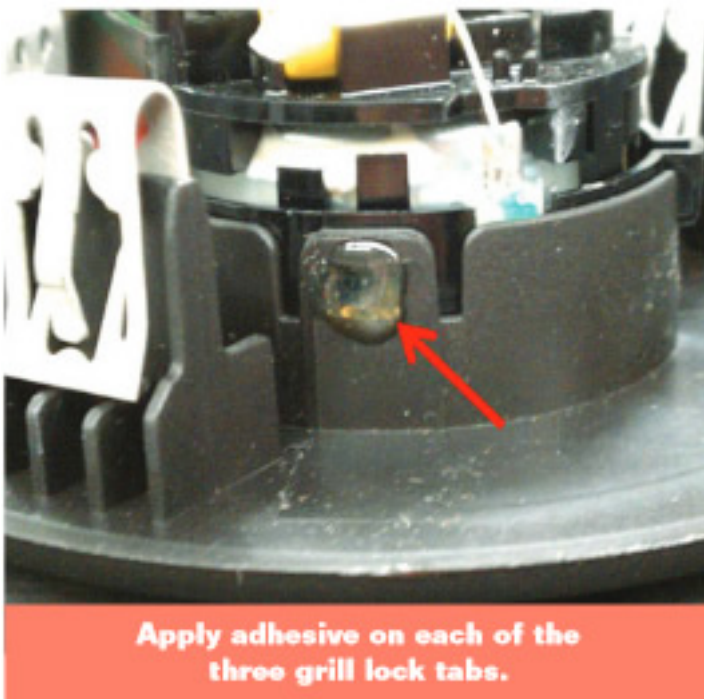
A rattle noise in left side of the instrument panel may be heard on some 2012-2013 Corvettes. The noise may be caused by the tweeter not being secured to the tweeter grill. The curvature of the instrument panel causes the rattle to appear to be on the left side.

**Apply adhesive on each of the three grill lock tabs.**

Remove the tweeter assembly from the instrument panel. Secure the tweeter in the grill by applying a small dot of hot melt adhesive on each of the three lock tabs. Only apply enough glue to fill each tab window. Reinstall the speaker assembly to the vehicle and confirm the repair.
