# 1997 - 2002 Corvette: Service Bulletin: Door Rattle with Moderate to High Audio System Volume

**Number:** 01-08-64-009A

**Date:** 06-19-2002

**Model Year:** 1997-2002 Chevrolet Corvette

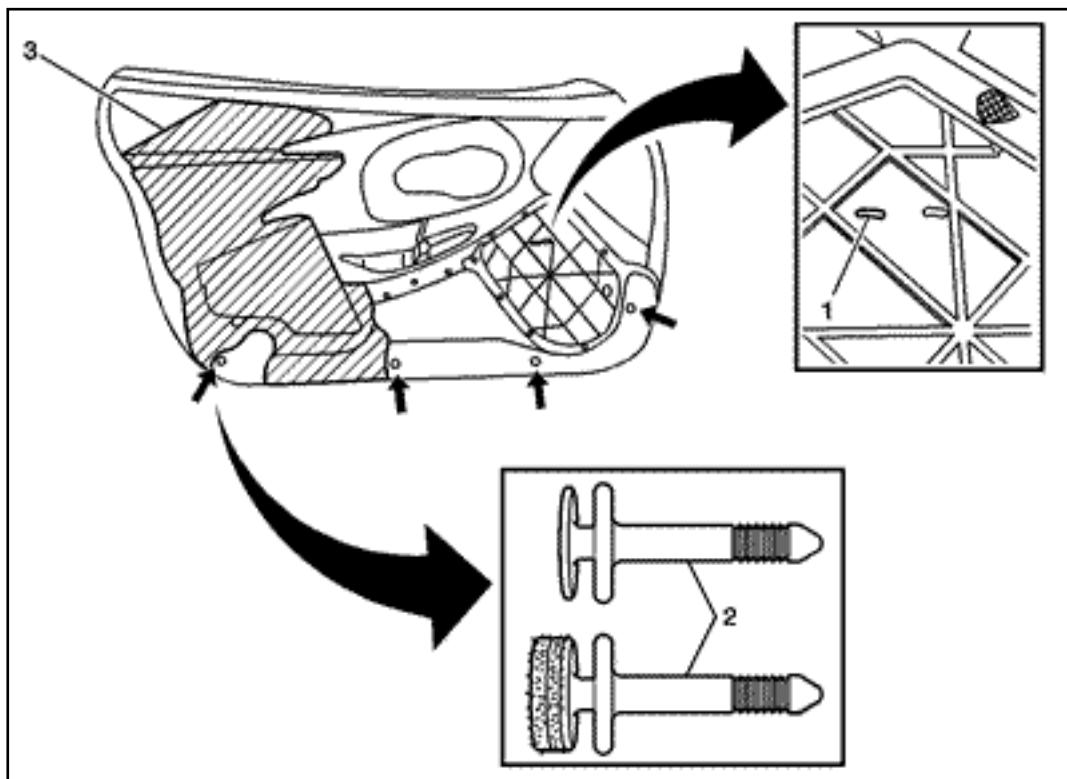
**Change implemented in 2002 VIN breakpoint 125078. Vehicles built prior to this breakpoint will require the following procedure.**

New speaker screen is made from a different material and Bose® emblem is provided due to risk of old emblem becoming damaged while removing.

1. Straighten the speaker grille tabs and remove the grille from the door panel.
2. Remove the Bose® emblem from the speaker grille and discard.
3. Remove the speaker screen from the grille and discard.
4. Install the new speaker screen to the grille.
5. Install the new Bose® emblem and carefully crimp the staples (1) to the speaker grille.
6. Insert the speaker grille tabs into the door panel slots and bend the tabs

to lock the grille in place.

7. Trim any extra loose door panel leather skin from around the speaker grille area on the back side of the door panel.
8. Repeat above steps for opposite side.

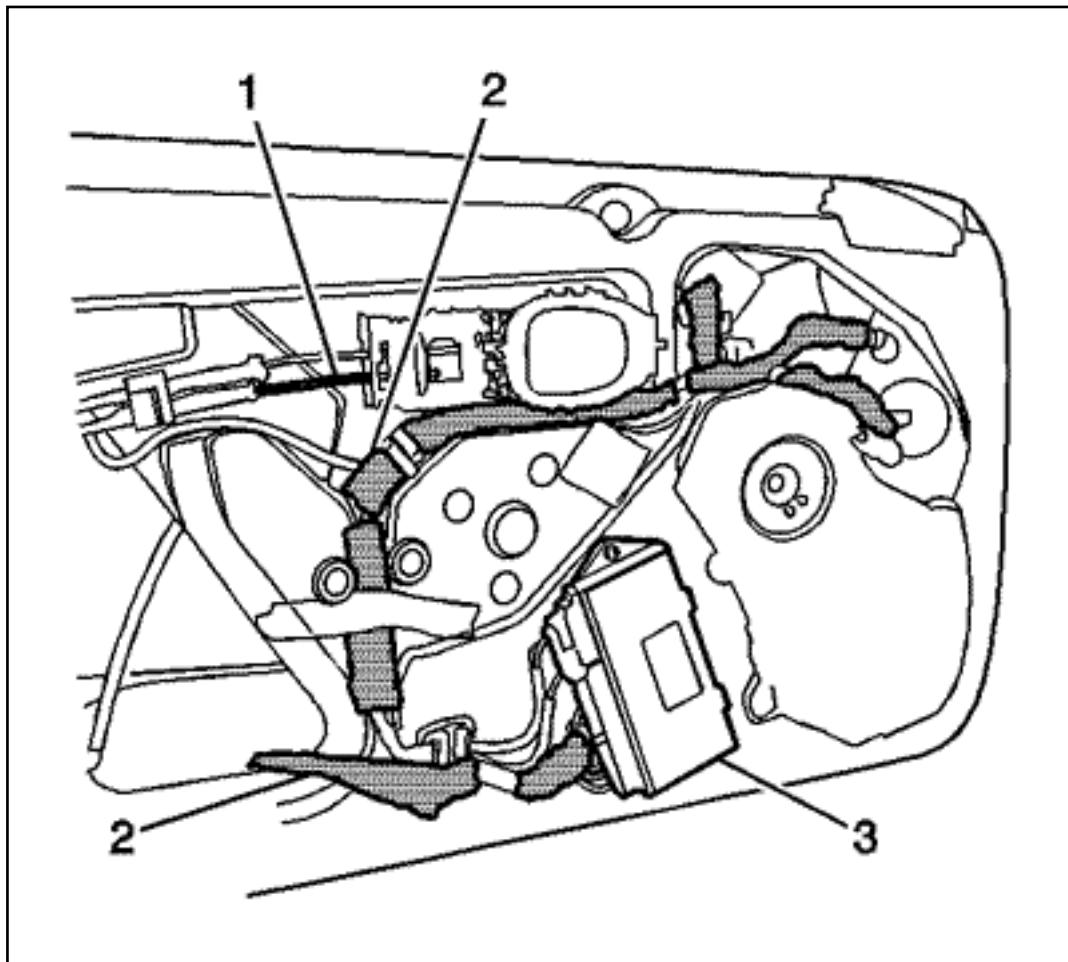
**Change implemented in 1999 VIN breakpoint 133100. Vehicles built prior to this breakpoint will require the following procedure.**

1. Remove the water deflector.

**Do not damage the push-in retainer/tie straps (2). They are to be reused.**

2. Remove the push-in retainer/tie straps (2) that retain the window regulator cables (3) to the inner door panels.
3. Reposition the push-in retainer/tie straps (2) out of the way.
4. Add 122 mm (5 in) of 3M® Open Cell Interior Foam Tape (1), P/N 051131-62385, or equivalent, to the window regulator cables (3) where they contact each other and the inner door panels.

5. Reinstall the push-in retainer/tie straps (2).
6. Reinstall the water deflector.

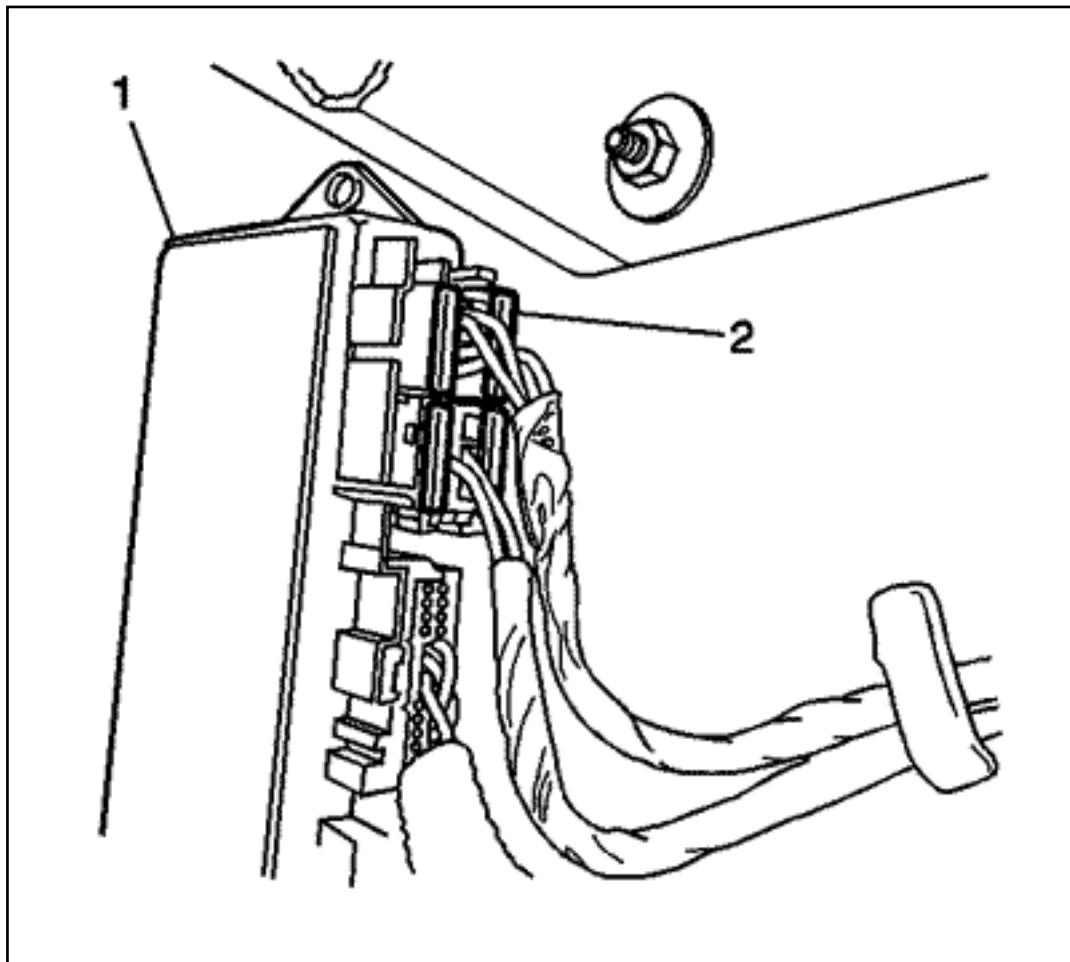
**Change implemented in 2000 VIN breakpoint 101578. Vehicles built prior to this breakpoint will require the following procedure.**

**Change implemented in 2000 VIN breakpoint 123000. Vehicles built prior to this breakpoint will require the following procedure.**

1. Remove the wire harness (2) from its retainers.
2. Insulate the wiring harness and in-line connectors (2) where the wiring harness and the in-line connectors (2) contact the door with 3M® Open Cell Interior Foam Tape (2), P/N 051131-62385, or equivalent. It is best to insulate the entire wiring harness (2).
3. Insulate the right door speaker connector with P/N 12378189.

1. Remove the screws attaching the door control modules (3).
2. Add felt, P/N 12378189, to the backside of the door control modules (3) where it contacts the inner door panels.
3. Position the door control modules (3) to the doors.
4. Install the screws attaching the modules (3). **Tighten**

Tighten the door control modules (3) attaching screws to 3 N·m (27 lb in).

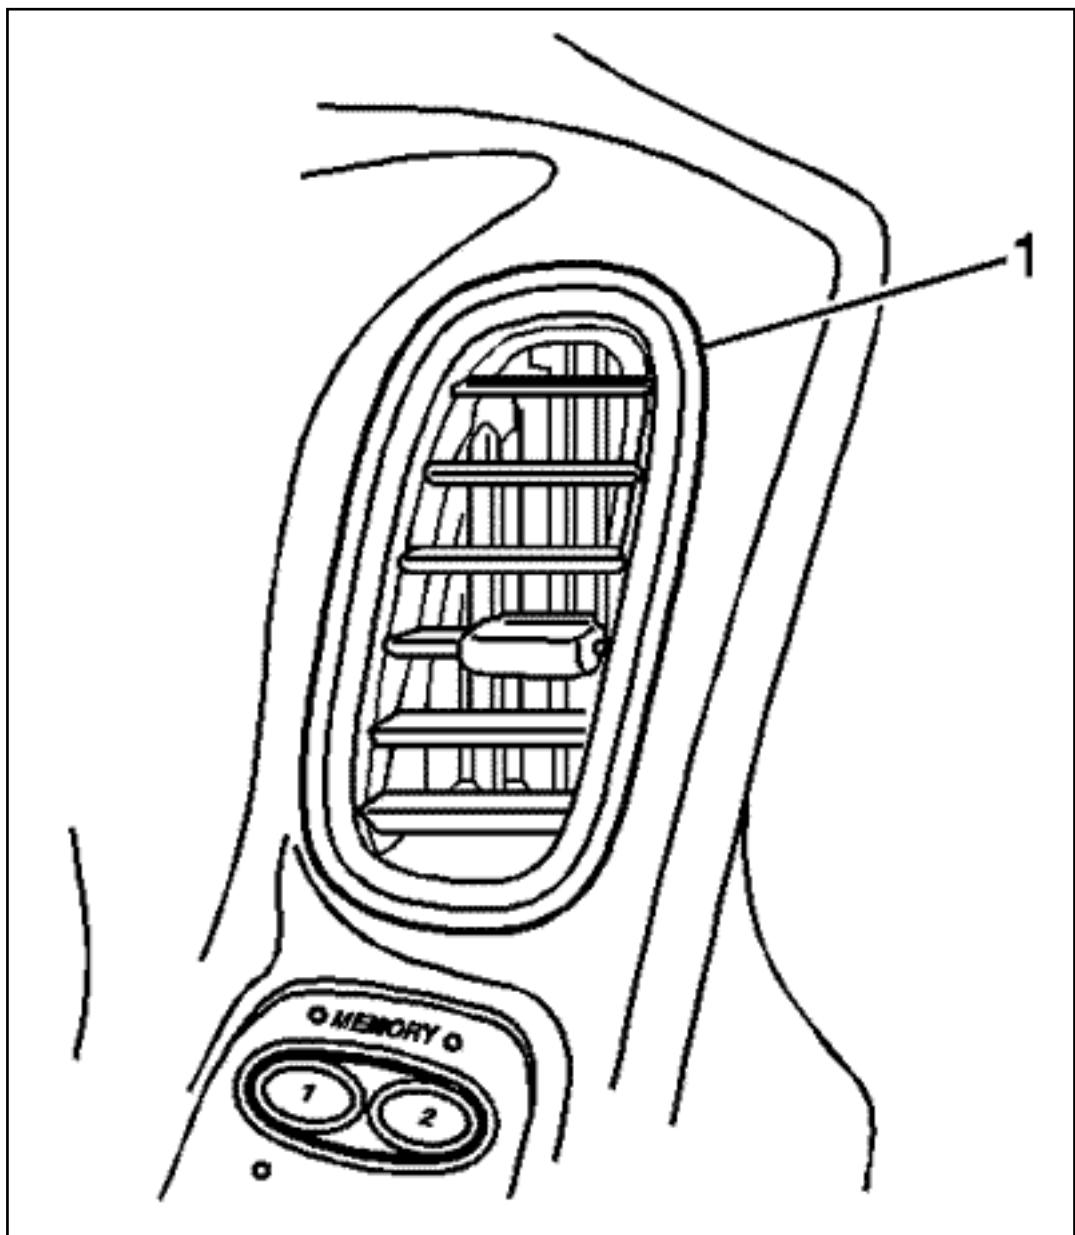
**Change implemented in 2000 VIN breakpoint 120397. Vehicles built prior to this breakpoint will require the following procedure.**

Add a small piece of duct tape, 3M® P/N 051131-06969, or equivalent, to the door control modules (1) terminal positive assurance (TPA)'s (2). They are grey in color and there are a total of 4 TPA's (2) per door. If the TPA's (2) are blue, they are the new design and do not need to be taped.

Replace the driver's door HVAC deflector (1), P/N 10406518, if the vanes of the deflector (1) are loose and vibrate. Refer to Door Trim Panel Air Duct and Deflector Replacement in the Service Manual.
