# 1997 - 2002 Corvette: Service Bulletin: Door Rattle with Moderate to High Audio System Volume

**Number:** 01-08-64-009A

**Date:** 06-19-2002

**Subject:** Door Rattle with Moderate to High Audio System Volume

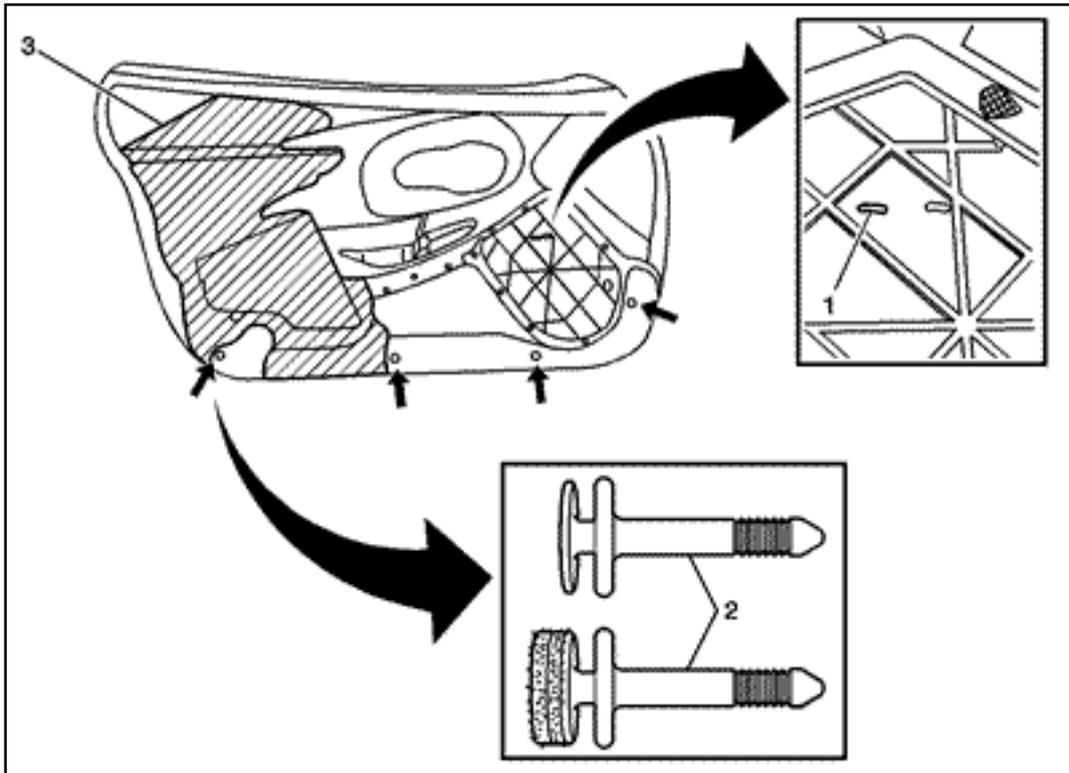
**Change implemented in 2002 VIN breakpoint 125078. Vehicles built prior to this breakpoint will require the following procedure.**

New speaker screen is made from a different material and Bose® emblem is provided due to risk of old emblem becoming damaged while removing.

1. Straighten the speaker grille tabs and remove the grille from the door panel.
2. Remove the Bose® emblem from the speaker grille and discard.
3. Remove the speaker screen from the grille and discard.
4. Install the new speaker screen to the grille.
5. Install the new Bose® emblem and carefully crimp the staples (1) to the speaker grille.
6. Insert the speaker grille tabs into the door panel slots and bend the tabs

to lock the grille in place.

7. Trim any extra loose door panel leather skin from around the speaker grille area on the back side of the door panel.
8. Repeat above steps for opposite side.

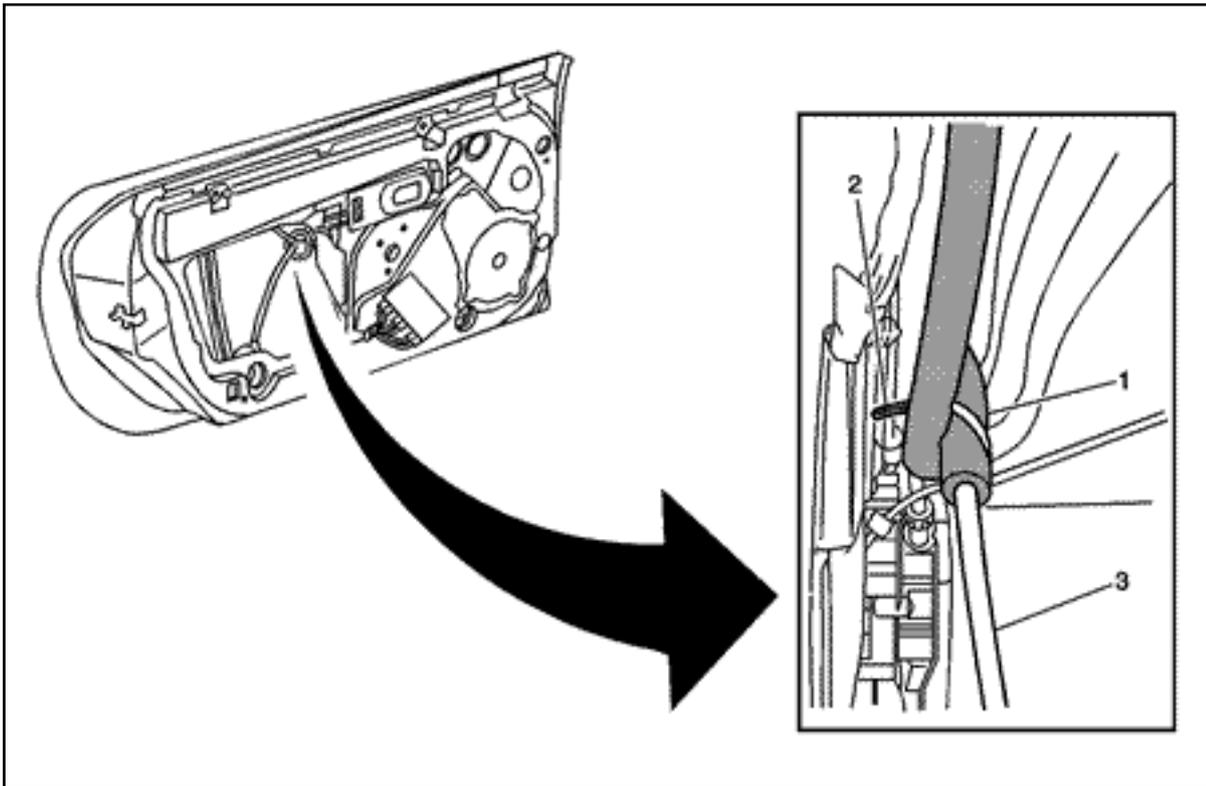
**Change implemented in 2001 VIN breakpoint 115500. Vehicles built prior to this breakpoint will require the following procedure.**

**Change implemented in 2000 VIN breakpoint 110900. Vehicles built prior to this breakpoint will require the following procedure.**

1. Remove the 4 lower door trim panel retainers (2) from both door panels.
2. Cut 16 dime sized coins from the fine side of Velcro®, 3M® P/N 051131-06481, or equivalent.
3. Install 2 Velcro® coins to each of the 8 door trim panel retainers (2).
4. Reinstall the door trim panel retainers (2) into the door trim panels.

1. Only perform the following procedure if the side impact styrofoam (3) is loose from the door panels.
2. Resecure the side impact foam (3) to the door trim panels using 3M® Urethane, P/N 051135-08690, or equivalent.
