# 1997 - 2002 Corvette: Service Bulletin: Door Rattle with Moderate to High Audio System Volume

**Number:** 01-08-64-009A

**Date:** 06-19-2002

**Model Year:** 1997-2002 Chevrolet Corvette

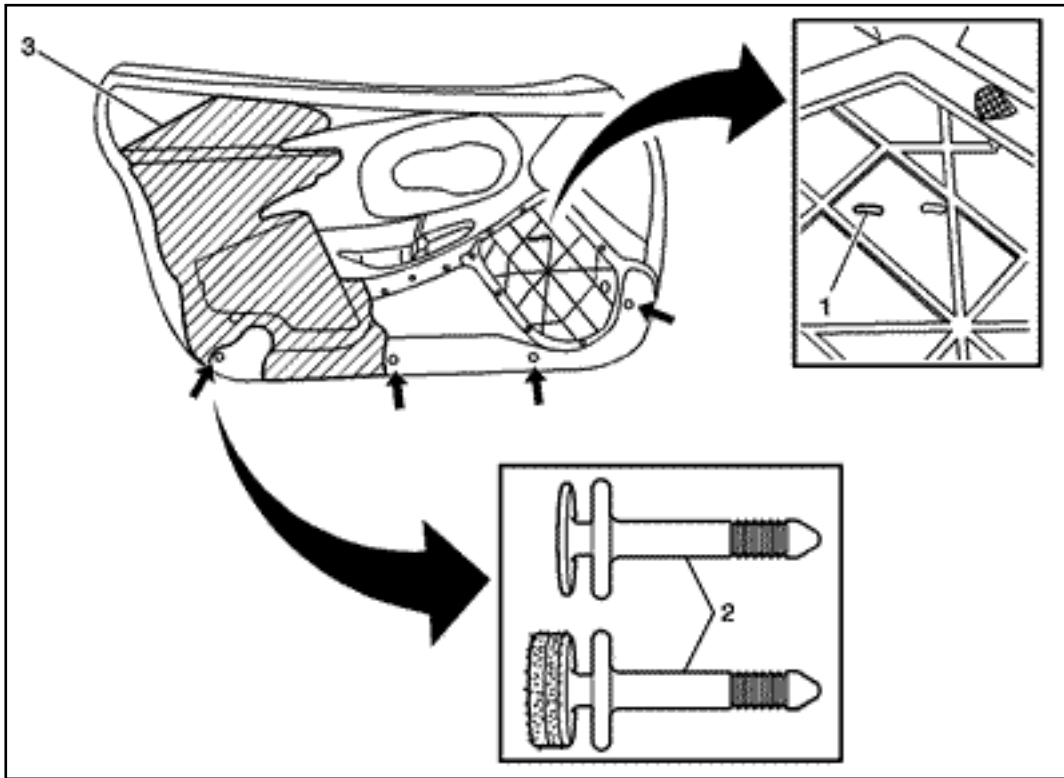
**Change implemented in 2002 VIN breakpoint 125078. Vehicles built prior to this breakpoint will require the following procedure.**

New speaker screen is made from a different material and Bose® emblem is provided due to risk of old emblem becoming damaged while removing.

1. Straighten the speaker grille tabs and remove the grille from the door panel.
2. Remove the Bose® emblem from the speaker grille and discard.
3. Remove the speaker screen from the grille and discard.
4. Install the new speaker screen to the grille.
5. Install the new Bose® emblem and carefully crimp the staples (1) to the speaker grille.
6. Insert the speaker grille tabs into the door panel slots and bend the tabs

to lock the grille in place.

7. Trim any extra loose door panel leather skin from around the speaker grille area on the back side of the door panel.
8. Repeat above steps for opposite side.

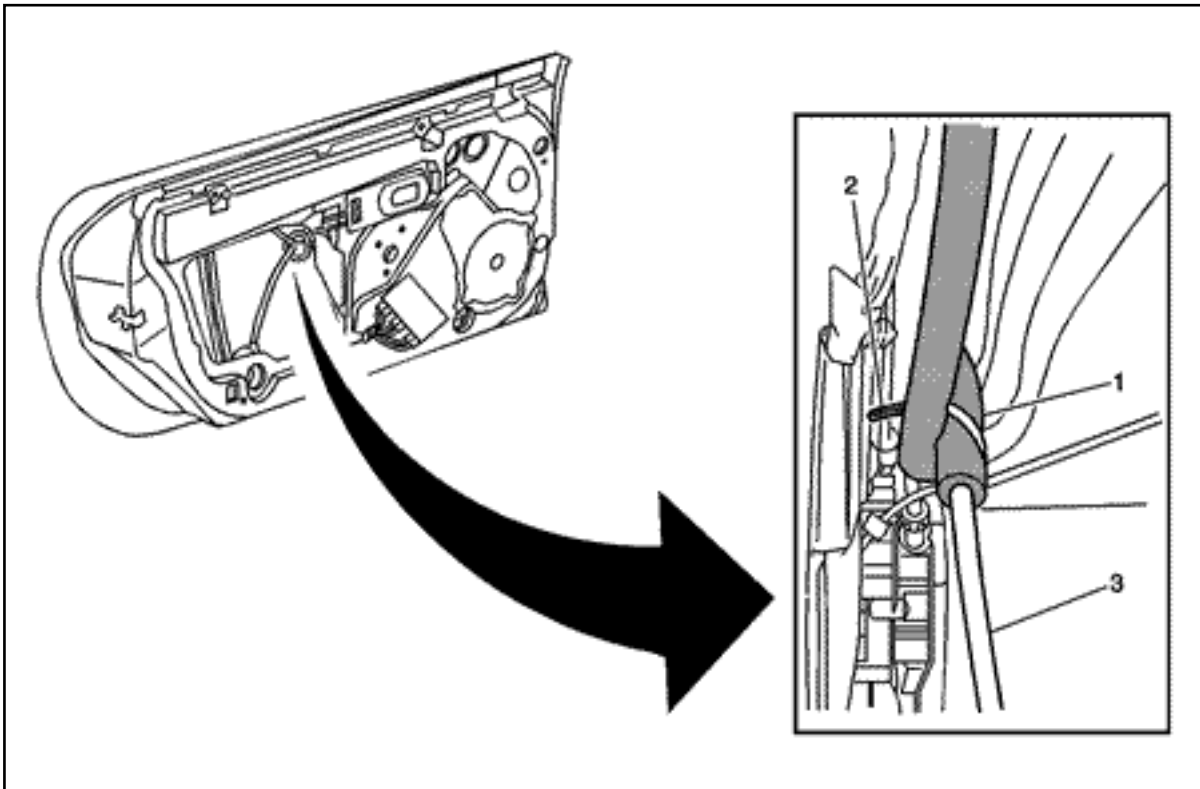
**Change implemented in 2001 VIN breakpoint 115500. Vehicles built prior to this breakpoint will require the following procedure.**

**Change implemented in 2000 VIN breakpoint 110900. Vehicles built prior to this breakpoint will require the following procedure.**

1. Remove the 4 lower door trim panel retainers (2) from both door panels.
2. Cut 16 dime sized coins from the fine side of Velcro®, 3M® P/N 051131-06481, or equivalent.
3. Install 2 Velcro® coins to each of the 8 door trim panel retainers (2).
4. Reinstall the door trim panel retainers (2) into the door trim panels.

1. Only perform the following procedure if the side impact styrofoam (3) is loose from the door panels.
2. Resecure the side impact foam (3) to the door trim panels using 3M® Urethane, P/N 051135-08690, or equivalent.

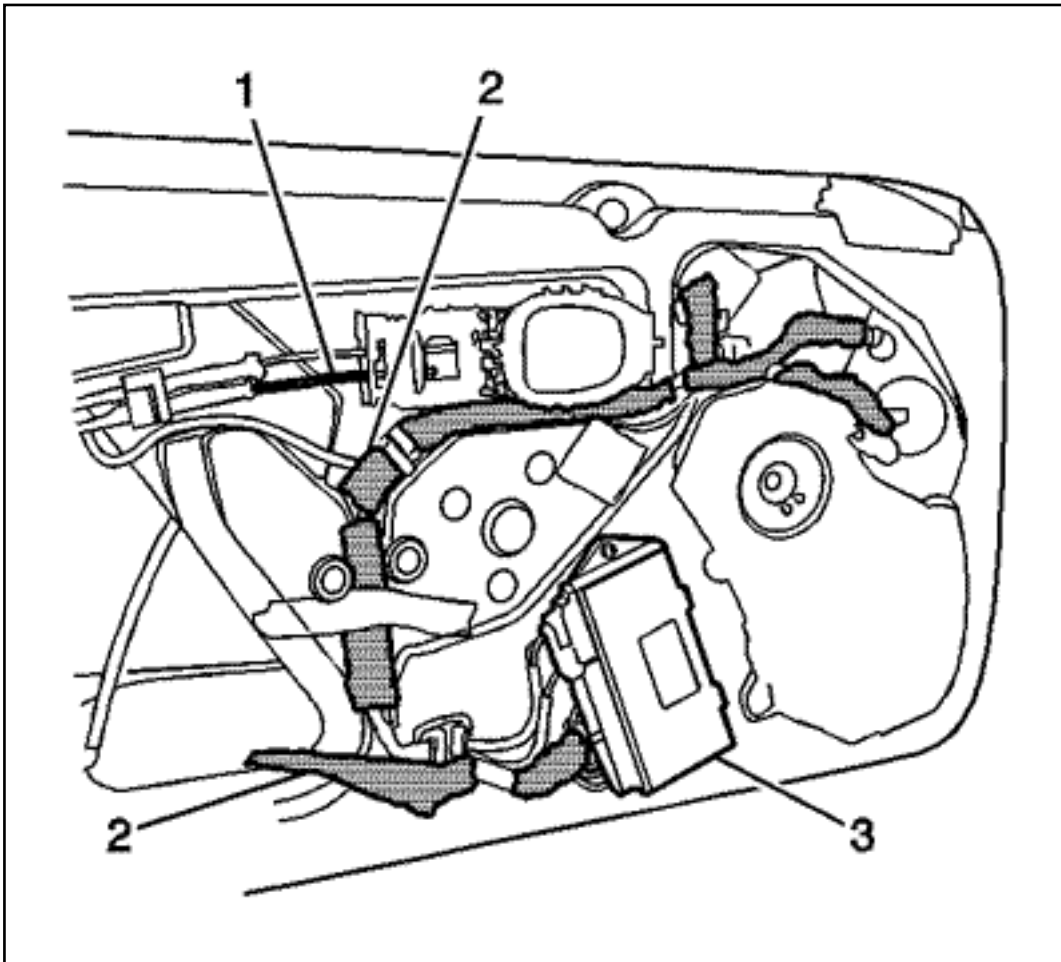
**Change implemented in 1999 VIN breakpoint 133100. Vehicles built prior to this breakpoint will require the following procedure.**

2. Remove the push-in retainer/tie straps (2) that retain the window regulator cables (3) to the inner door panels.
3. Reposition the push-in retainer/tie straps (2) out of the way.
4. Add 122 mm (5 in) of 3M® Open Cell Interior Foam Tape (1), P/N 051131-62385, or equivalent, to the window regulator cables (3) where they contact each other and the inner door panels.

5. Reinstall the push-in retainer/tie straps (2).
6. Reinstall the water deflector.

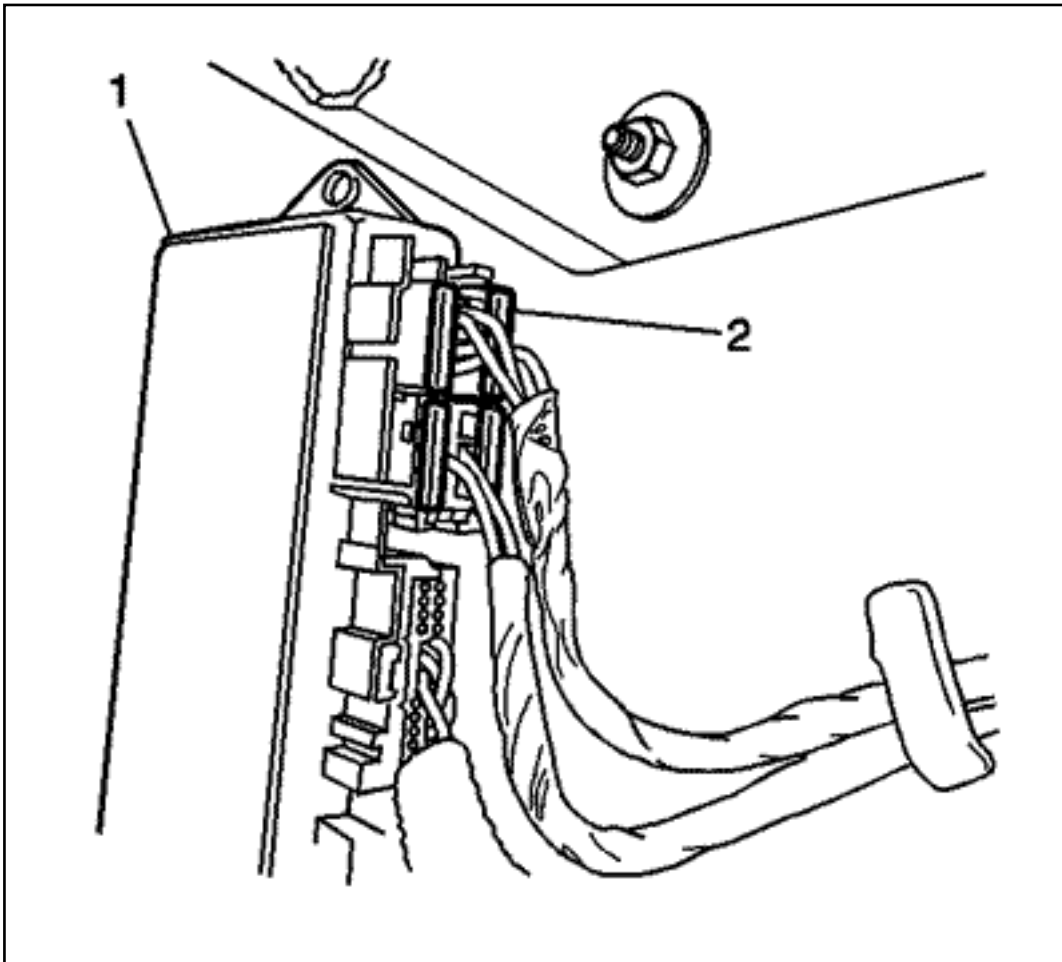
**Change implemented in 2000 VIN breakpoint 101578. Vehicles built prior to this breakpoint will require the following procedure.**

**Change implemented in 2000 VIN breakpoint 123000. Vehicles built prior to this breakpoint will require the following procedure.**

1. Remove the wire harness (2) from its retainers.
2. Insulate the wiring harness and in-line connectors (2) where the wiring harness and the in-line connectors (2) contact the door with 3M® Open Cell Interior Foam Tape (2), P/N 051131-62385, or equivalent. It is best to insulate the entire wiring harness (2).
3. Insulate the right door speaker connector with P/N 12378189.

1. Remove the screws attaching the door control modules (3).
2. Add felt, P/N 12378189, to the backside of the door control modules (3) where it contacts the inner door panels.
3. Position the door control modules (3) to the doors.
4. Install the screws attaching the modules (3). **Tighten**

Tighten the door control modules (3) attaching screws to 3 N·m (27 lb in).
