1997 - 2002 Corvette: Service Bulletin: Door Rattle with Moderate to High Audio System Volume

Number: 01-08-64-009A

Date: 06-19-2002

Model Year: 1997-2002 Chevrolet Corvette

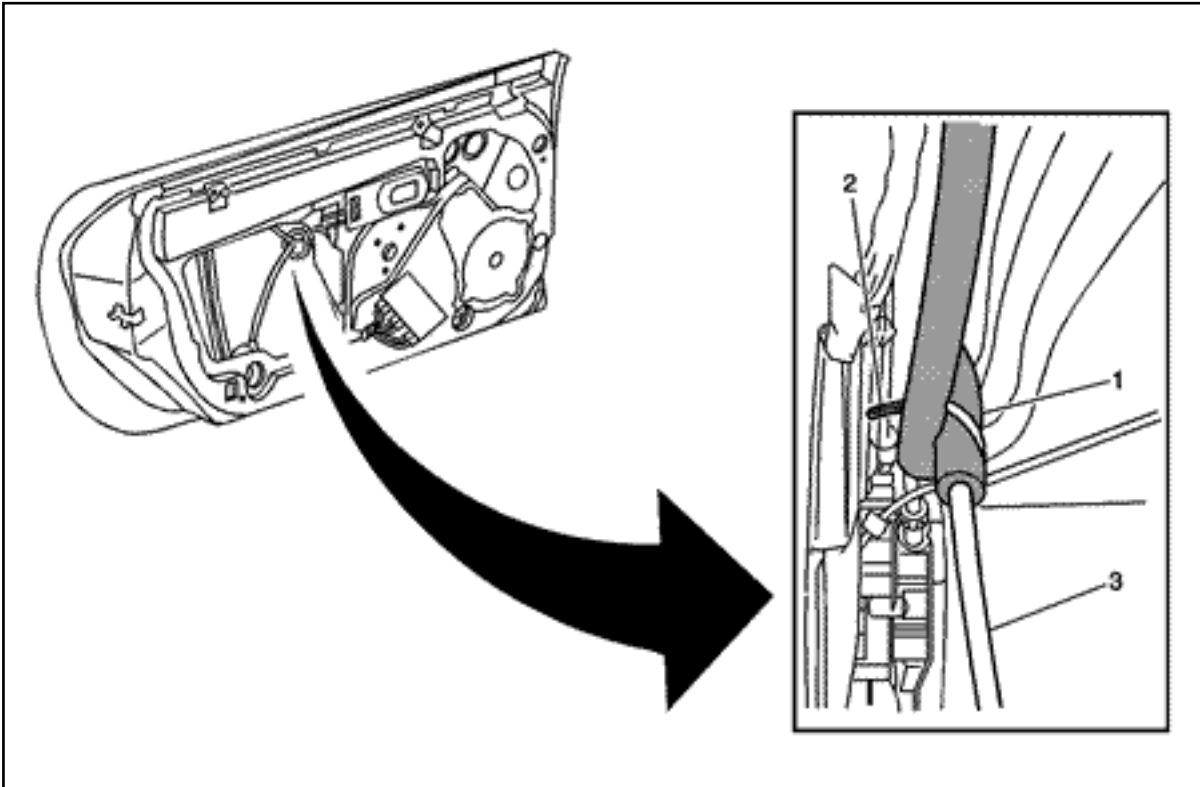
Change implemented in 2001 VIN breakpoint 115500. Vehicles built prior to this breakpoint will require the following procedure.

Change implemented in 2000 VIN breakpoint 110900. Vehicles built prior to this breakpoint will require the following procedure.

1. Remove the 4 lower door trim panel retainers (2) from both door panels.
2. Cut 16 dime sized coins from the fine side of Velcro®, 3M® P/N 051131-06481, or equivalent.
3. Install 2 Velcro® coins to each of the 8 door trim panel retainers (2).
4. Reinstall the door trim panel retainers (2) into the door trim panels.

1. Only perform the following procedure if the side impact styrofoam (3) is loose from the door panels.
2. Resecure the side impact foam (3) to the door trim panels using 3M® Urethane, P/N 051135-08690, or equivalent.

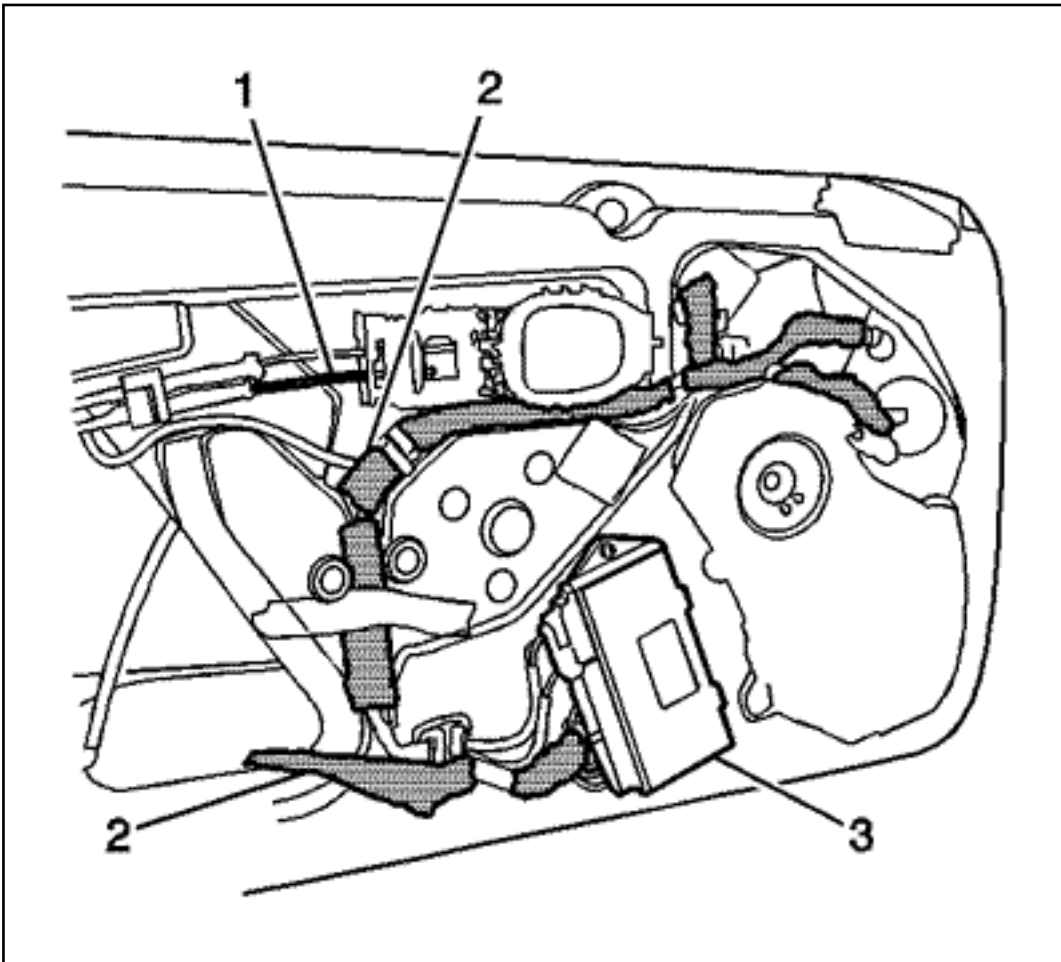
Change implemented in 1999 VIN breakpoint 133100. Vehicles built prior to this breakpoint will require the following procedure.

1. Remove the water deflector.

Do not damage the push-in retainer/tie straps (2). They are to be reused.

2. Remove the push-in retainer/tie straps (2) that retain the window regulator cables (3) to the inner door panels.
3. Reposition the push-in retainer/tie straps (2) out of the way.
4. Add 122 mm (5 in) of 3M® Open Cell Interior Foam Tape (1), P/N 051131-62385, or equivalent, to the window regulator cables (3) where they contact each other and the inner door panels.

5. Reinstall the push-in retainer/tie straps (2).
6. Reinstall the water deflector.
