1998 - 2002 Corvette: Service Bulletin: Audible Spark Knock (Detonation), MIL Illuminated, DTC P0332 Set

Subject: Audible Spark Knock (Detonation), MIL Illuminated, DTC P0332 Set
(Replace Rear Bank Knock Sensor and RTV Area Around Sensor)

Number: 02-06-04-023

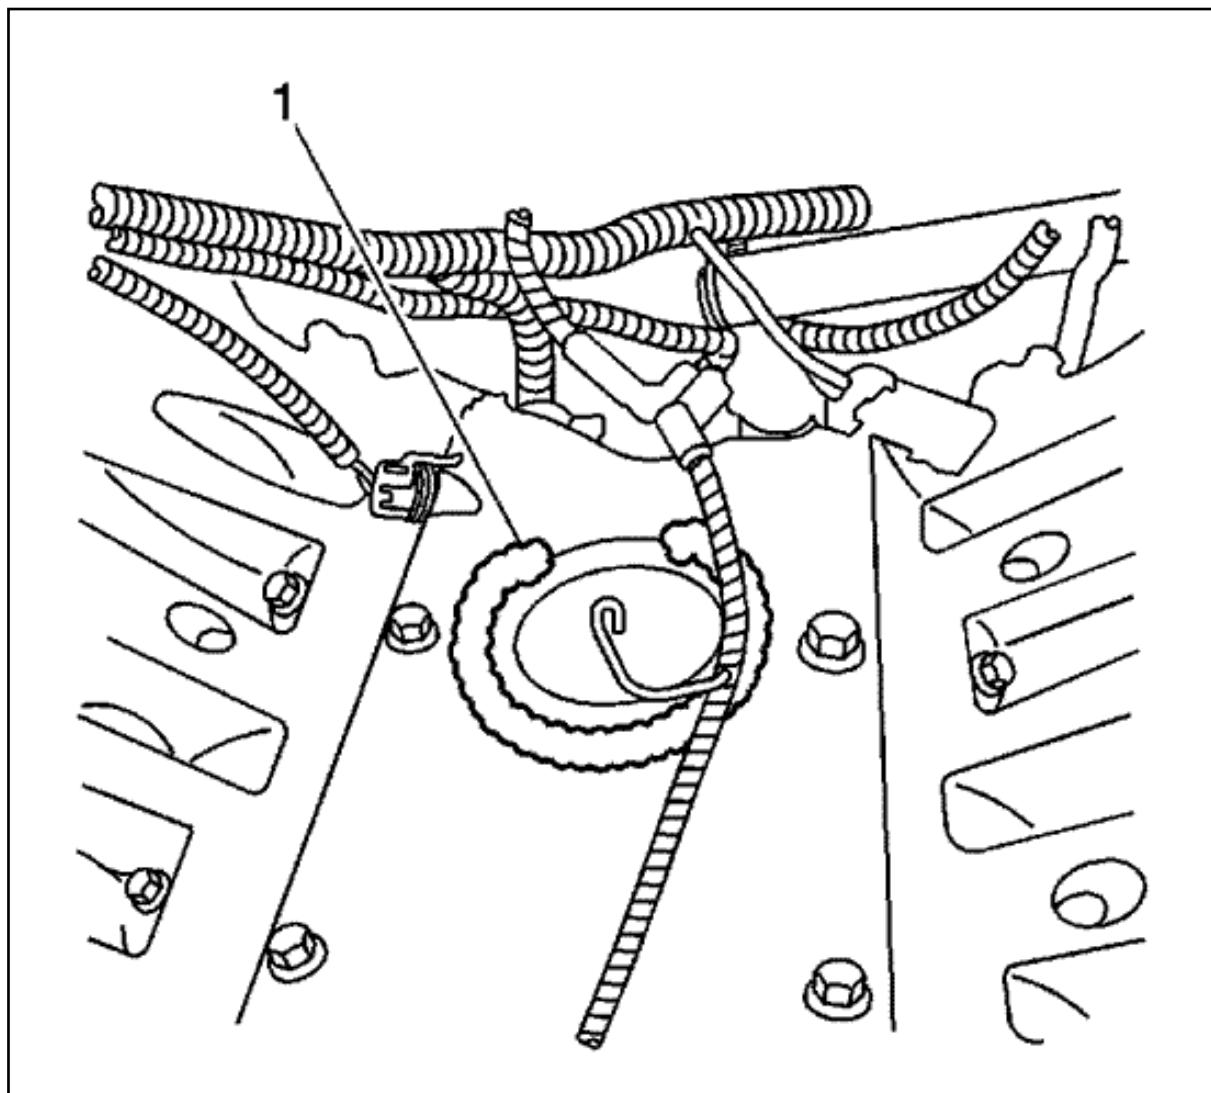
This condition may be the result of corrosion of the rear bank knock sensor due to water intrusion into the sensor cavity. This condition is more apparent on vehicles in which customers frequently wash the engine compartment.

- Remove the rear bank knock sensor.
- Install the new rear bank knock sensor. **Tighten** the knock sensor to 20 N·m(15 lb ft).
- Install the wiring harness assembly to the knock sensor.

- Apply a bead of RTV silicone sealant approximately 9 mm (3/8 in) wide and 6 mm (1/4 in) high along the outside edge of the ridge on the engine block valley cover around the rear bank knock sensor. DO NOT form a complete circle. Leave the rear section open as shown.
- From the underside of the intake manifold, completely remove the
