1997 - 1999 Corvette: Service Bulletin: Accessory Drive Squeak (Replace Idler Pulley)

Number: 99-06-01-007

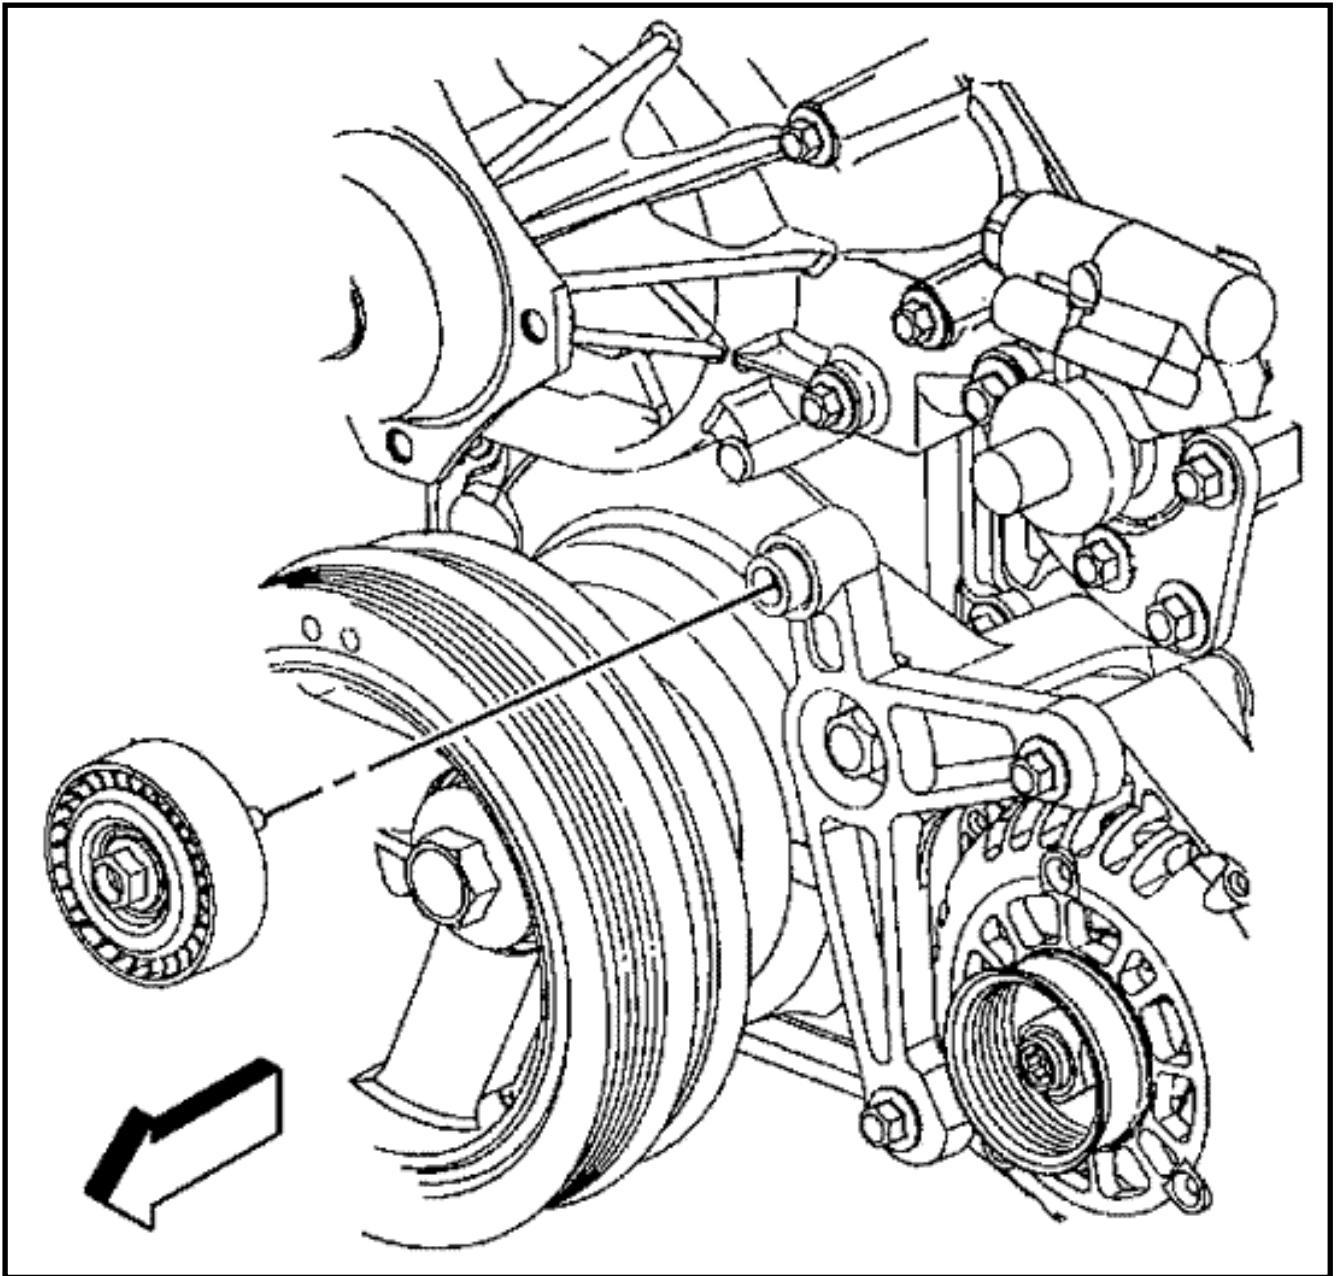
The idler pulley dust shield may distort during assembly due to torquing of the mounting bolt. This distortion may cause the idler pulley dust shield to contact the bearing race and the pulley resulting in the squeak noise.

A new idler pulley assembly is available with a thicker dust shield to prevent the distortion of the dust shield. The previous dust shield thickness is 0.61 mm. The new dust shield thickness is 1.37 mm.

- **Do not over-torque the mounting bolt or the condition may reoccur.**

Do not use pneumatic or electric tools for installation of the idler pulley assembly.

Torque the idler pulley bolt to 50 N·m (37 lb ft).
