1997 - 1999 Corvette: Service Bulletin: Accessory Drive Squeak (Replace Idler Pulley)

Number: 99-06-01-007

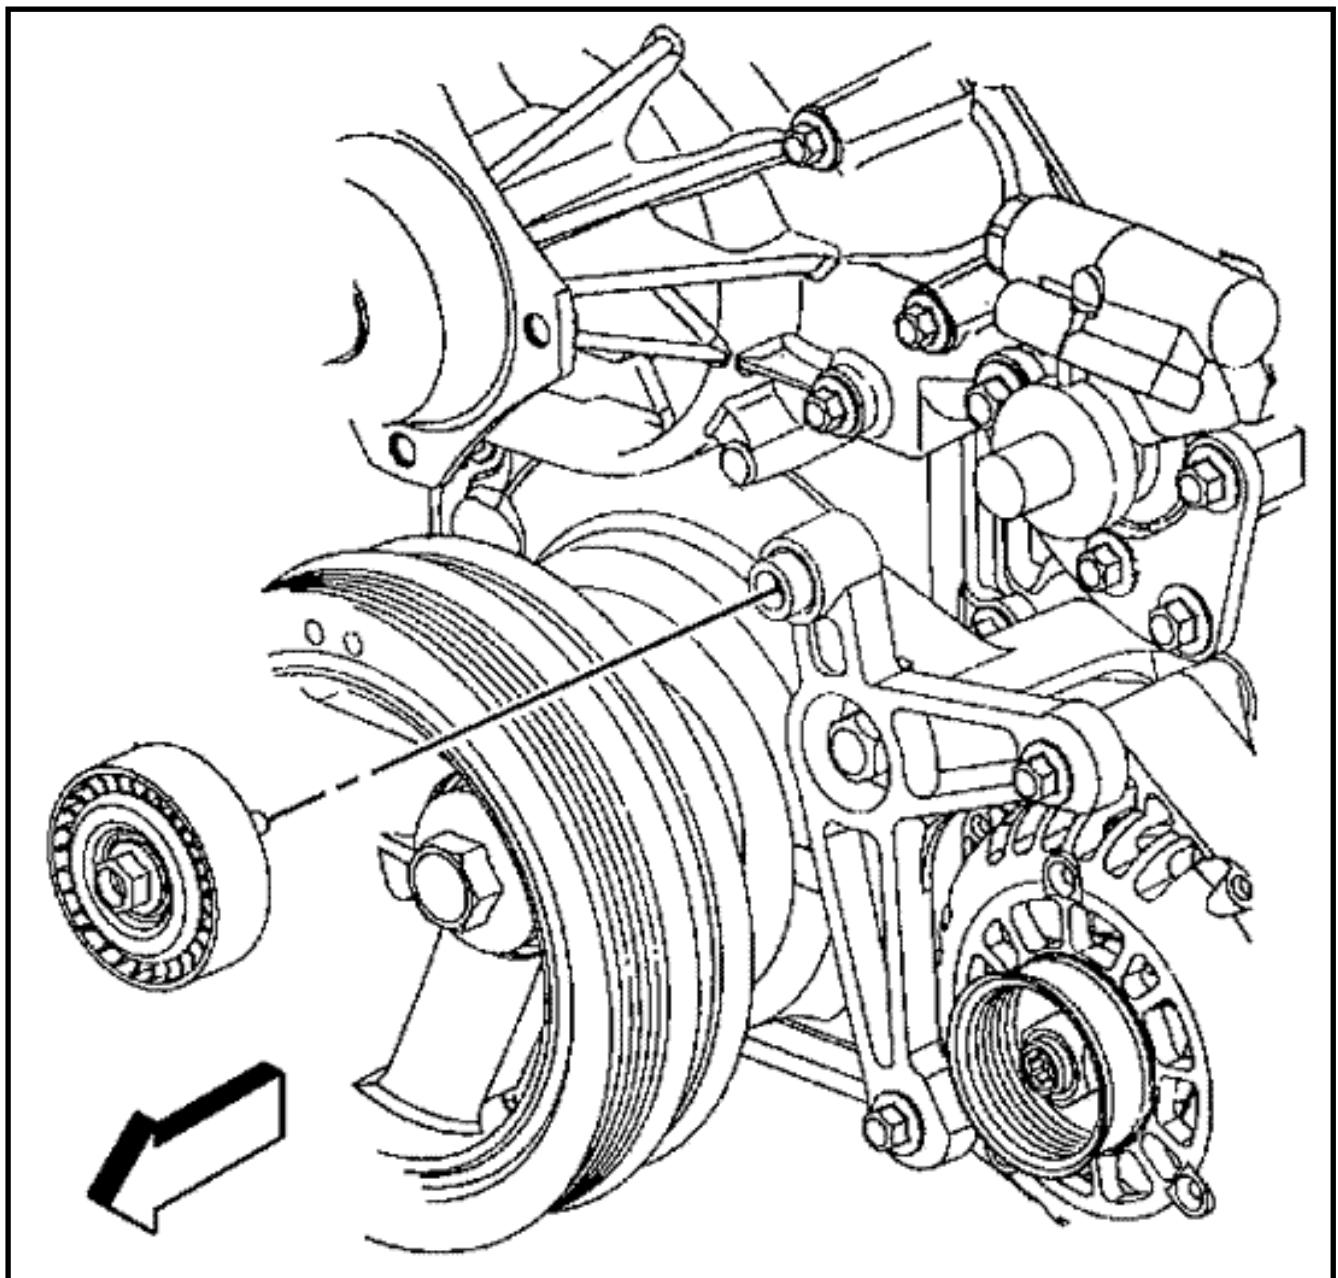
The idler pulley dust shield may distort during assembly due to torquing of the mounting bolt. This distortion may cause the idler pulley dust shield to contact the bearing race and the pulley resulting in the squeak noise.

A new idler pulley assembly is available with a thicker dust shield to prevent the distortion of the dust shield. The previous dust shield thickness is 0.61 mm. The new dust shield thickness is 1.37 mm.

- **Do not over-torque the mounting bolt or the condition may reoccur.**
Do not use pneumatic or electric tools for installation of the idler pulley assembly.

Torque the idler pulley bolt to 50 N·m (37 lb ft).
