1997 - 1999 Corvette: Service Bulletin: Accessory Drive Squeak (Replace Idler Pulley)

Subject: Technical - Accessory Drive Squeak (Replace Idler Pulley)

Number: 99-06-01-007

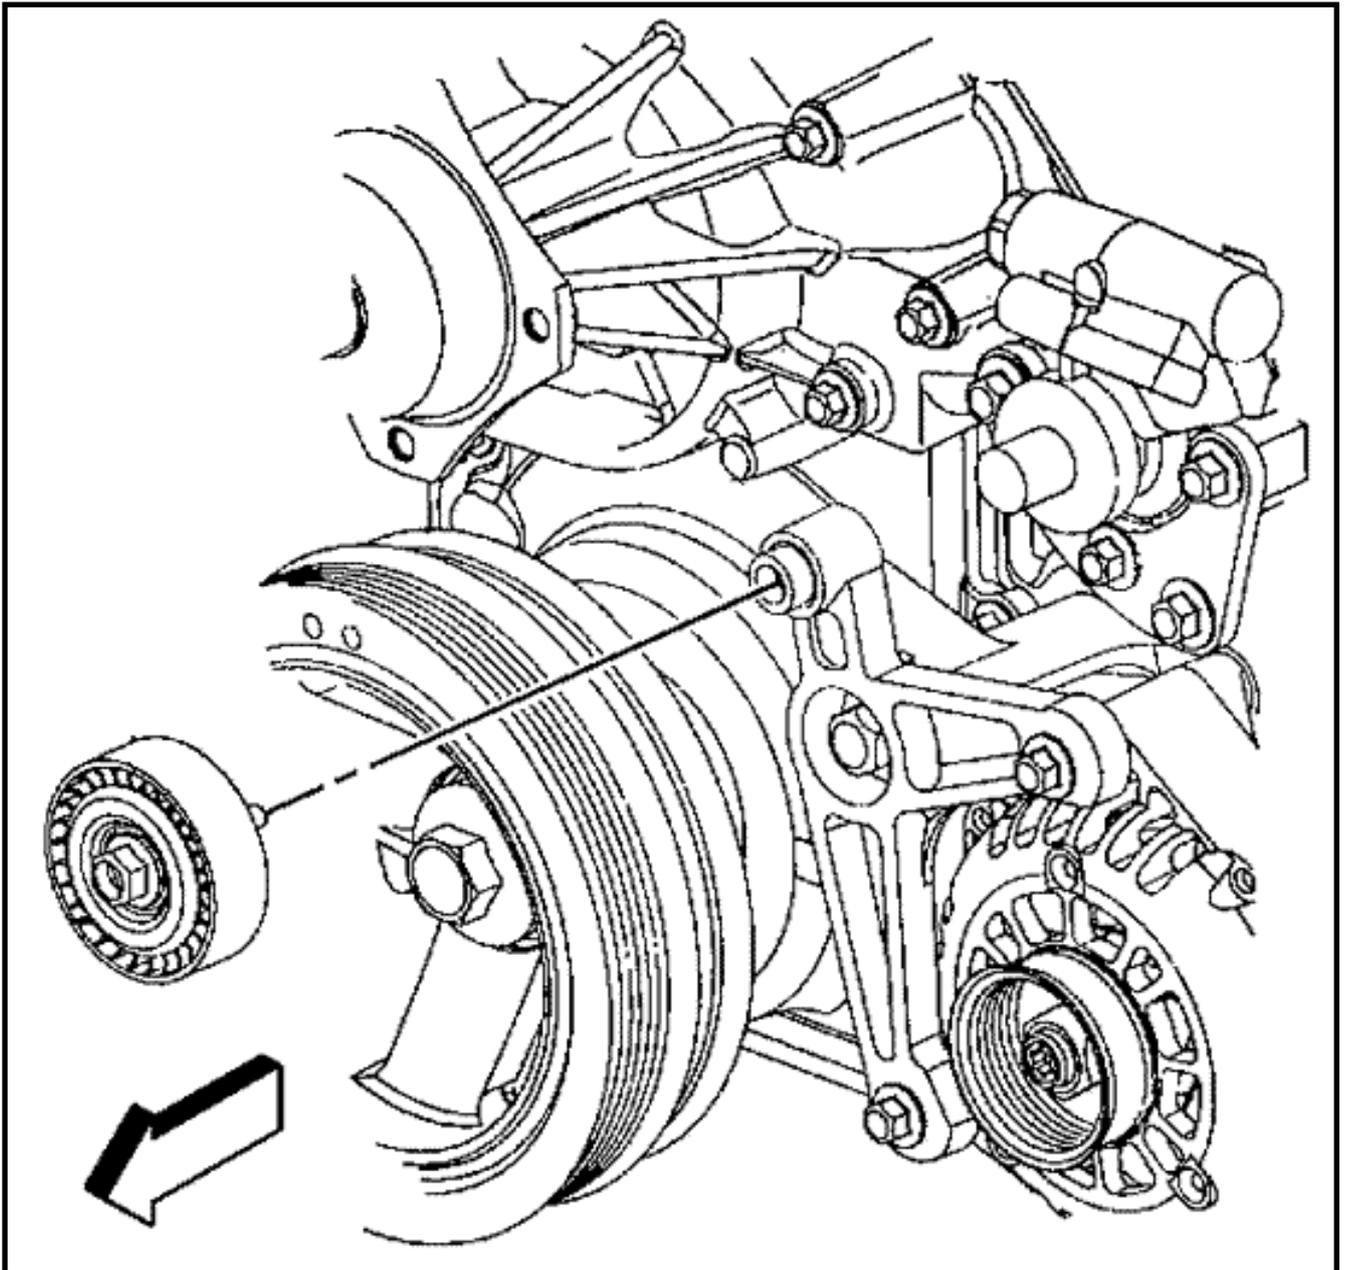
The idler pulley dust shield may distort during assembly due to torquing of the mounting bolt. This distortion may cause the idler pulley dust shield to contact the bearing race and the pulley resulting in the squeak noise.

A new idler pulley assembly is available with a thicker dust shield to prevent the distortion of the dust shield. The previous dust shield thickness is 0.61 mm. The new dust shield thickness is 1.37 mm.

- **Do not over-torque the mounting bolt or the condition may reoccur.**

Do not use pneumatic or electric tools for installation of the idler pulley assembly.

Torque the idler pulley bolt to 50 N·m (37 lb ft).
