# 2000 Corvette: Service Bulletin: Exhaust Boom at 1500 RPM

**Number:** 00-06-05-002

**Subject:** Exhaust Boom at 1500 RPM (Install Spacers to Exhaust Hanger)

**Model Year:** 2000 Chevrolet Corvette

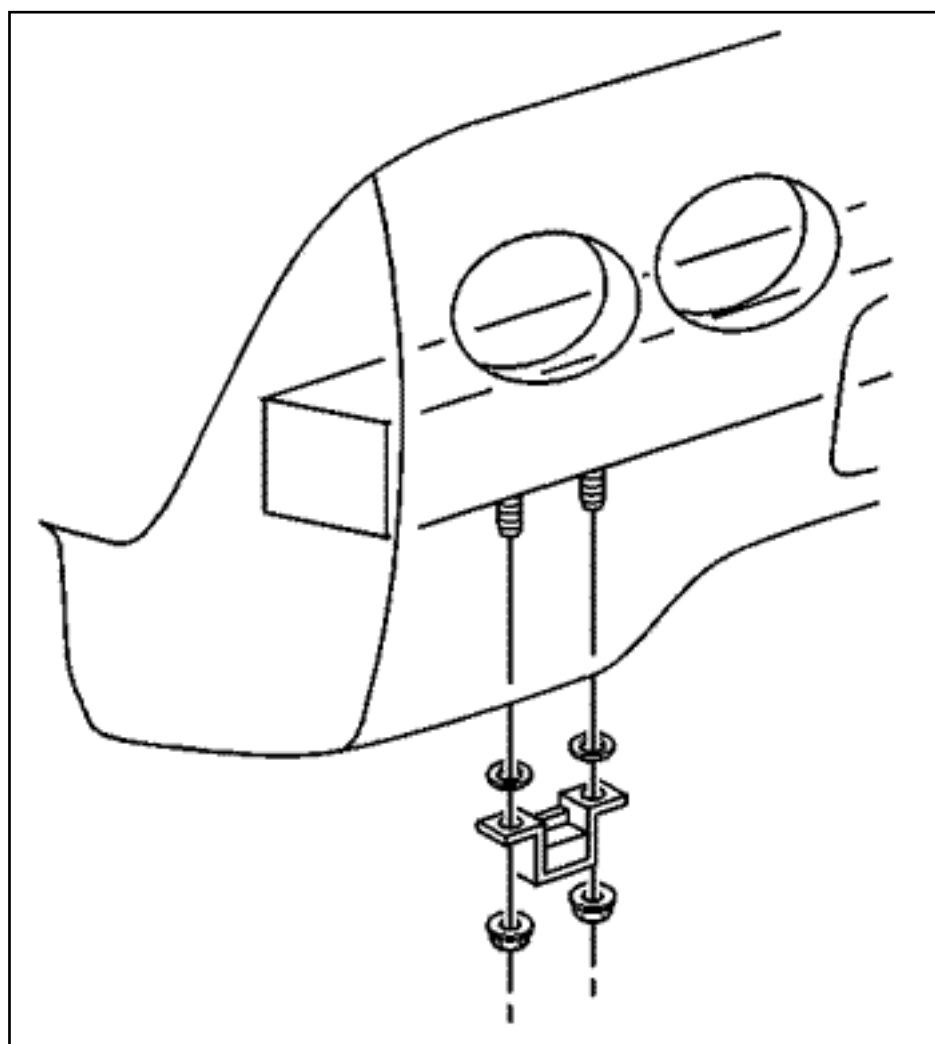
Some customers may comment on an exhaust boom heard inside the vehicle at 1500 RPM. Customers may also indicate an exhaust pipe outlet to fascia misalignment.

Install one 2 mm (.079 in) thick washer on each stud (2 per side), P/N 11505463, between the bumper bar and the muffler hanger, using the following procedure:

1. Raise the vehicle.
2. Remove the two nuts securing the left rear muffler hanger to the bumper reinforcement bar, then lower the exhaust.

3. Insert a washer on each muffler hanger mounting stud, as shown in the figure, then raise the exhaust.
4. Install the muffler hanger mounting nuts. Tighten

Tighten the nuts to 16 N·m (12 lb ft).
