1998 - 2001 Corvette Convertible: Service Bulletin: Squeak From Rear of Convertible Top (Replace Protector Assembly)

Number: 01-08-67-003

Subject: Squeak From Rear of Convertible Top (Replace Protector Assembly)

Model Year: 1998-2001 Corvette

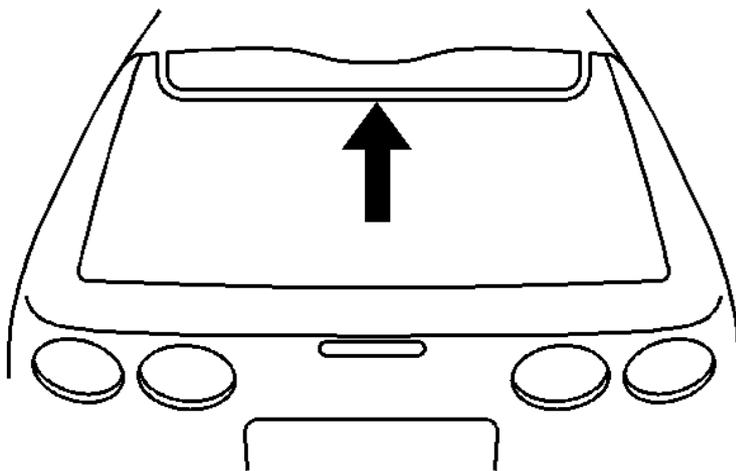
Some customers may comment on a squeak coming from the rear of the convertible top.

This condition may be caused by interference between the fifth bow seal and the tonneau cover rub strip. (Refer to the illustration above).

1. Remove the old seal.
2. Remove any two way tape from the body.
3. Clean the surface.
4. Install a new front top stow compartment lid protector assembly.
