# 1998 - 2001 Corvette Convertible: Service Bulletin: Squeak From Rear of Convertible Top (Replace Protector Assembly)

**Number:** 01-08-67-003

**Subject:** Squeak From Rear of Convertible Top (Replace Protector Assembly)

**Model Year:** 1998-2001 Corvette

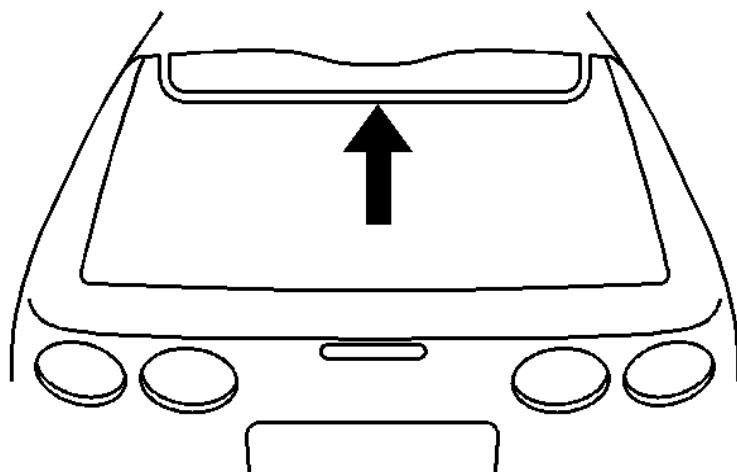
Some customers may comment on a squeak coming from the rear of the convertible top.

This condition may be caused by interference between the fifth bow seal and the tonneau cover rub strip. (Refer to the illustration above).

1. Remove the old seal.
2. Remove any two way tape from the body.
3. Clean the surface.
4. Install a new front top stow compartment lid protector assembly.

Part Number	Description
10313384	Front Top Stow Compartment Lid Protector Assembly
