1998 Corvette Convertible: Service Bulletin: Tonneau Cover Makes Noise When Going Over Bumps

Subject: TONNEAU COVER MAKES NOISE WHEN GOING OVER BUMPS
(INSTALL TAPE)

Number: 83-15-06 - (04/22/1998)

Models: 1998 CHEVROLET CORVETTE CONVERTIBLE

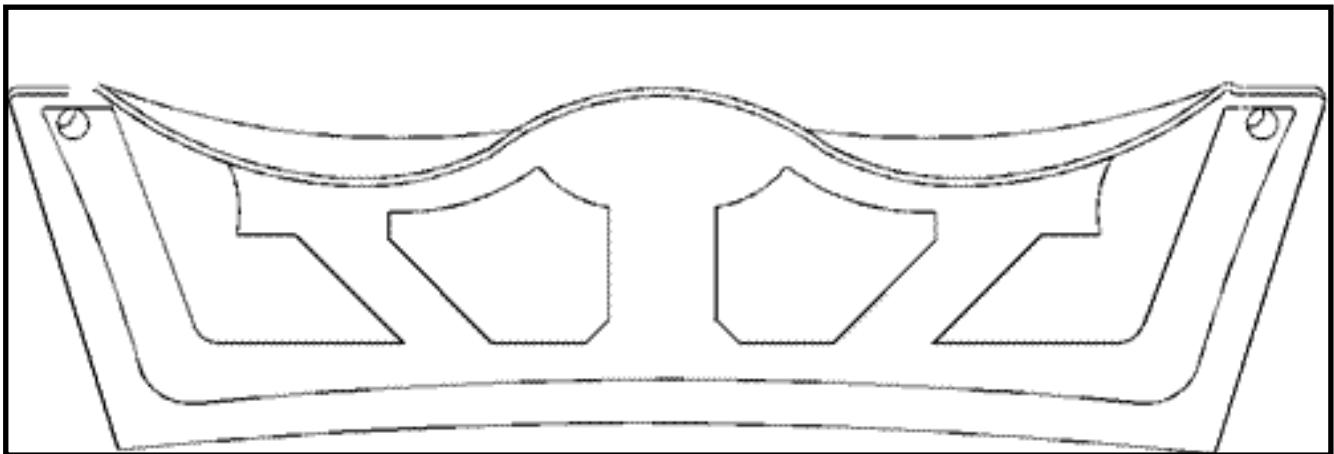
SOME CUSTOMERS MAY COMMENT THAT THE TONNEAU COVER MAKES NOISE WHEN GOING OVER BUMPS, WITH TOP IN THE UP POSITION.

THIS SITUATION MAY BE CAUSED BY THE RUBBER STOP BUMPERS HAVING A STICK/SLIP CONDITION TO THE TONNEAU COVER.

1. CLEAN TONNEAU COVER IN THE AREA SHOWN (FIGURE 1) WITH A GENERAL PURPOSE CLEANER.
2. INSTALL A PIECE OF 3M(R) SCOTCH SQUEAK REDUCTION TAPE (P/N 06356), OR EQUIVALENT, TO THE TONNEAU COVER.
