# 1997 Corvette: Service Bulletin: Water Drips into Rear Compartment After Hatch/Glass Has Been Opened

**Subject:** Water Drips into Rear Compartment After Hatch/Glass Has Been Opened (Modify Weatherstrip)

**Number:** 73-10-55

**Models:** 1997 Chevrolet Corvette

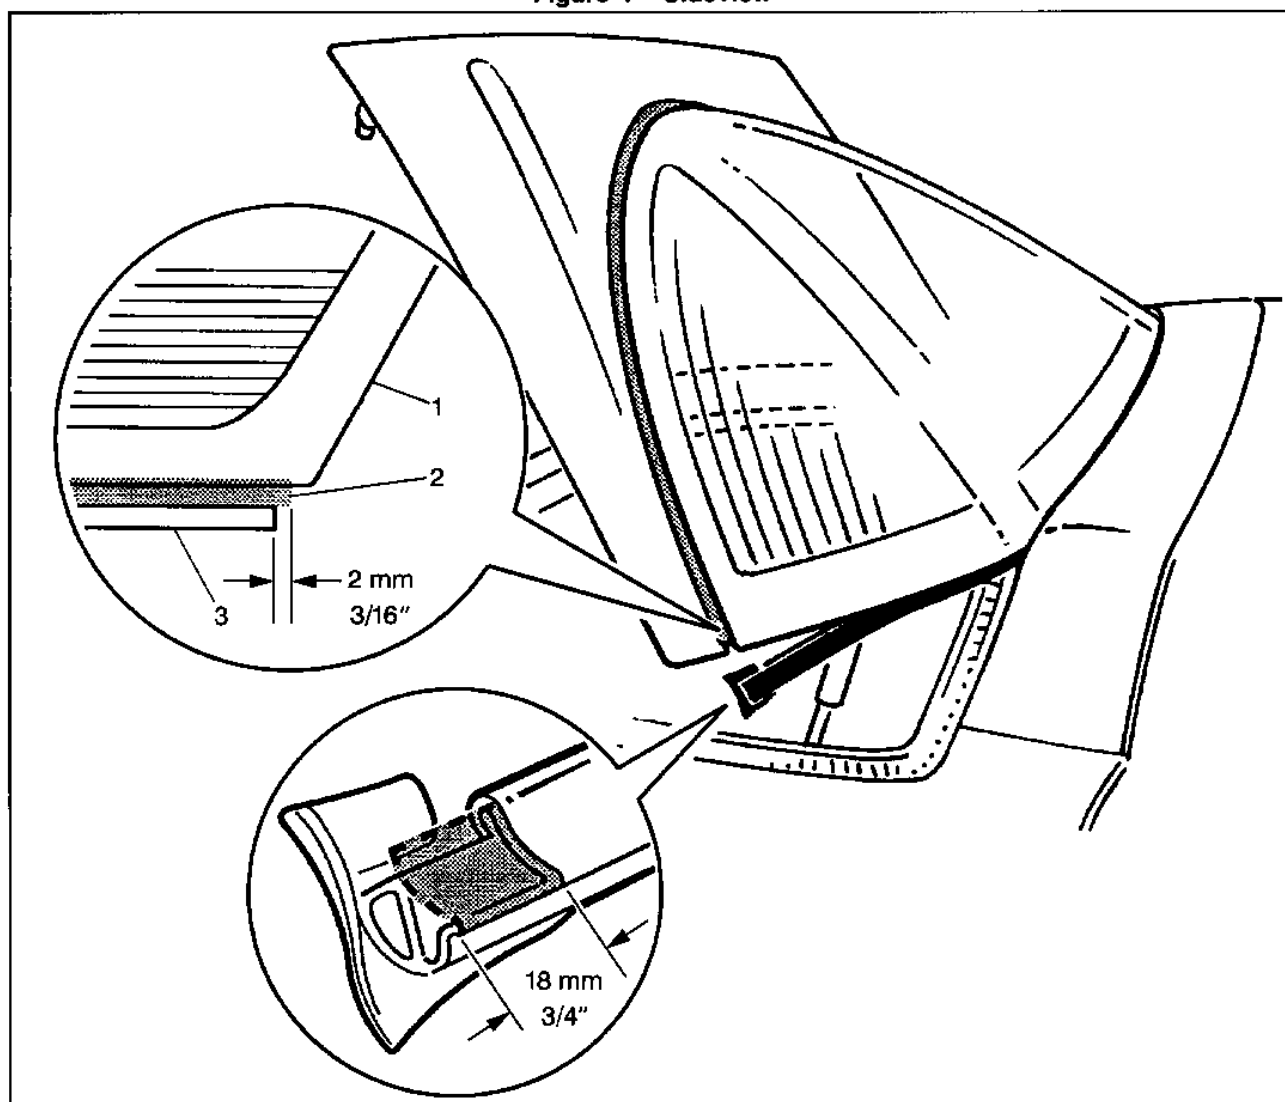
**Figure 1 - Sideview**

**Condition:** Some owners may comment that water drips into the rear compartment after the hatch glass has been opened.

**Correction:** Modify weatherstrip following instructions below.

1. Pull down weatherstrip to gain access to the end of the black close out weatherstrip (see Figure 1, top view). With a utility knife, cut the close out weatherstrip so there is a 2 MM (3/16 in.) overhang of the weatherstrip to its mounting surface (See Figure 1, top view)
2. With weatherstrip pulled down, measure 18 MM (3/4 in.) from end of weatherstrip and remove shaded area from weatherstrip (see Figure 1, bottom view). Reinstall weatherstrip on hatch.
