# 1997 Corvette: Service Bulletin: Water Drips into Rear Compartment After Hatch/Glass Has Been Opened

**Number:** 73-10-55

**Models:** 1997 Chevrolet Corvette

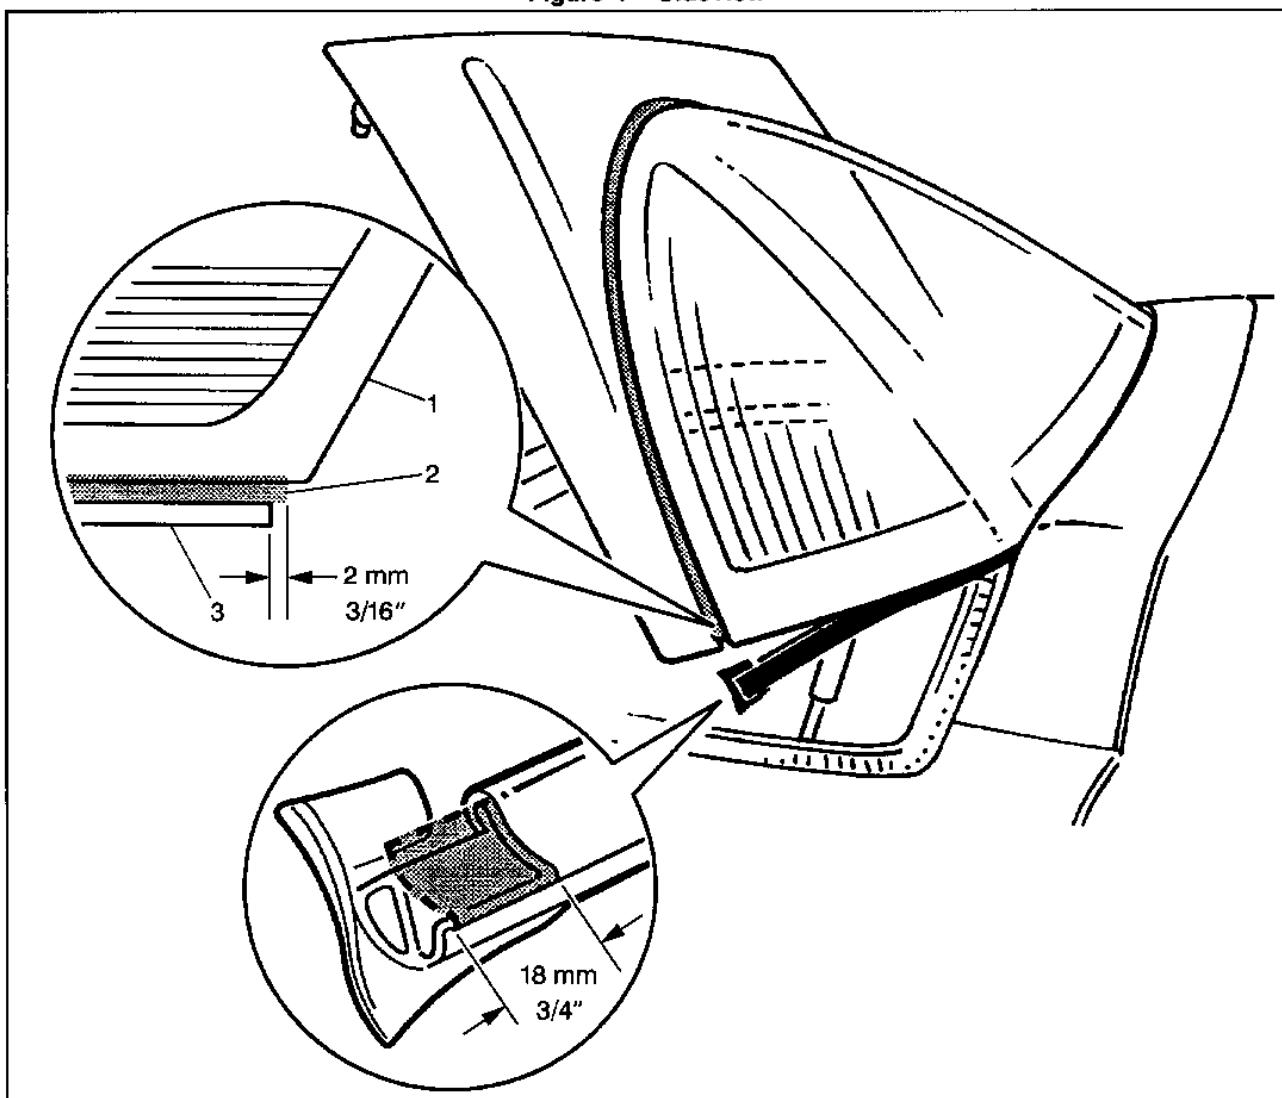
**Figure 1 - Sideview**

**Condition:** Some owners may comment that water drips into the rear compartment after the hatch glass has been opened.

1. Pull down weatherstrip to gain access to the end of the black close out weatherstrip (see Figure 1, top view). With a utility knife, cut the close out weatherstrip so there is a 2 MM (3/16 in.) overhang of the weatherstrip to its mounting surface (See Figure 1, top view)
2. With weatherstrip pulled down, measure 18 MM (3/4 in.) from end of weatherstrip and remove shaded area from weatherstrip (see Figure 1, bottom view). Reinstall weatherstrip on hatch.
