# 1997 Corvette: Service Bulletin: Water Drips into Rear Compartment After Hatch/Glass Has Been Opened

**Number:** 73-10-55

**Models:** 1997 Chevrolet Corvette

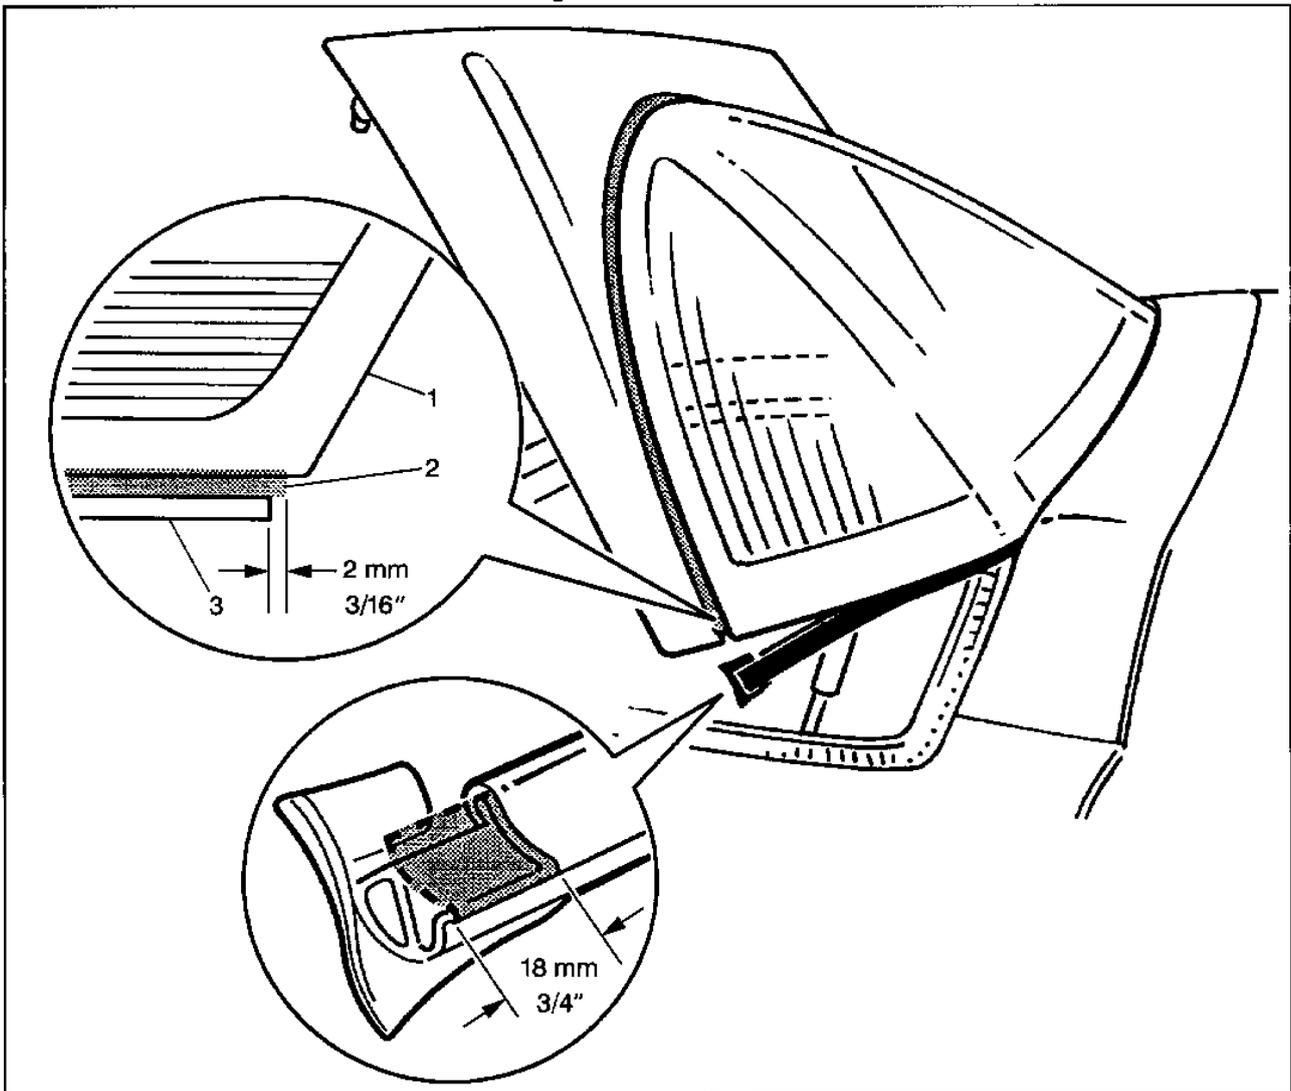
Figure 1 - Sideview

**Condition:** Some owners may comment that water drips into the rear compartment after the hatch glass has been opened.

1. Pull down weatherstrip to gain access to the end of the black close out weatherstrip (see Figure 1, top view). With a utility knife, cut the close out weatherstrip so there is a 2 MM (3/16 in.) overhang of the weatherstrip to its mounting surface (See Figure 1, top view)
2. With weatherstrip pulled down, measure 18 MM (3/4 in.) from end of weatherstrip and remove shaded area from weatherstrip (see Figure 1, bottom view). Reinstall weatherstrip on hatch.
