# 1997 - 2004 Corvette: Service Bulletin: General Waterleak Guide

**Subject:** General Waterleak Guide

**Source:** Chevrolet Dealer Technical Service Bulletin

**Number:** 02-08-57-003

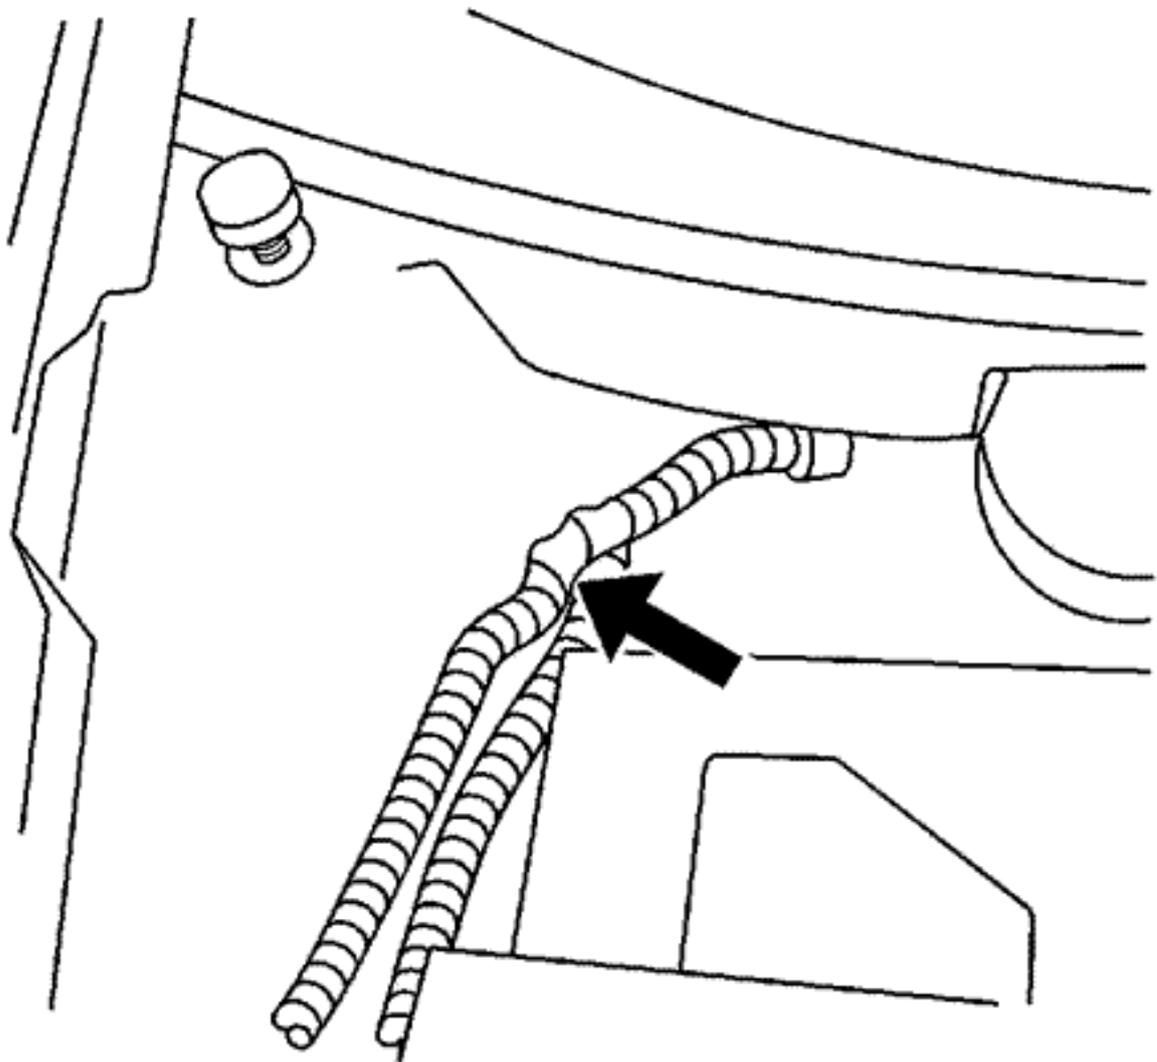
Water is dripping on top of the passenger side carpet.

A wire harness leading into the passenger side compartment may be mis-routed (bent upward) at the first split in the wire harness. This may allow water to enter the harness and into the passenger side compartment. Refer to the arrow in the illustration.

Remove the battery and push the harness downward.

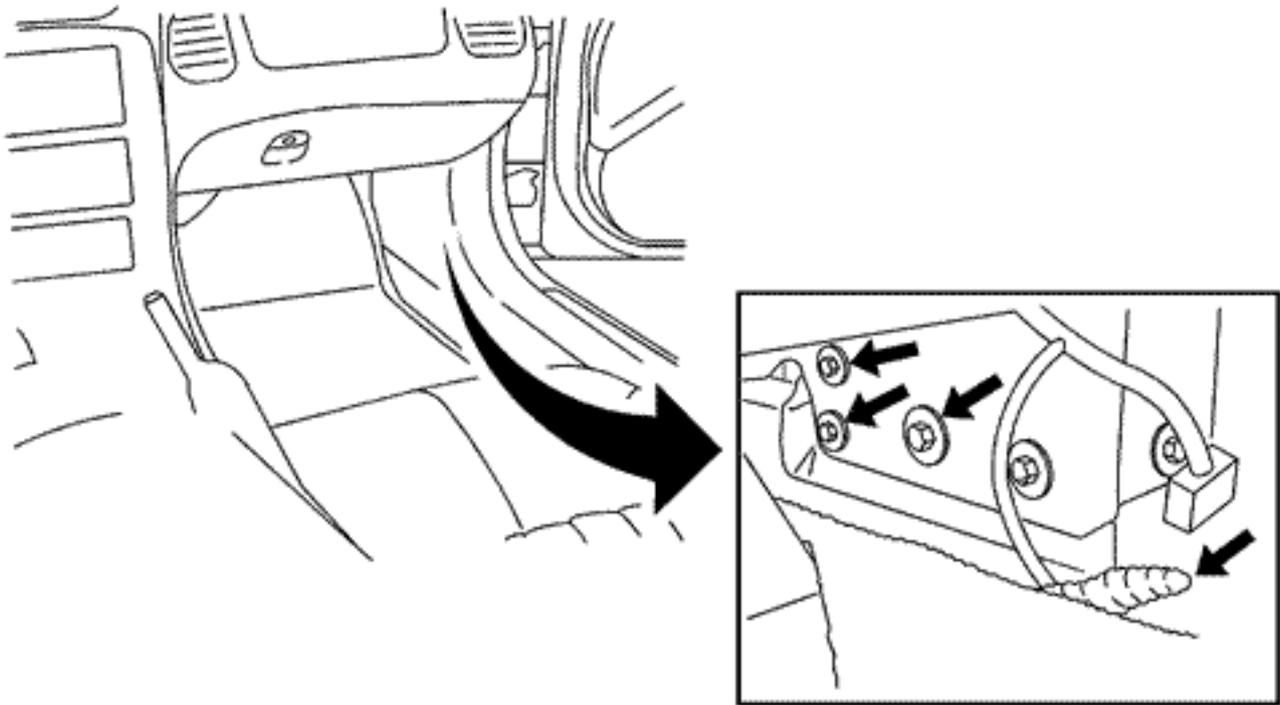
The carpet is wet under the passenger side floor.

The dash attaching bolts may not be sealed. Refer to the bolts in the illustration.

The lower hinge pillar may not be sealed. Refer to the arrow in the lower right hand corner in the illustration above.

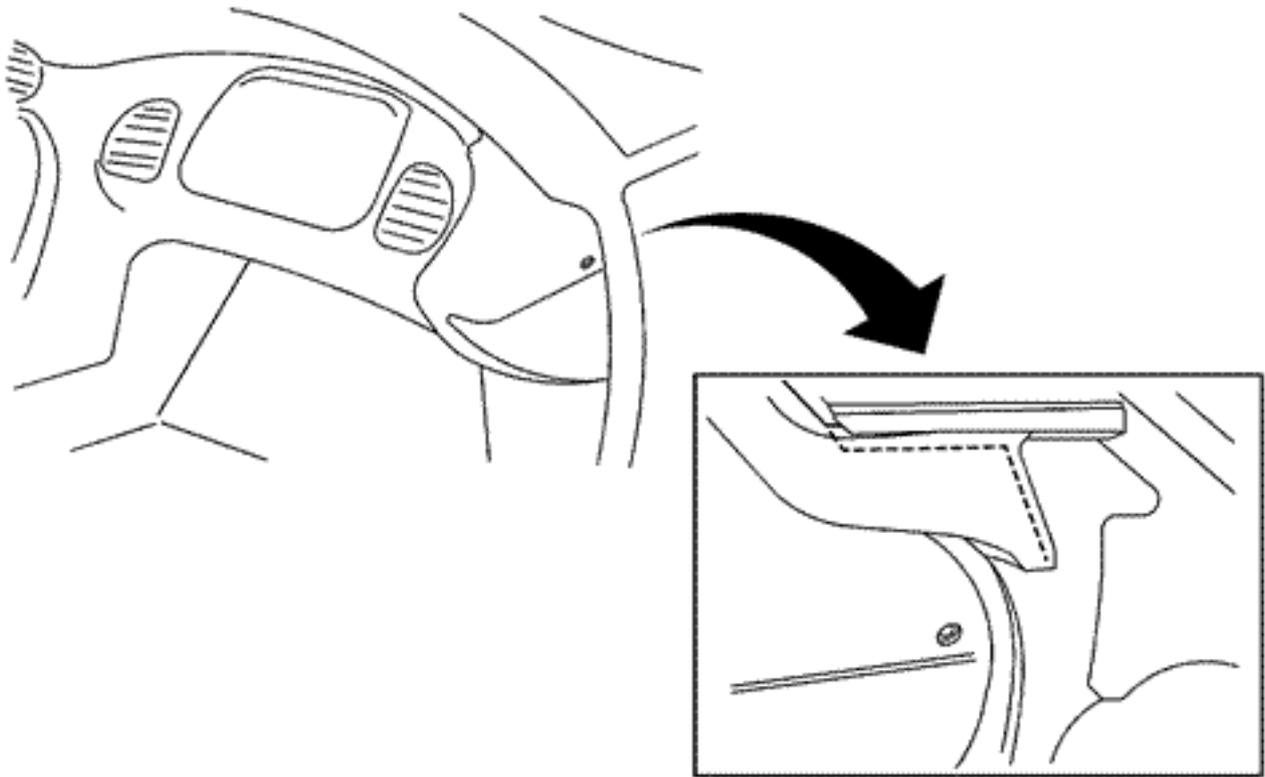
Water is running down the front edge of the door or water is on top of the sill plate.

The butyl strip under the seal at the base of the "A" pillar may not be sealing properly or the push-in fastener may not be seated.

Clean the area with one of the cleaners listed below.

Reseal the "A" pillar starting at the bottom of the weatherstrip retainer with the GM sealer listed below. Refer to the dotted line in the illustration for sealing.

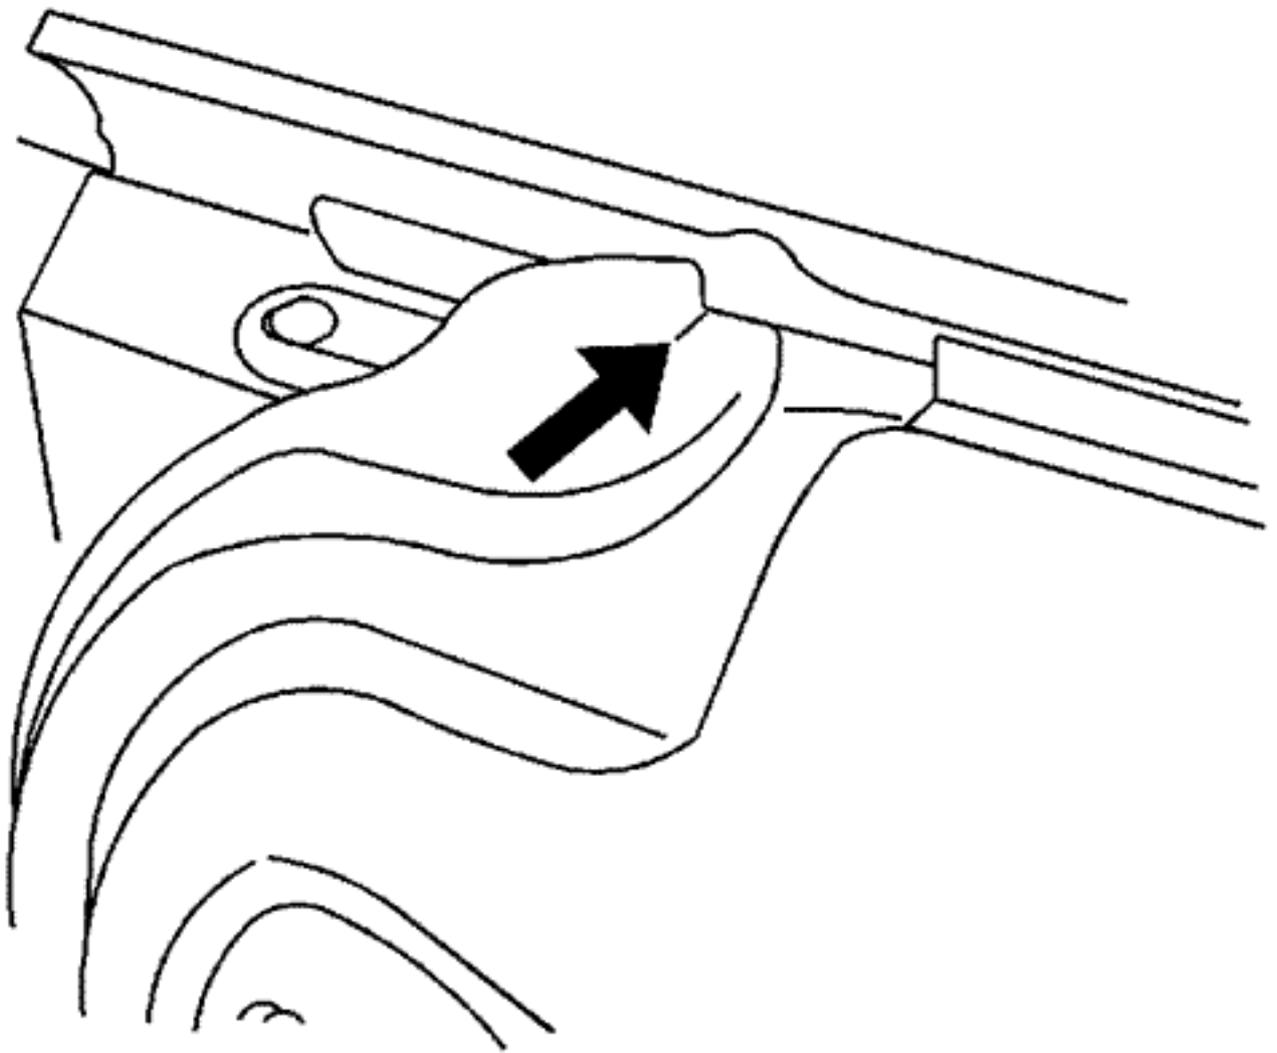
Water may be leaking around the weatherstrip at the top of the door due to an undesirable nub in the weatherstrip at the top of the door. Refer to the arrow in the illustration .

Replace the weatherstrip.

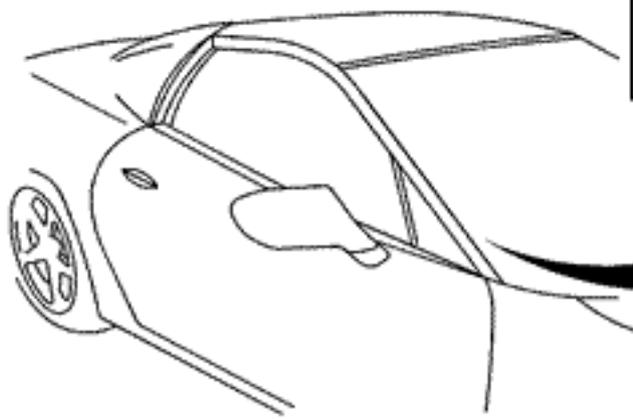
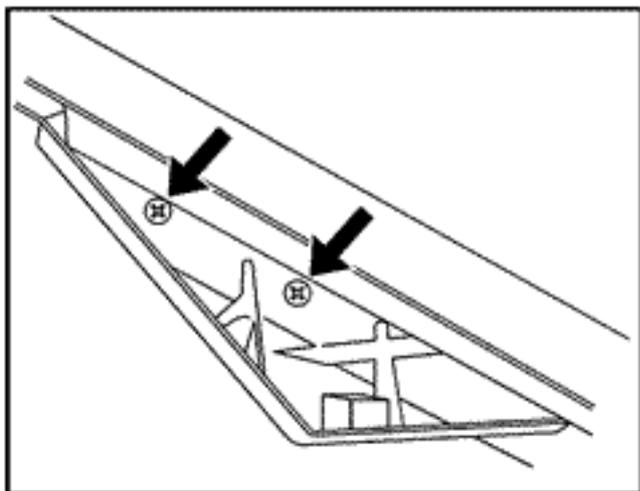
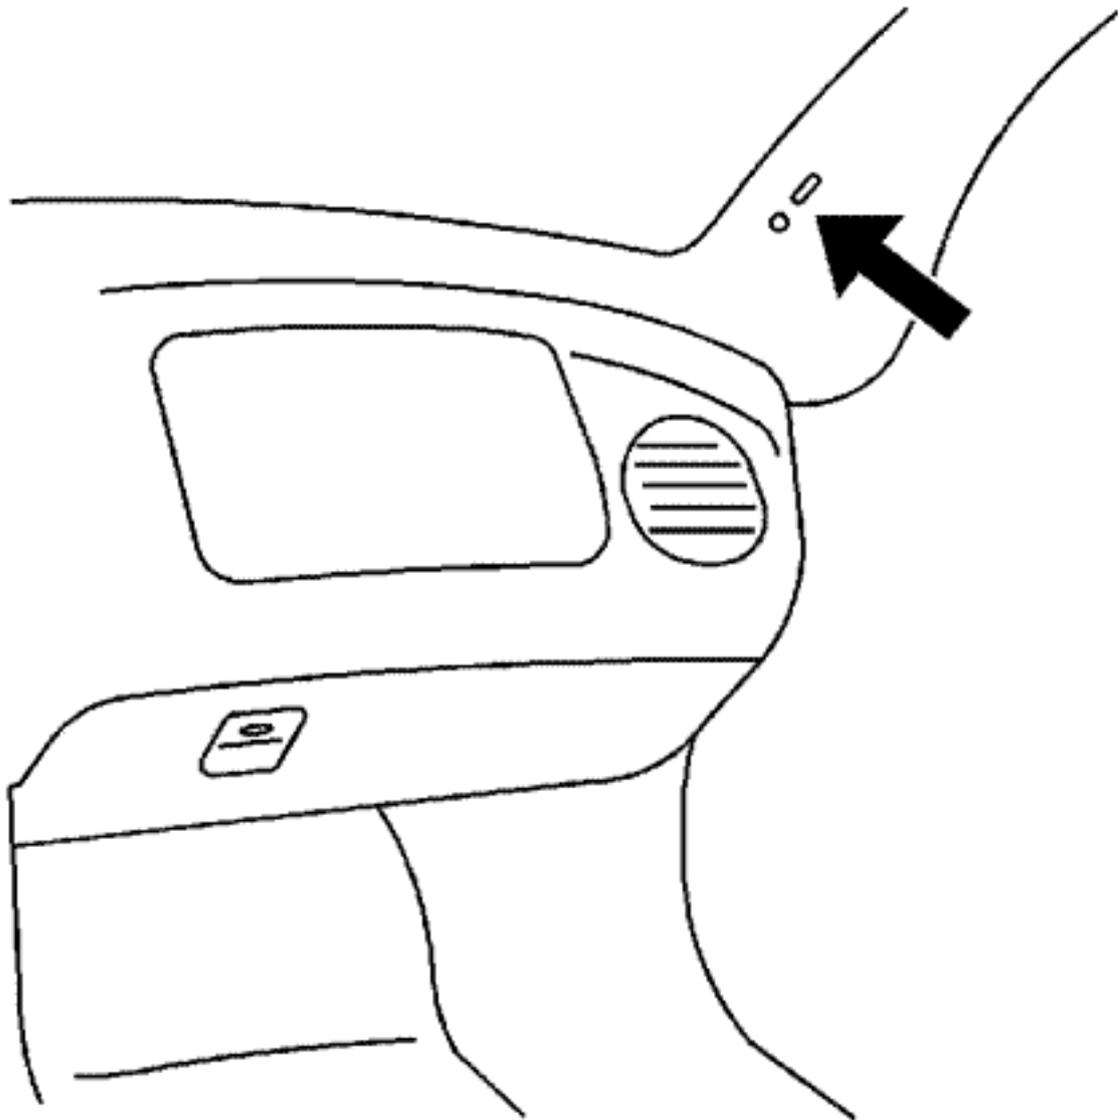
Two screws may not be sealed under the "A" pillar garnish molding. Refer to the illustration. During water test with the "A" pillar molding off, there may be water coming out of either the garnish molding retaining hole or the wire harness retaining hole. Refer to the arrow in the illustration.

Seal the two screws with the Kent™ sealer listed below.

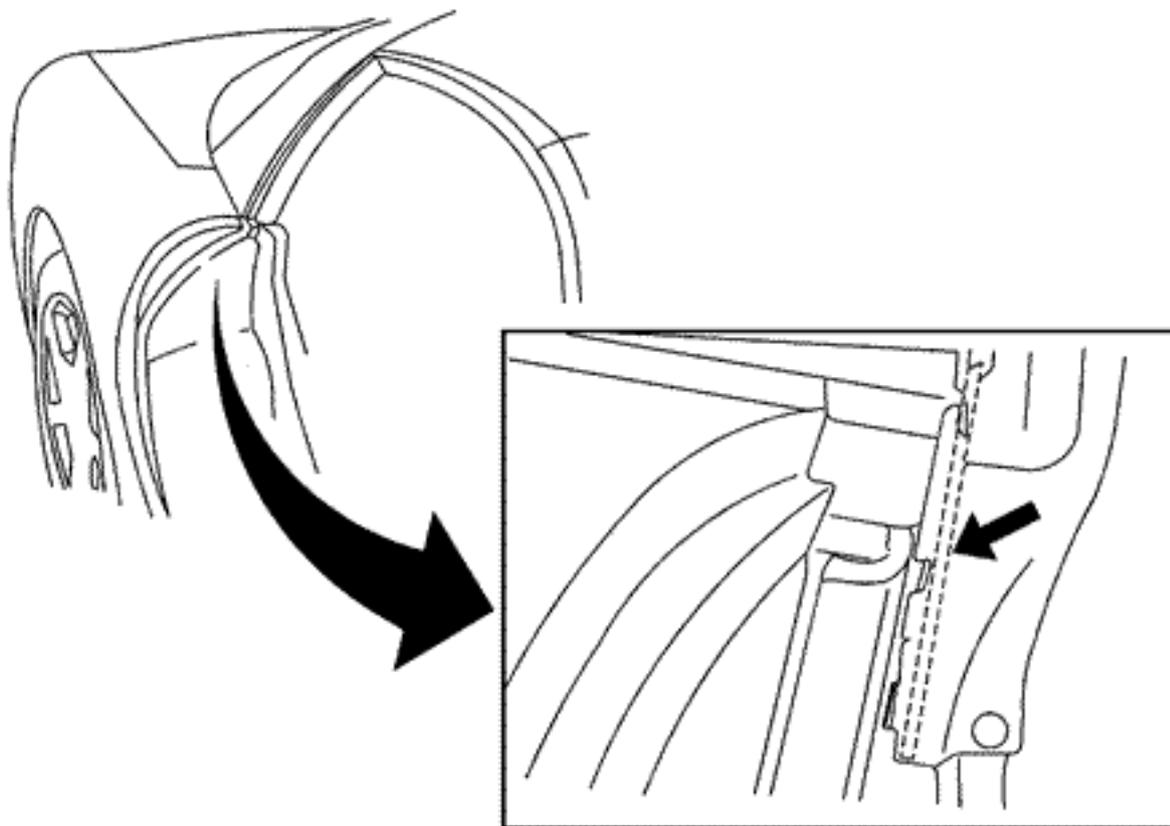
The floor is wet behind the seat belts.

The "B" pillar weatherstrip may not be sealed properly.

Reseal the weatherstrip with the GM sealer listed below. Refer to the dotted line in the illustration for sealing area.

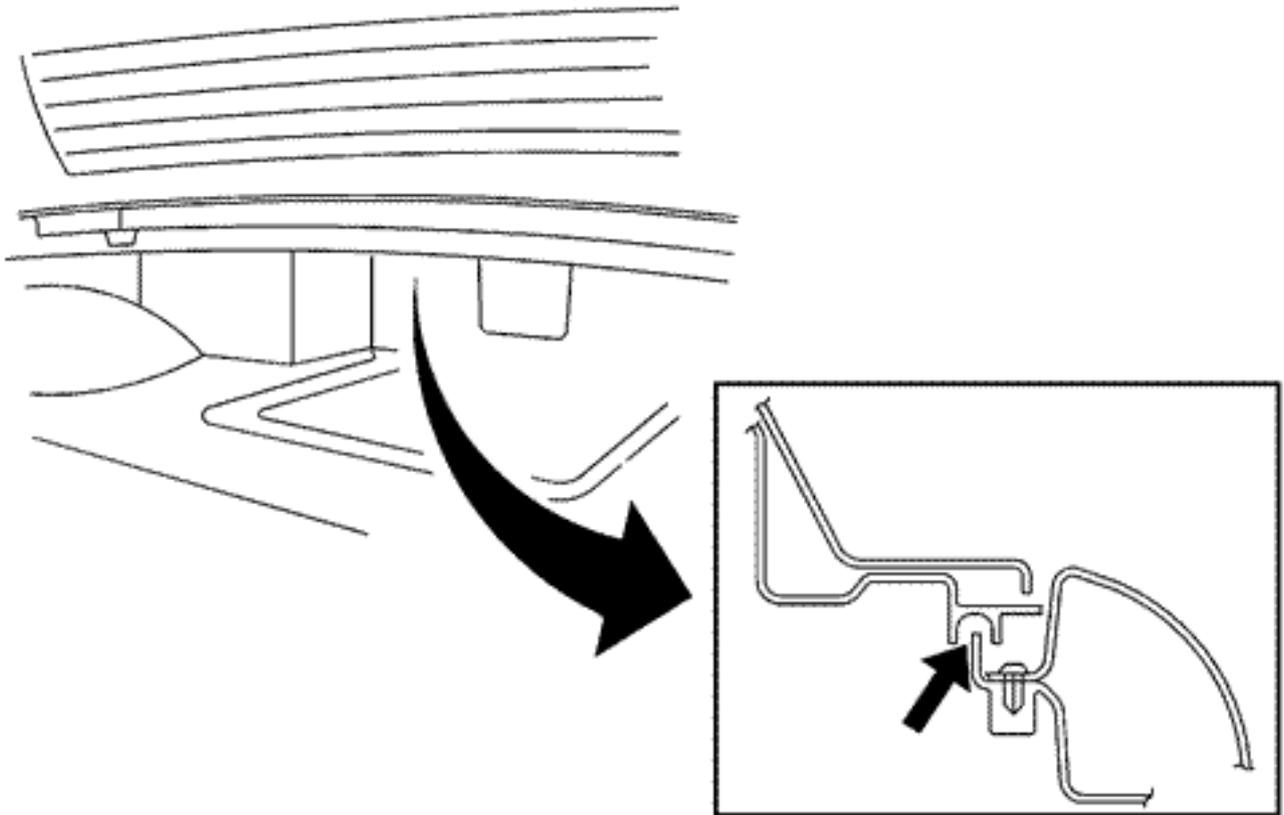
There may be a leak around the perimeter of the hard top causing water to drip from the garnish molding into the rear compartment.

There may be a void in the sealer between the body and the hard top.

Clean the area with one of the cleaners listed below and seal the area shown in the illustration with the Kent™ sealer listed below.

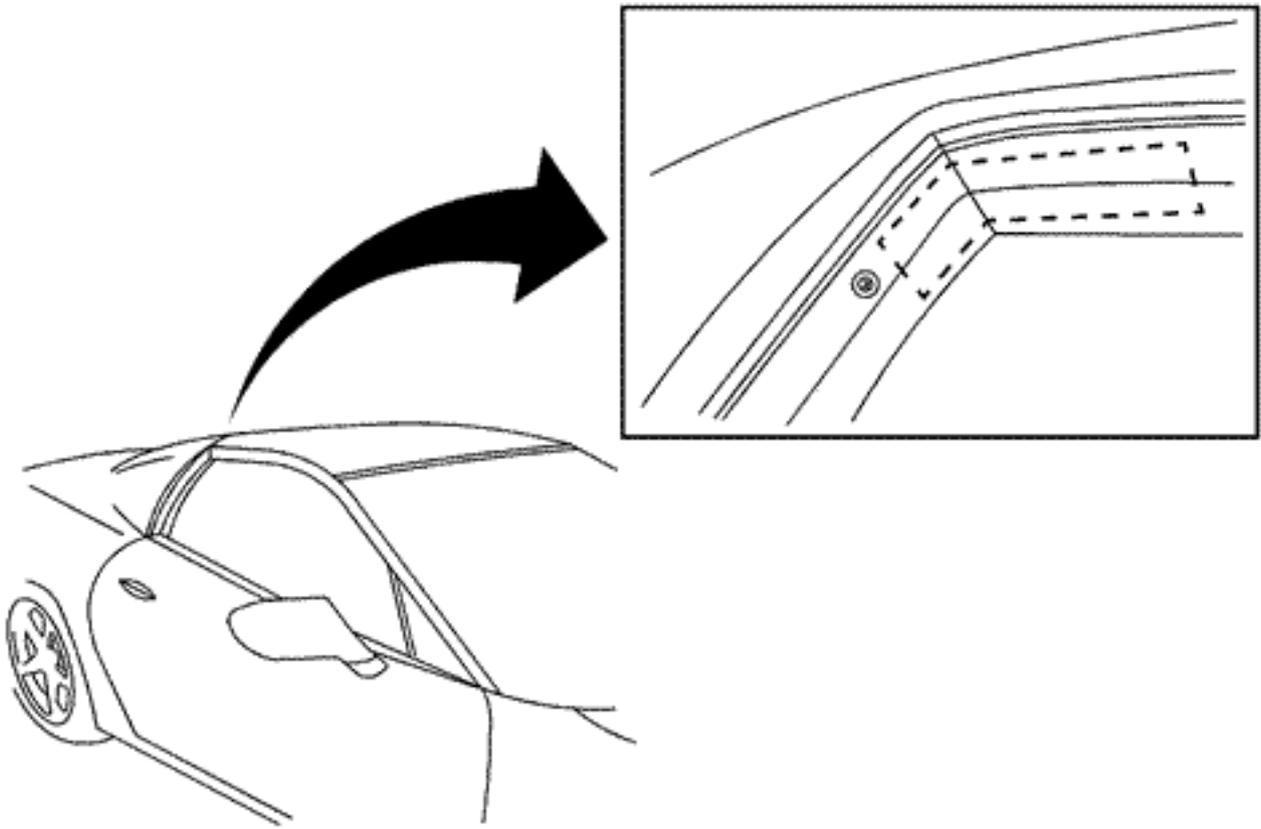
The floor is wet behind the seat belts (Hardtop/ Z06 only).

The top corner of the weatherstrip may not be sealed properly. Refer to the area shown in the illustration.

Reseal the weatherstrip with the GM sealer listed below. Refer to the sealer in the illustration.

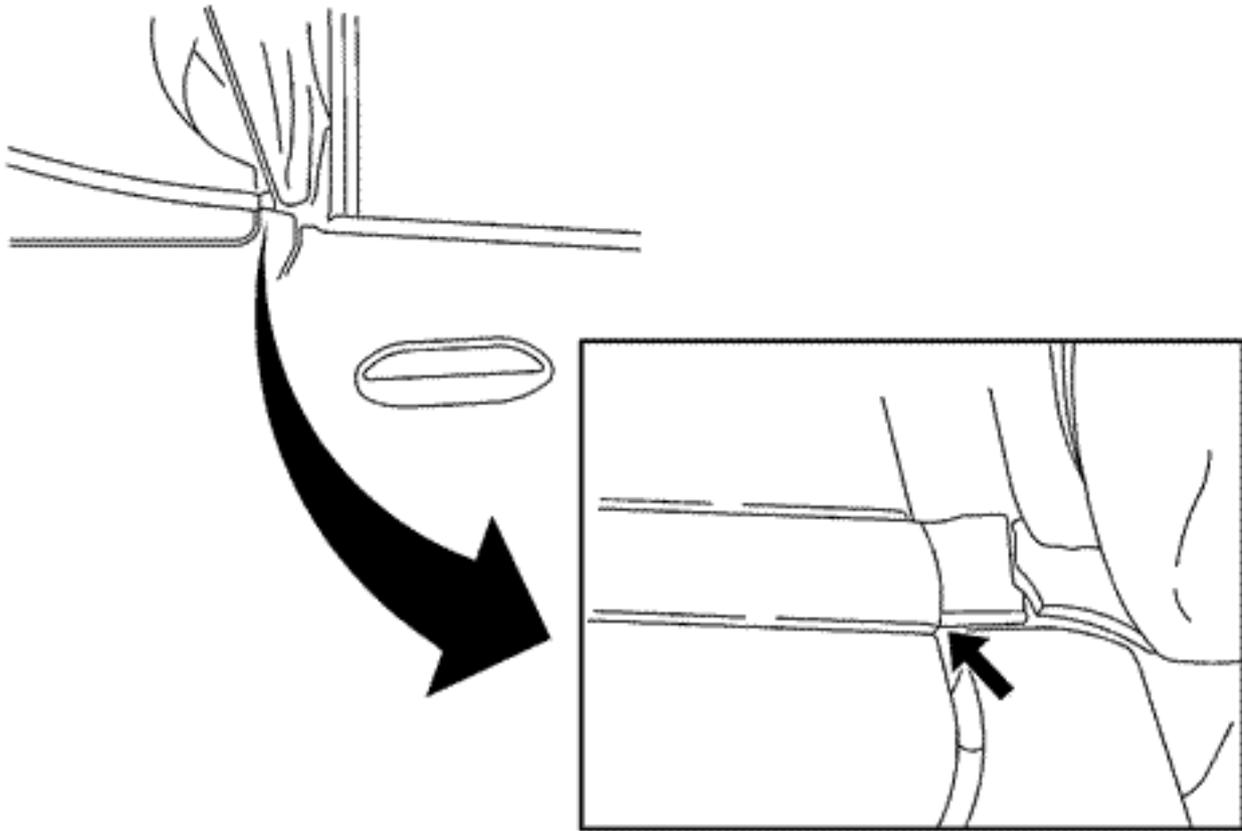
The floor is wet behind the seat belts or water seems to be entering through the hole in the interior trim panel where the seat belt feeds through.

The fit where the front edge of the convertible top stowage compartment lid "protector" contacts the rear edge "bulb seal" of the "mucket"\*. Refer to the illustration above.

The front edge of the stowage lid protector should overhang the stowage lid by approximately 3 mm (0.12 in). That 3 mm (0.12 in) overhang should then firmly contact the bulb seal rear edge of the mucket to complete the seal between the stowage lid and the lower "B" pillar.
