1997 - 2004 Corvette: Service Bulletin: General Waterleak Guide

Subject: General Waterleak Guide

Number: 02-08-57-003

Models: 1997-2002 Chevrolet Corvette

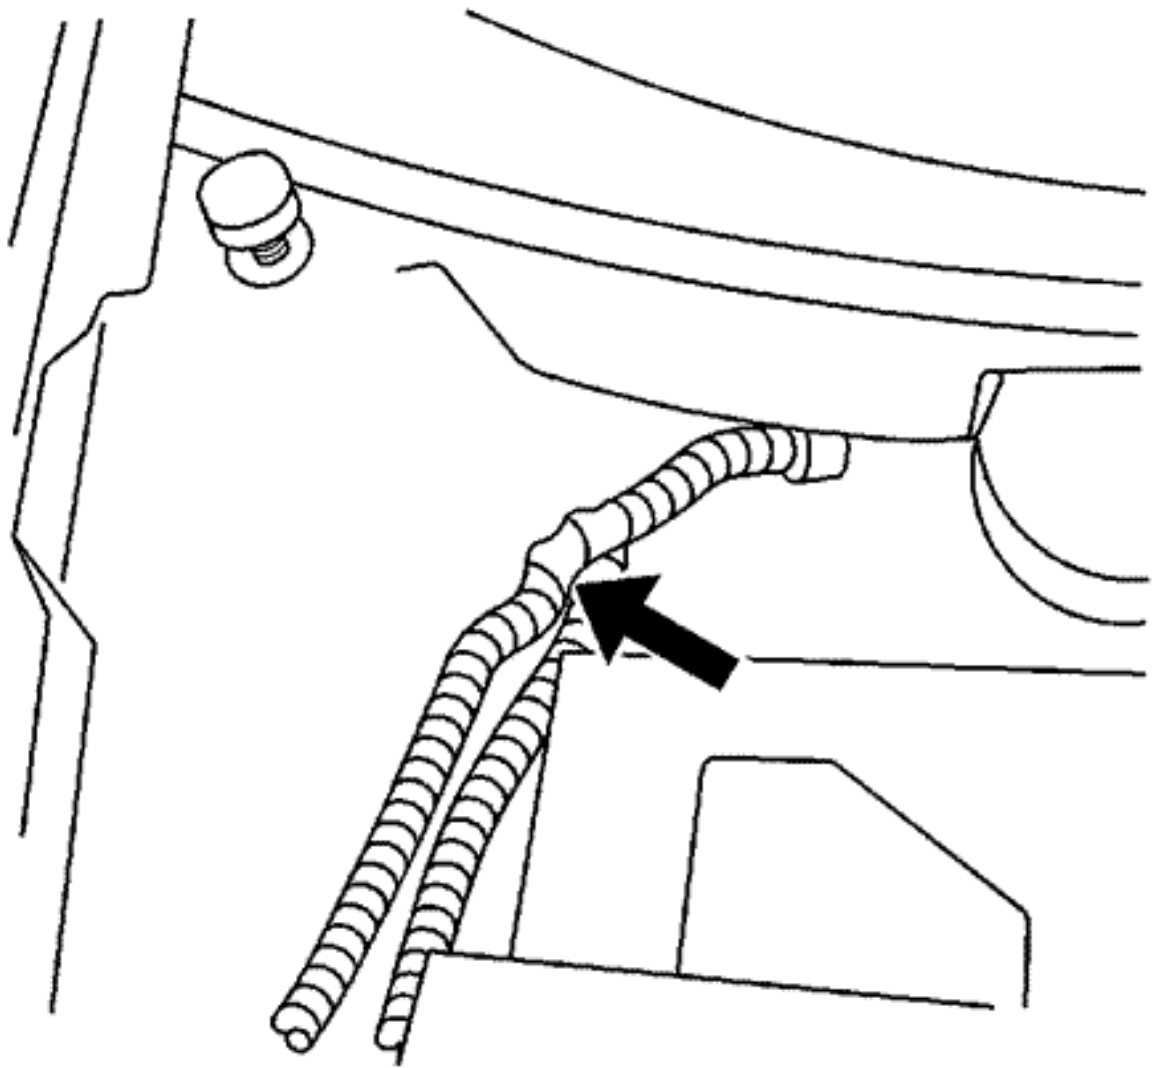
Water is dripping on top of the passenger side carpet.

A wire harness leading into the passenger side compartment may be mis-routed (bent upward) at the first split in the wire harness. This may allow water to enter the harness and into the passenger side compartment. Refer to the arrow in the illustration.

Remove the battery and push the harness downward.

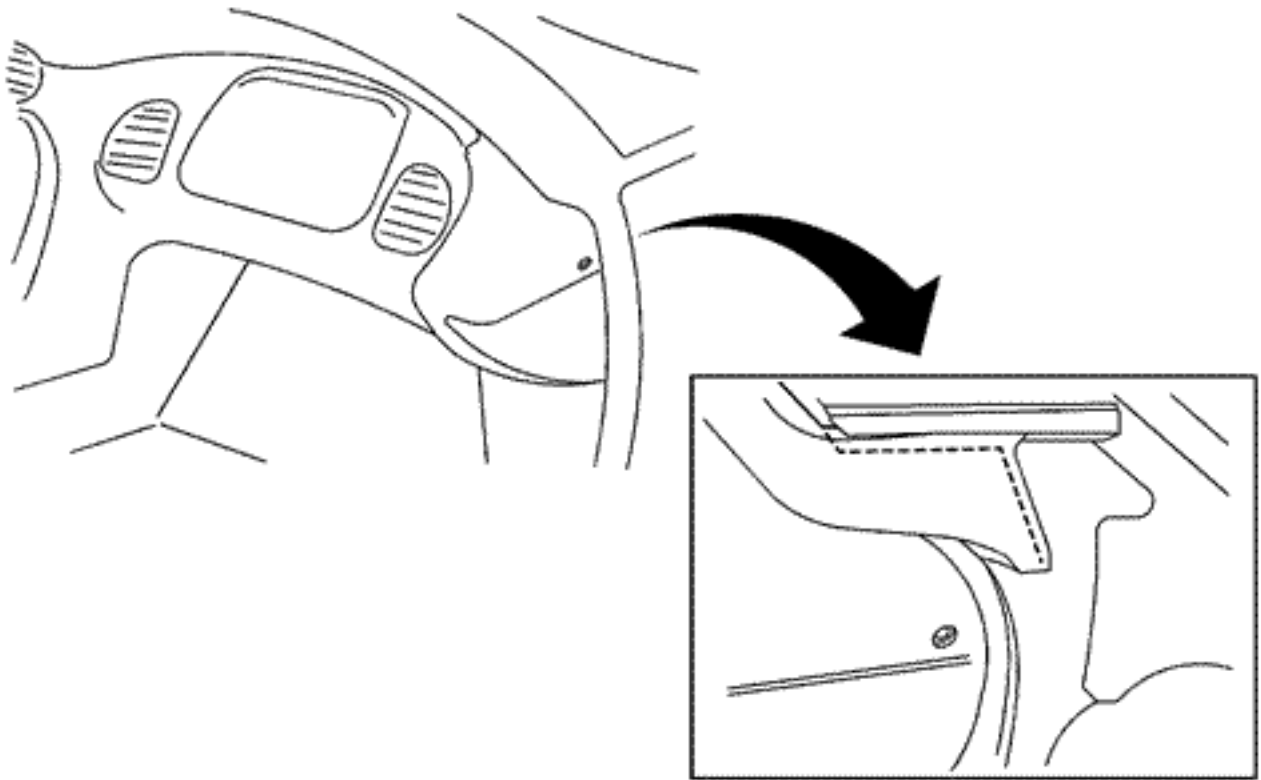
Water is running down the front edge of the door or water is on top of the sill plate.

The butyl strip under the seal at the base of the "A" pillar may not be sealing properly or the push-in fastener may not be seated.

Clean the area with one of the cleaners listed below.

Reseal the "A" pillar starting at the bottom of the weatherstrip retainer with the GM sealer listed below. Refer to the dotted line in the illustration for sealing.

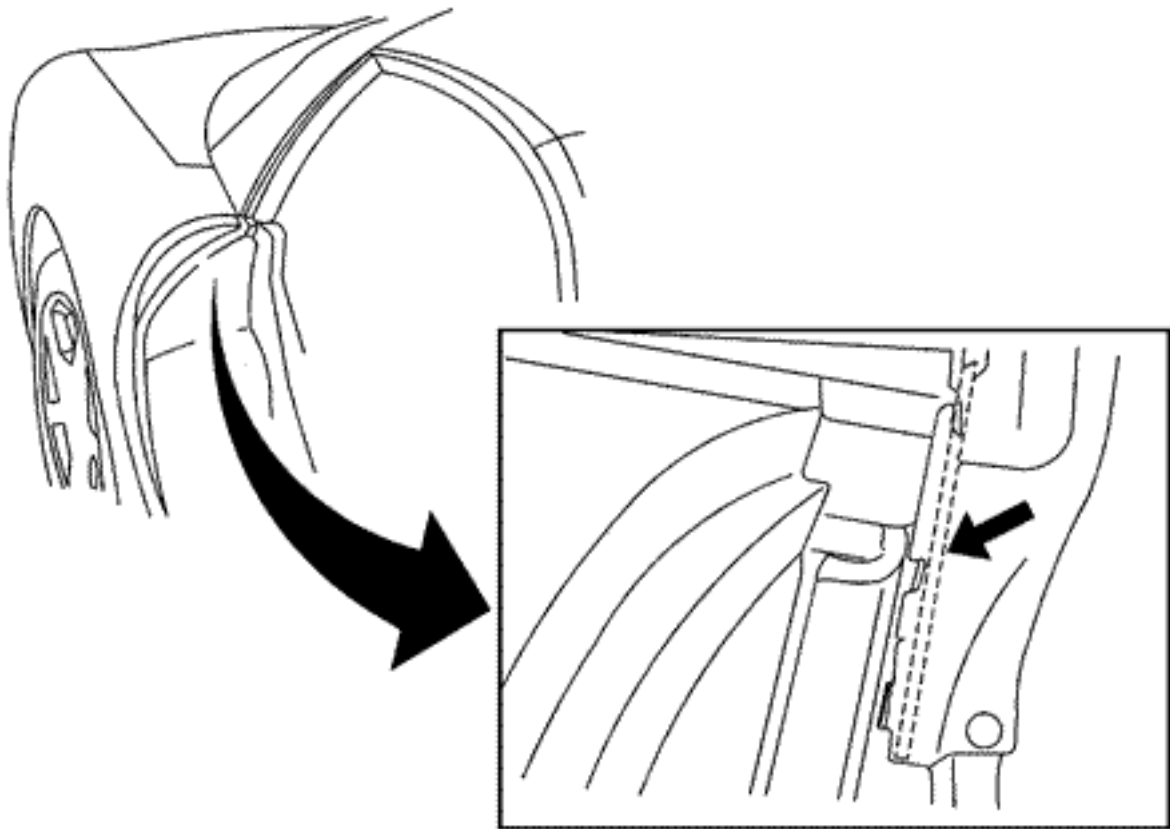
The floor is wet behind the seat belts.

The "B" pillar weatherstrip may not be sealed properly.

Reseal the weatherstrip with the GM sealer listed below. Refer to the dotted line in the illustration for sealing area.
