1997 - 2004 Corvette: Service Bulletin: General Waterleak Guide

Subject: General Waterleak Guide

Number: 02-08-57-003

Models: 1997-2002 Chevrolet Corvette

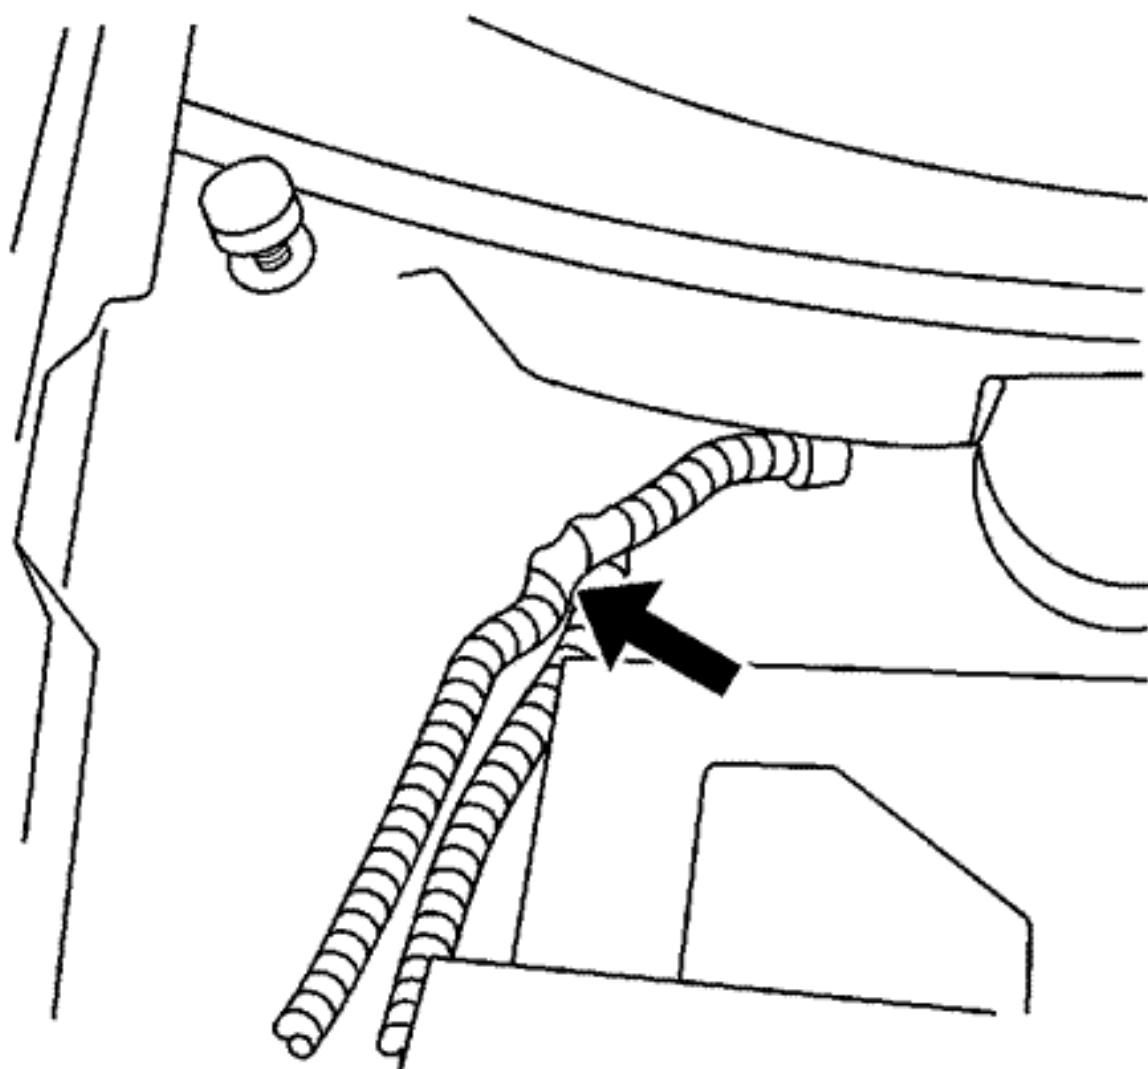
Water is dripping on top of the passenger side carpet.

A wire harness leading into the passenger side compartment may be misrouted (bent upward) at the first split in the wire harness. This may allow water to enter the harness and into the passenger side compartment. Refer to the arrow in the illustration.

Remove the battery and push the harness downward.

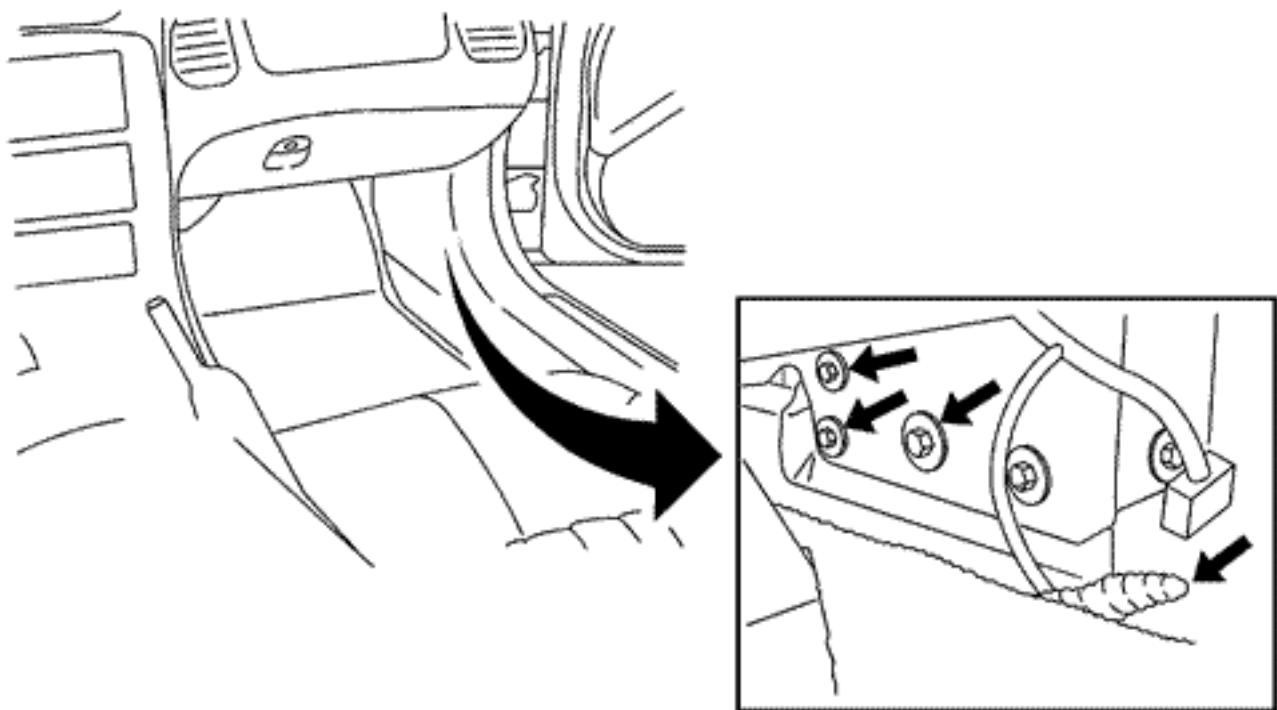
The carpet is wet under the passenger side floor.

The dash attaching bolts may not be sealed. Refer to the bolts in the illustration.

The lower hinge pillar may not be sealed. Refer to the arrow in the lower right hand corner in the illustration above.

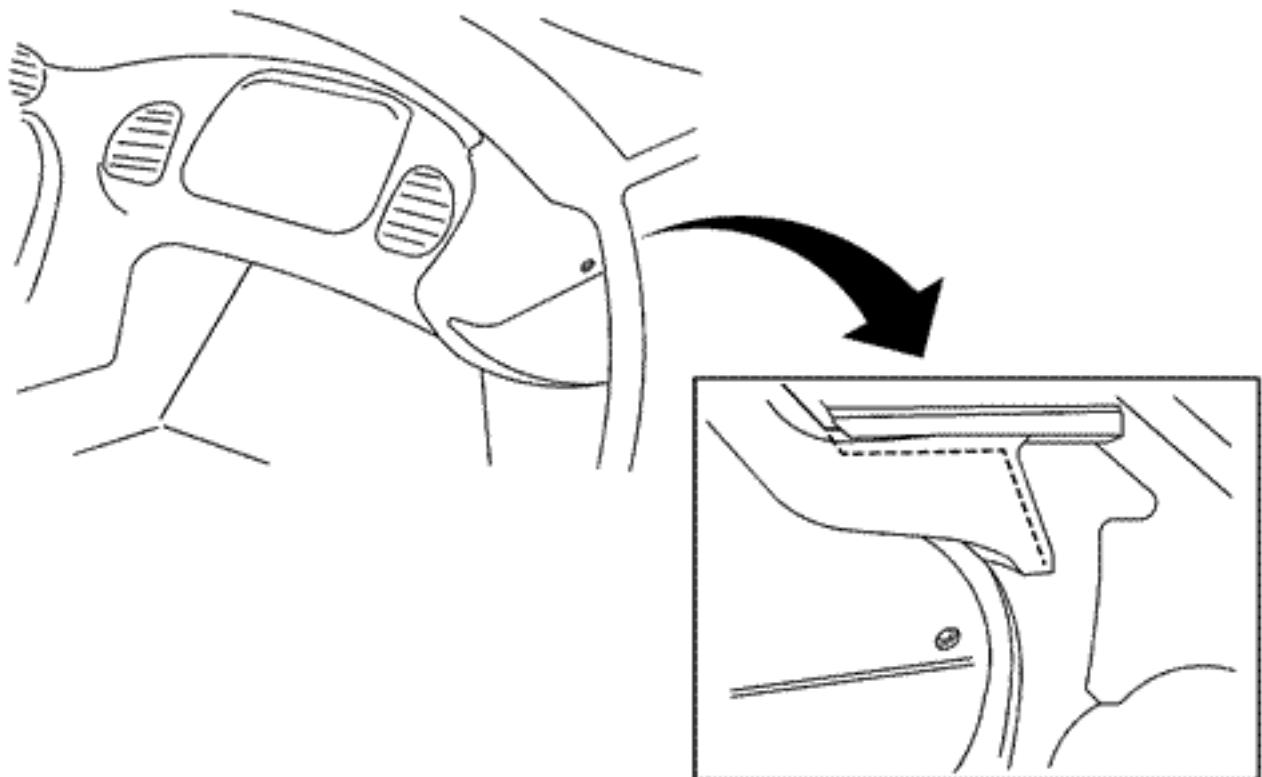
Water is running down the front edge of the door or water is on top of the sill plate.

The butyl strip under the seal at the base of the "A" pillar may not be sealing properly or the push-in fastener may not be seated.

Clean the area with one of the cleaners listed below.

Reseal the "A" pillar starting at the bottom of the weatherstrip retainer with the GM sealer listed below. Refer to the dotted line in the illustration for sealing.

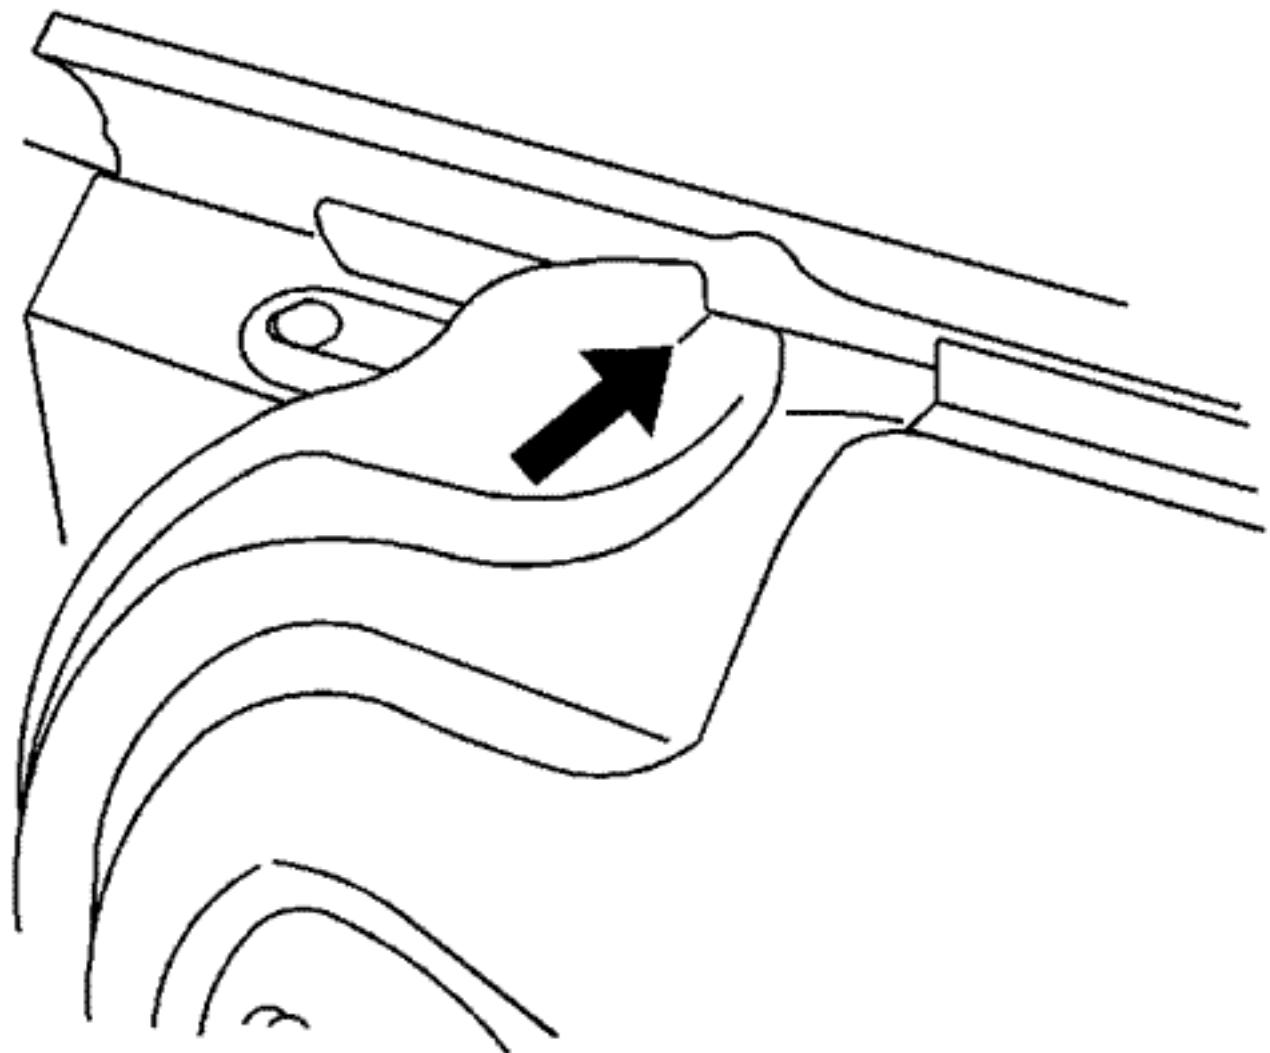
Water may be leaking around the weatherstrip at the top of the door due to an undesirable nub in the weatherstrip at the top of the door. Refer to the arrow in the illustration .

Replace the weatherstrip.

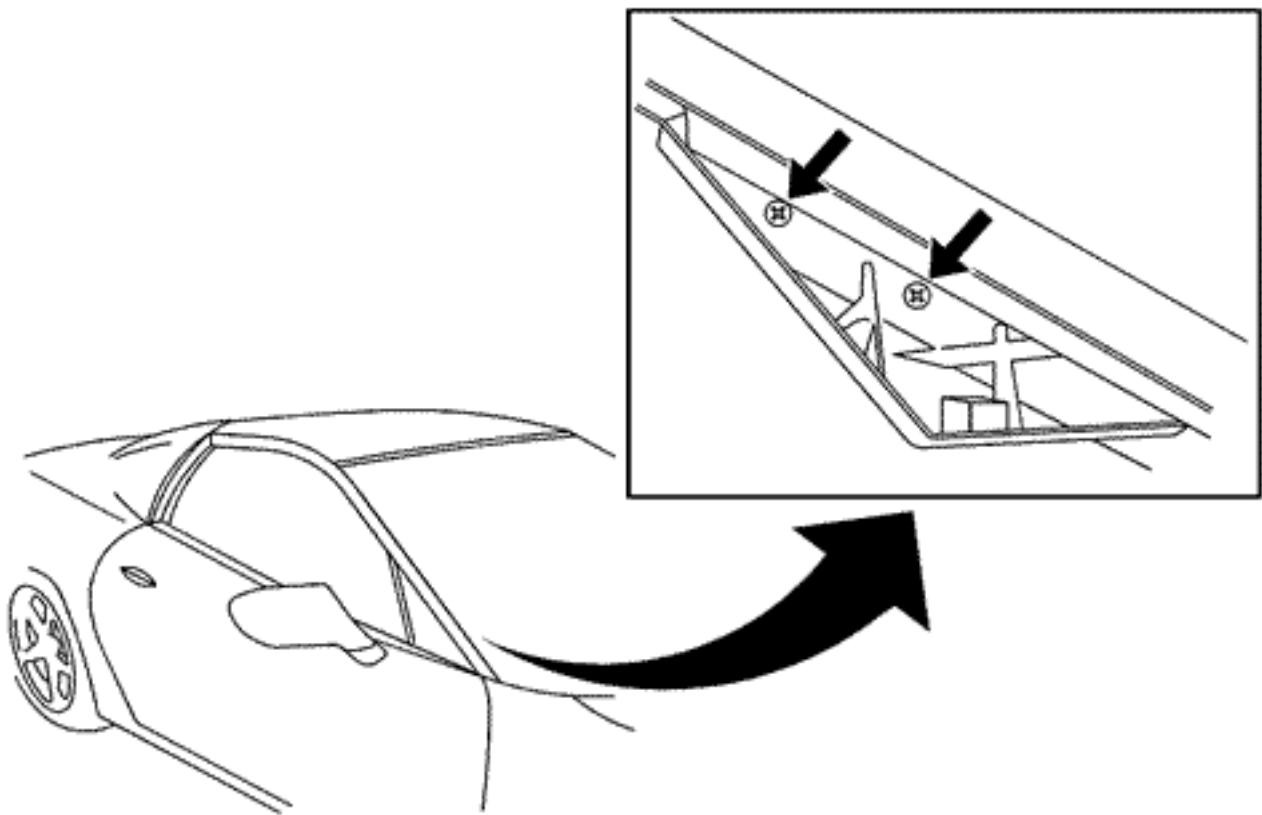
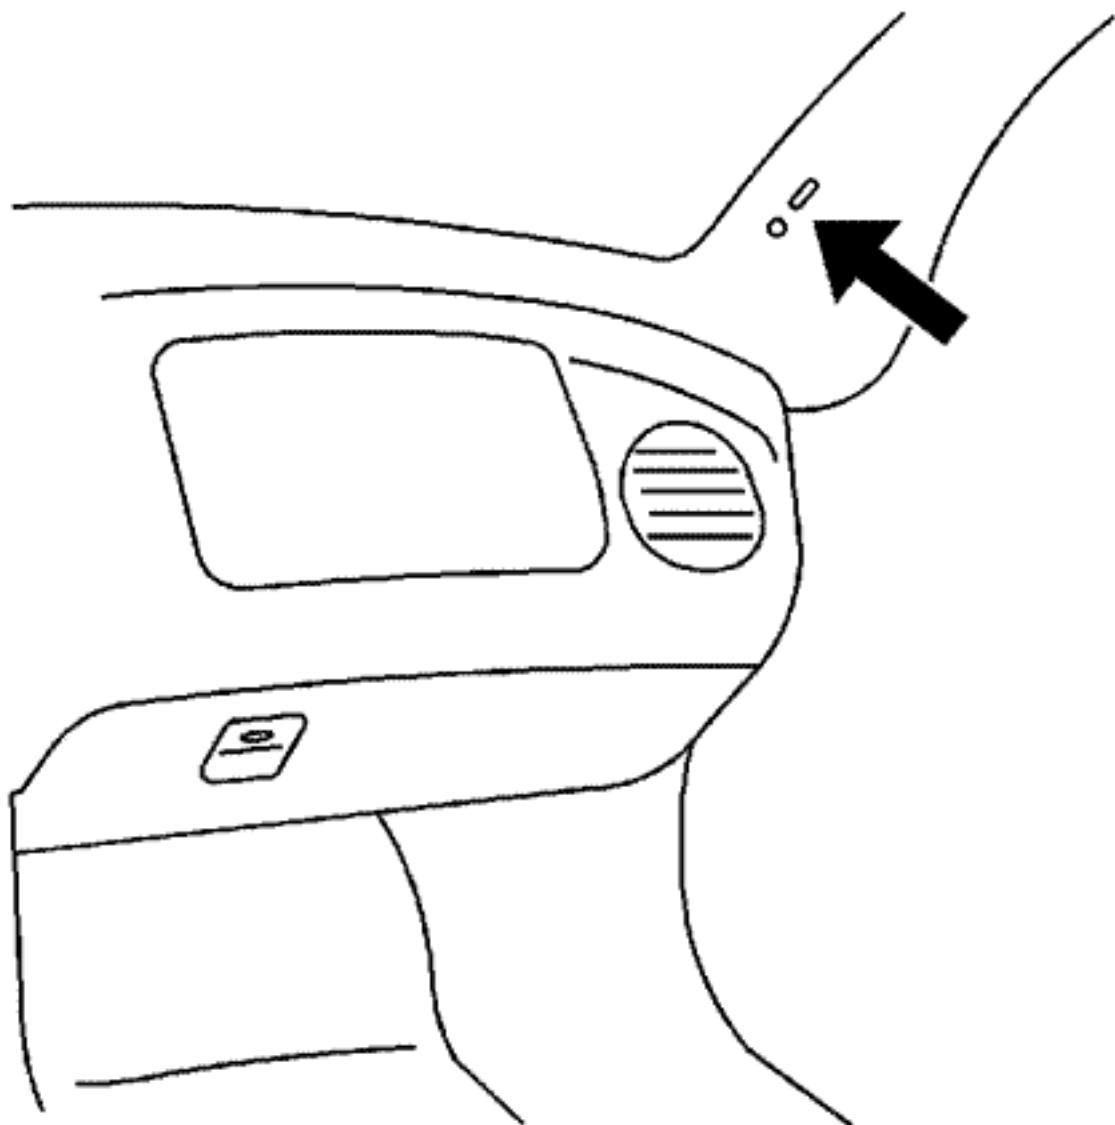
Two screws may not be sealed under the "A" pillar garnish molding. Refer to the illustration. During water test with the "A" pillar molding off, there may be water coming out of either the garnish molding retaining hole or the wire harness retaining hole. Refer to the arrow in the illustration.

Seal the two screws with the Kent™ sealer listed below.

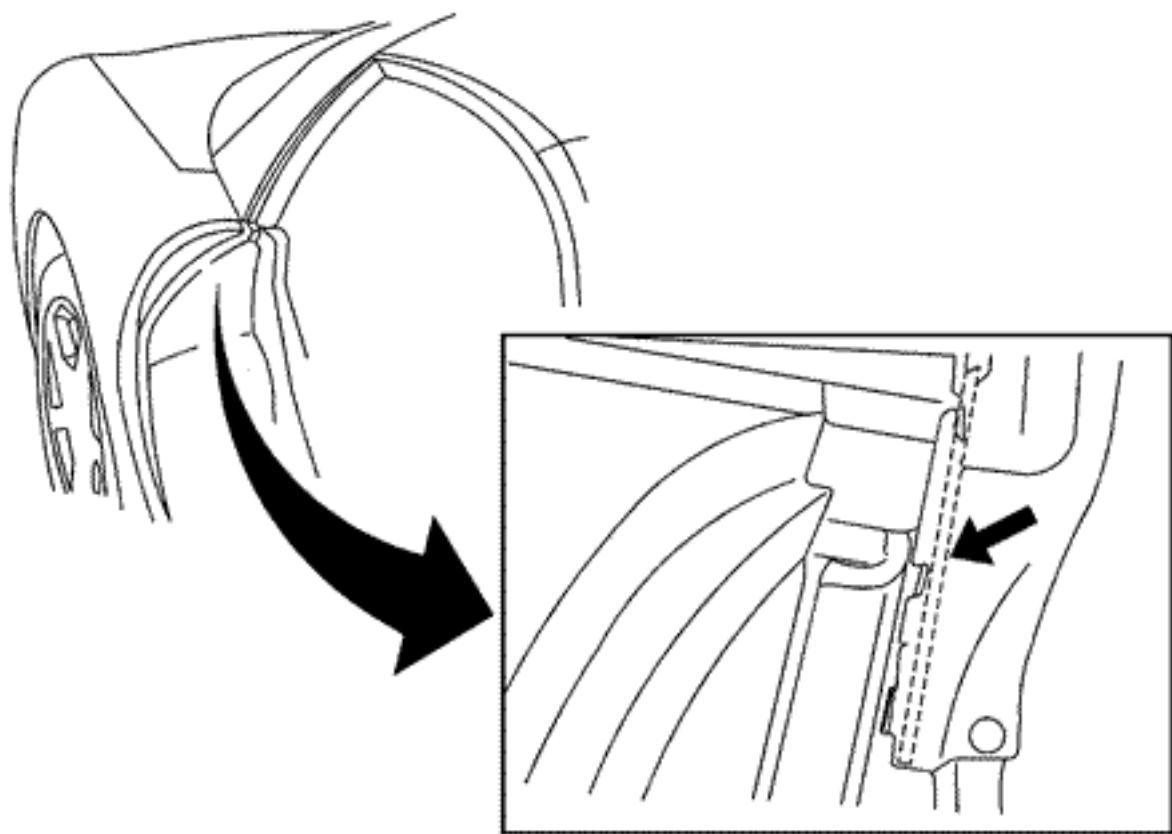
The floor is wet behind the seat belts.

The "B" pillar weatherstrip may not be sealed properly.

Reseal the weatherstrip with the GM sealer listed below. Refer to the dotted line in the illustration for sealing area.

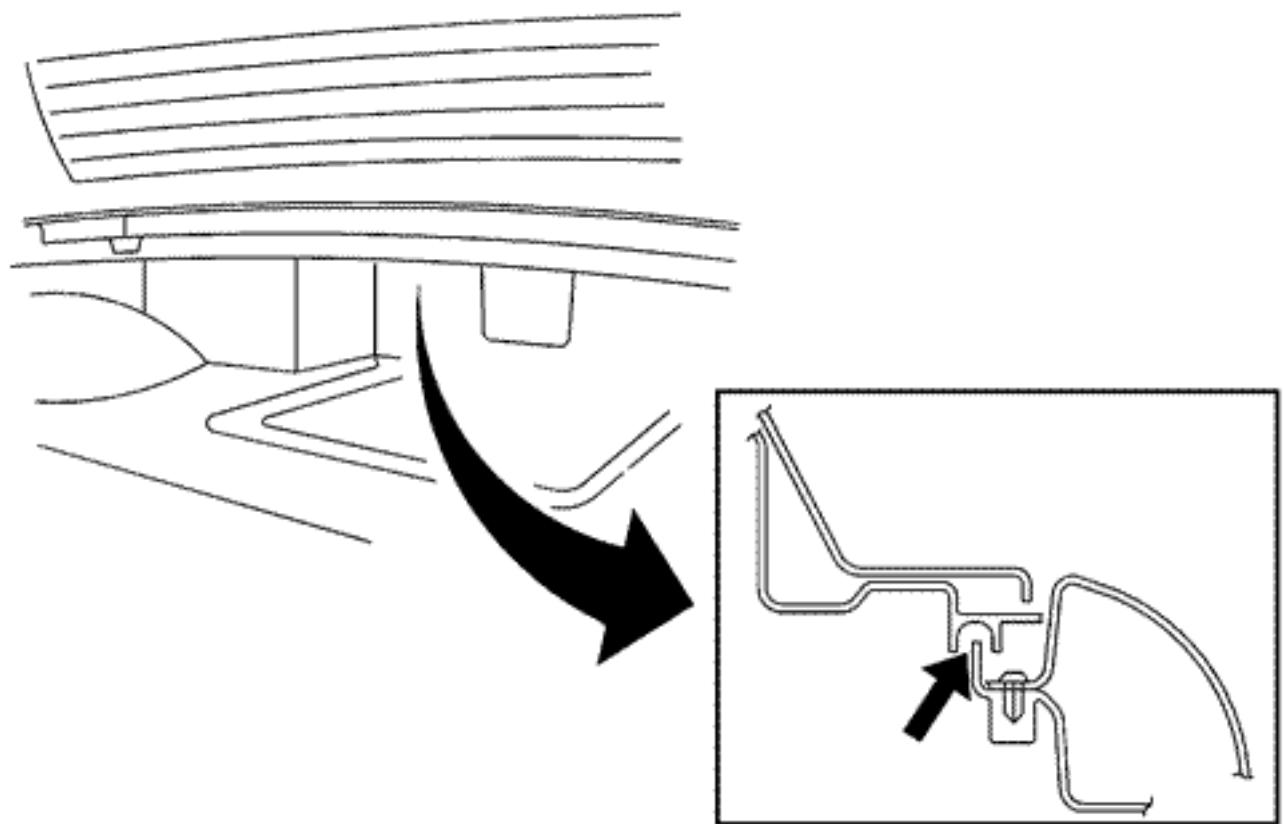
There may be a leak around the perimeter of the hard top causing water to drip from the garnish molding into the rear compartment.

There may be a void in the sealer between the body and the hard top.

Clean the area with one of the cleaners listed below and seal the area shown in the illustration with the Kent™ sealer listed below.

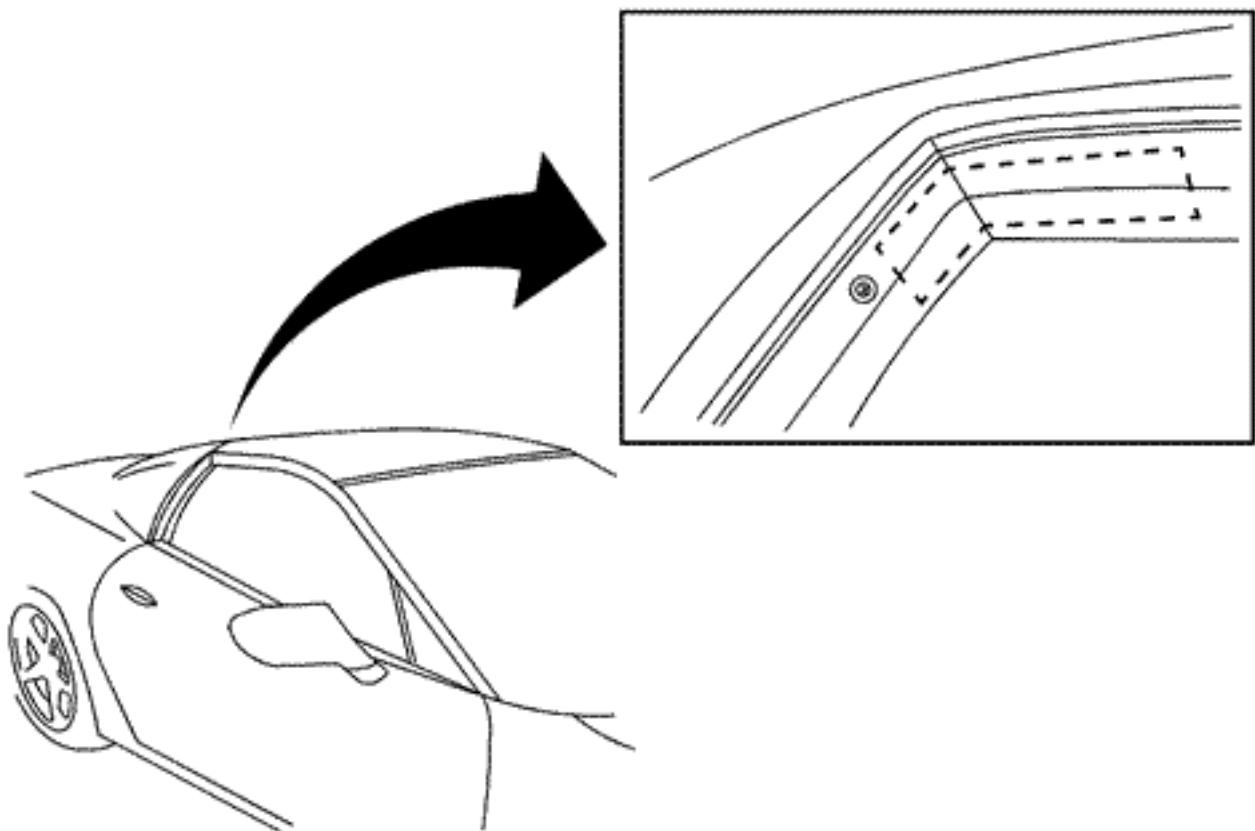
The floor is wet behind the seat belts (Hardtop/ Z06 only).

The top corner of the weatherstrip may not be sealed properly. Refer to the area shown in the illustration.

Reseal the weatherstrip with the GM sealer listed below. Refer to the sealer in the illustration.

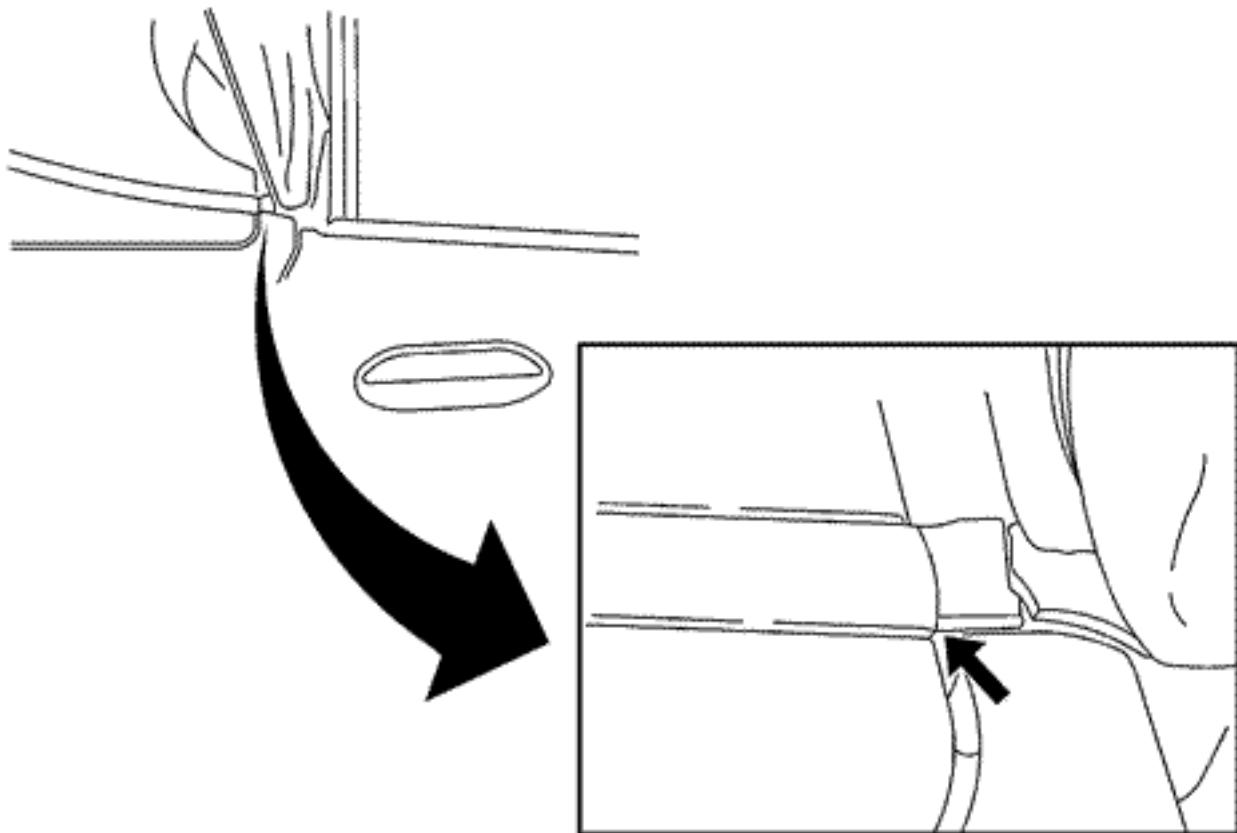
The floor is wet behind the seat belts or water seems to be entering through the hole in the interior trim panel where the seat belt feeds through.

The fit where the front edge of the convertible top stowage compartment lid "protector" contacts the rear edge "bulb seal" of the "mucket"*. Refer to the illustration above.

The front edge of the stowage lid protector should overhang the stowage lid by approximately 3 mm (0.12 in). That 3 mm (0.12 in) overhang should then firmly contact the bulb seal rear edge of the mucket to complete the seal between the stowage lid and the lower "B" pillar.
