1997 - 2004 Corvette: Service Bulletin: General Waterleak Guide

Subject: General Waterleak Guide

Number: 02-08-57-003

Models: 1997-2002 Chevrolet Corvette

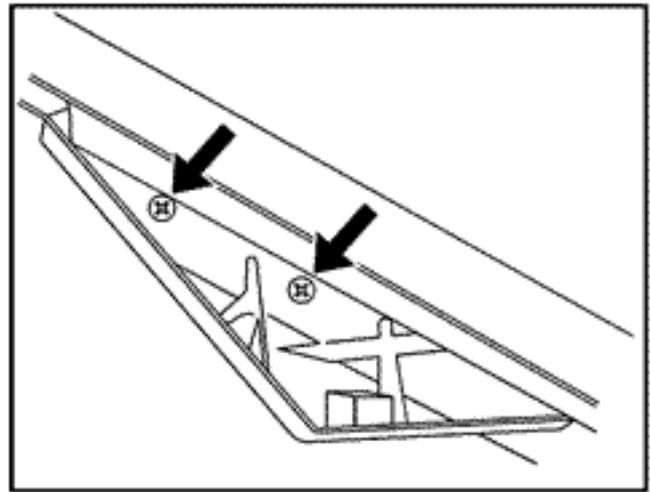
Two screws may not be sealed under the "A" pillar garnish molding. Refer to the illustration. During water test with the "A" pillar molding off, there may be water coming out of either the garnish molding retaining hole or the wire harness retaining hole. Refer to the arrow in the illustration.

Seal the two screws with the Kent™ sealer listed below.

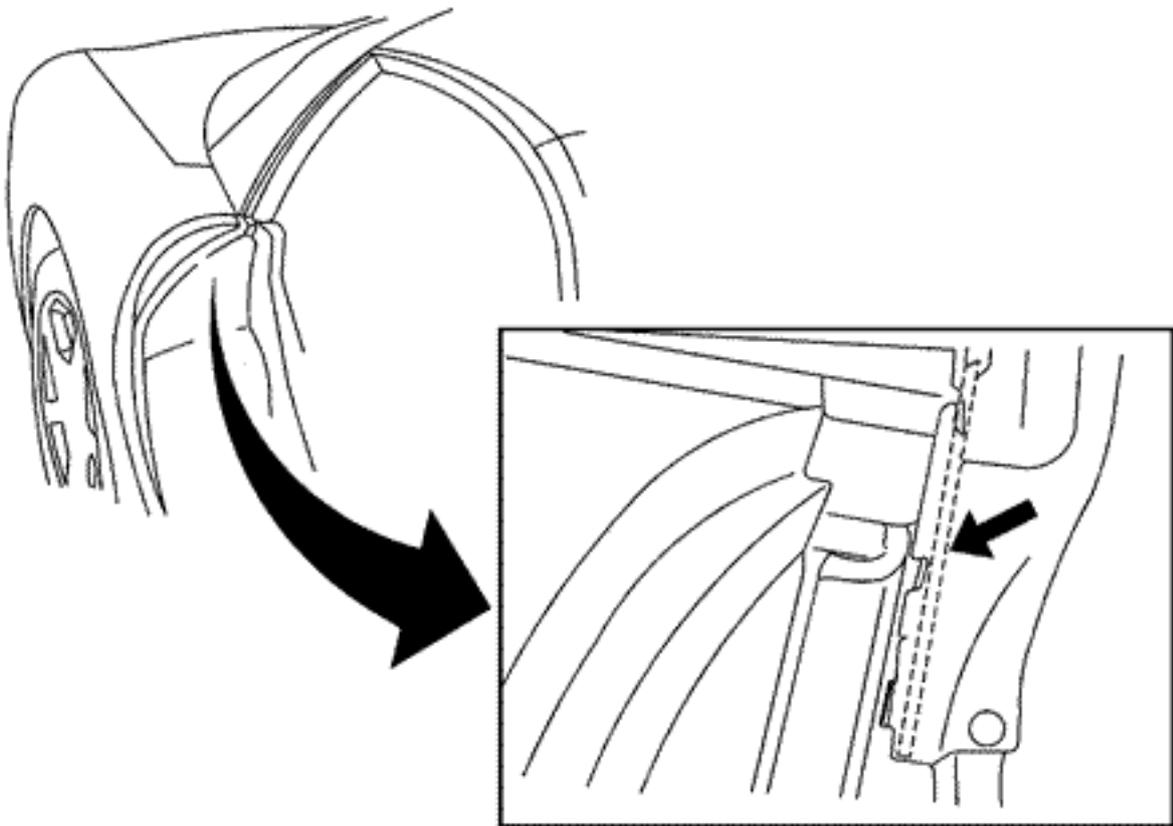
The floor is wet behind the seat belts.

The "B" pillar weatherstrip may not be sealed properly.

Reseal the weatherstrip with the GM sealer listed below. Refer to the dotted line in the illustration for sealing area.
