# 1997 - 1998 Corvette: Service Bulletin: Discoloration or Staining of Plenum (Cowl) Air Inlet Screen

**Source:** Chevrolet Dealer Technical Service Bulletin

**Number:** 83-15-11

**Models:** 1997-1998 Chevrolet Corvette

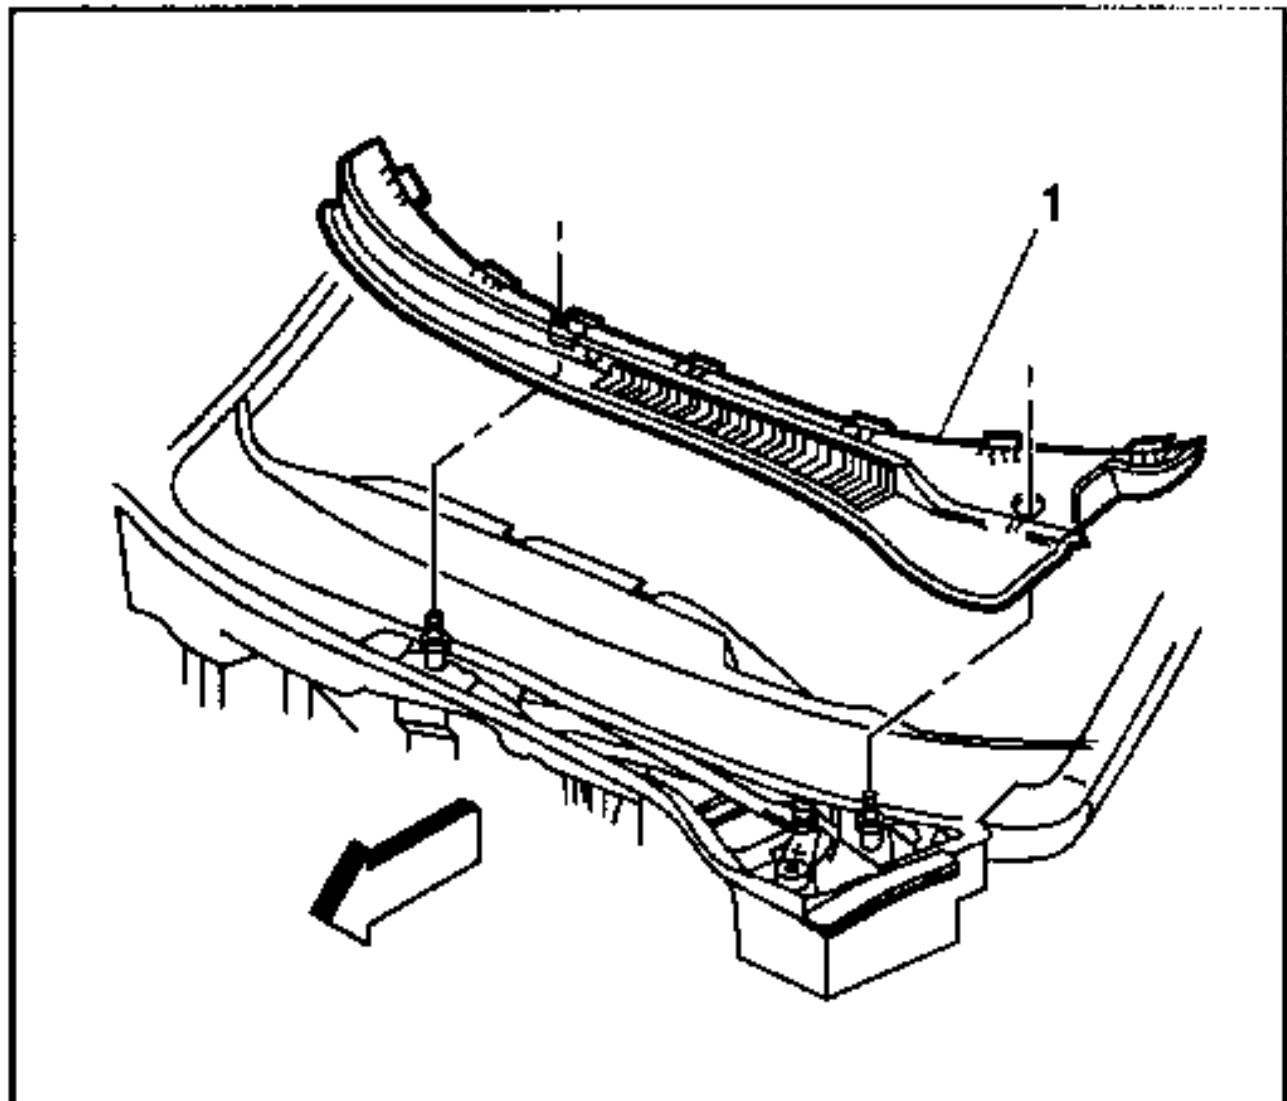
**Figure 1**

**Condition:** SOME CUSTOMERS MAY COMMENT THAT THERE ARE WHITISH SPOTS OR STAINS ON THE PLENUM AIR INLET SCREEN AT THE BASE OF THE WINDSHIELD. THESE SPOTS OR STAINS ARE USUALLY FOUND IN THE AREAS AROUND AND BELOW THE WINDSHIELD WIPER ARMS AND BLADES.

THIS CONDITION MAY BE CAUSED BY A CHEMICAL RESIDUE USED IN THE MANUFACTURING PROCESS OF THE WINDSHIELD WIPER WASHER NOZZLES. RESIDUE IS WASHED OUT FROM INSIDE THE NOZZLES DURING THE FIRST FEW USAGES OF THE WINDSHIELD WIPER WASHERS.

INSTALL NEW AIR INLET SCREEN (P/N 10418245), USING THE PROCEDURES IN THE APPROPRIATE SERVICE MANUAL
