1997 - 1998 Corvette: Service Bulletin: Discoloration or Staining of Plenum (Cowl) Air Inlet Screen

Source: Chevrolet Dealer Technical Service Bulletin

Number: 83-15-11

Models: 1997-1998 Chevrolet Corvette

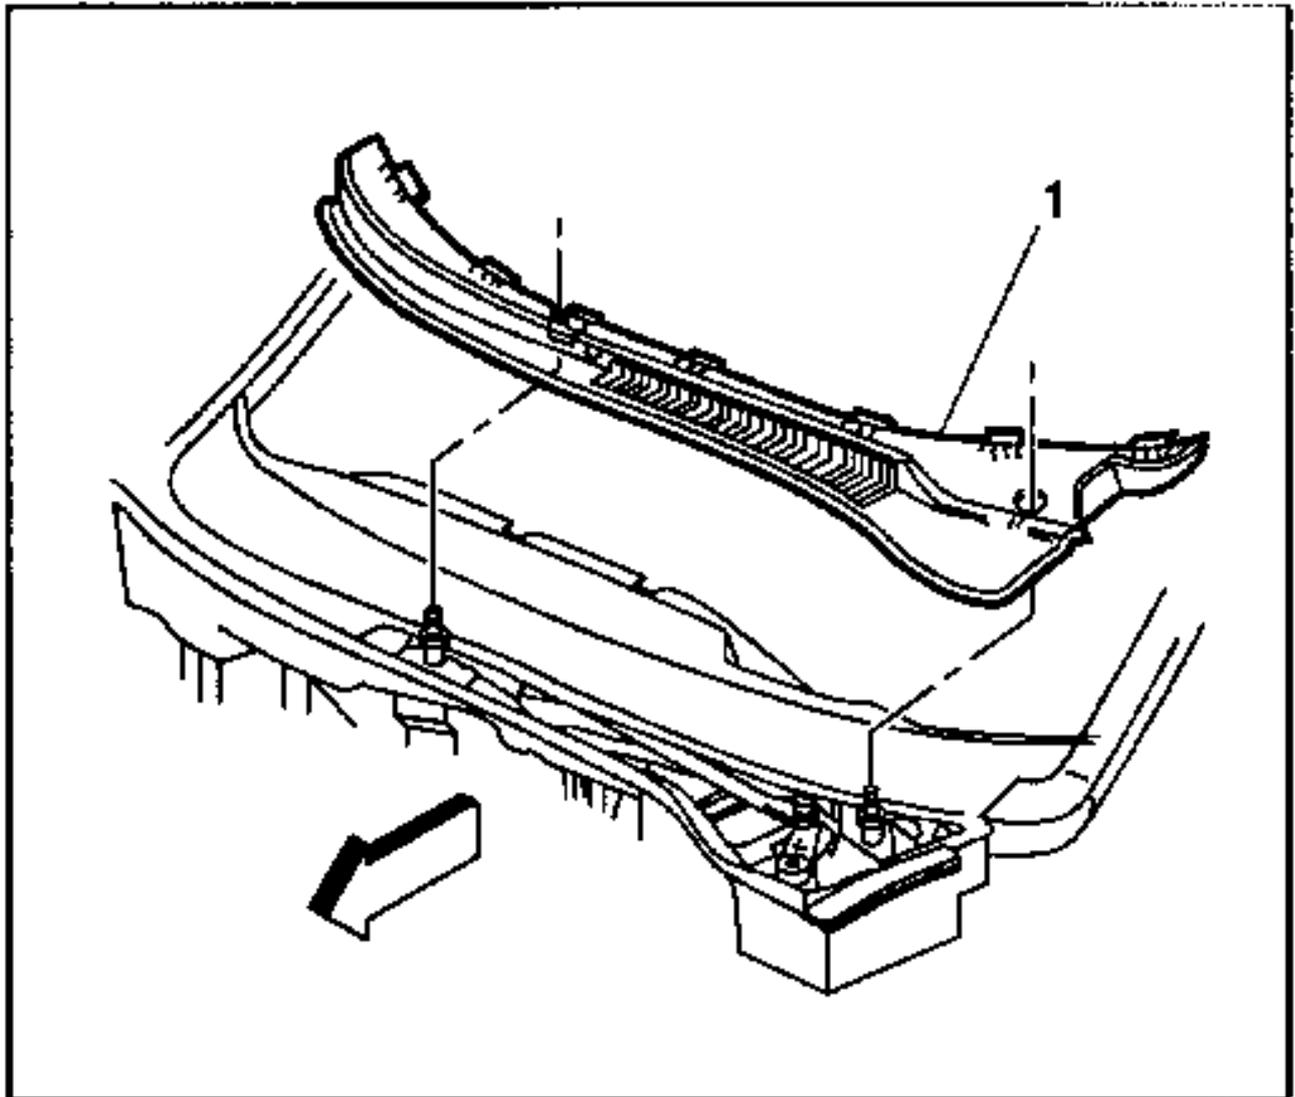
Figure 1

Condition: SOME CUSTOMERS MAY COMMENT THAT THERE ARE WHITISH SPOTS OR STAINS ON THE PLENUM AIR INLET SCREEN AT THE BASE OF THE WINDSHIELD. THESE SPOTS OR STAINS ARE USUALLY FOUND IN THE AREAS AROUND AND BELOW THE WINDSHIELD WIPER ARMS AND BLADES.

THIS CONDITION MAY BE CAUSED BY A CHEMICAL RESIDUE USED IN THE MANUFACTURING PROCESS OF THE WINDSHIELD WIPER WASHER NOZZLES. RESIDUE IS WASHED OUT FROM INSIDE THE NOZZLES DURING THE FIRST FEW USAGES OF THE WINDSHIELD WIPER WASHERS.

INSTALL NEW AIR INLET SCREEN (P/N 10418245), USING THE PROCEDURES IN THE APPROPRIATE SERVICE MANUAL
