1997 - 1998 Corvette: Service Bulletin: Discoloration or Staining of Plenum (Cowl) Air Inlet Screen

Number: 83-15-11

Models: 1997-1998 Chevrolet Corvette

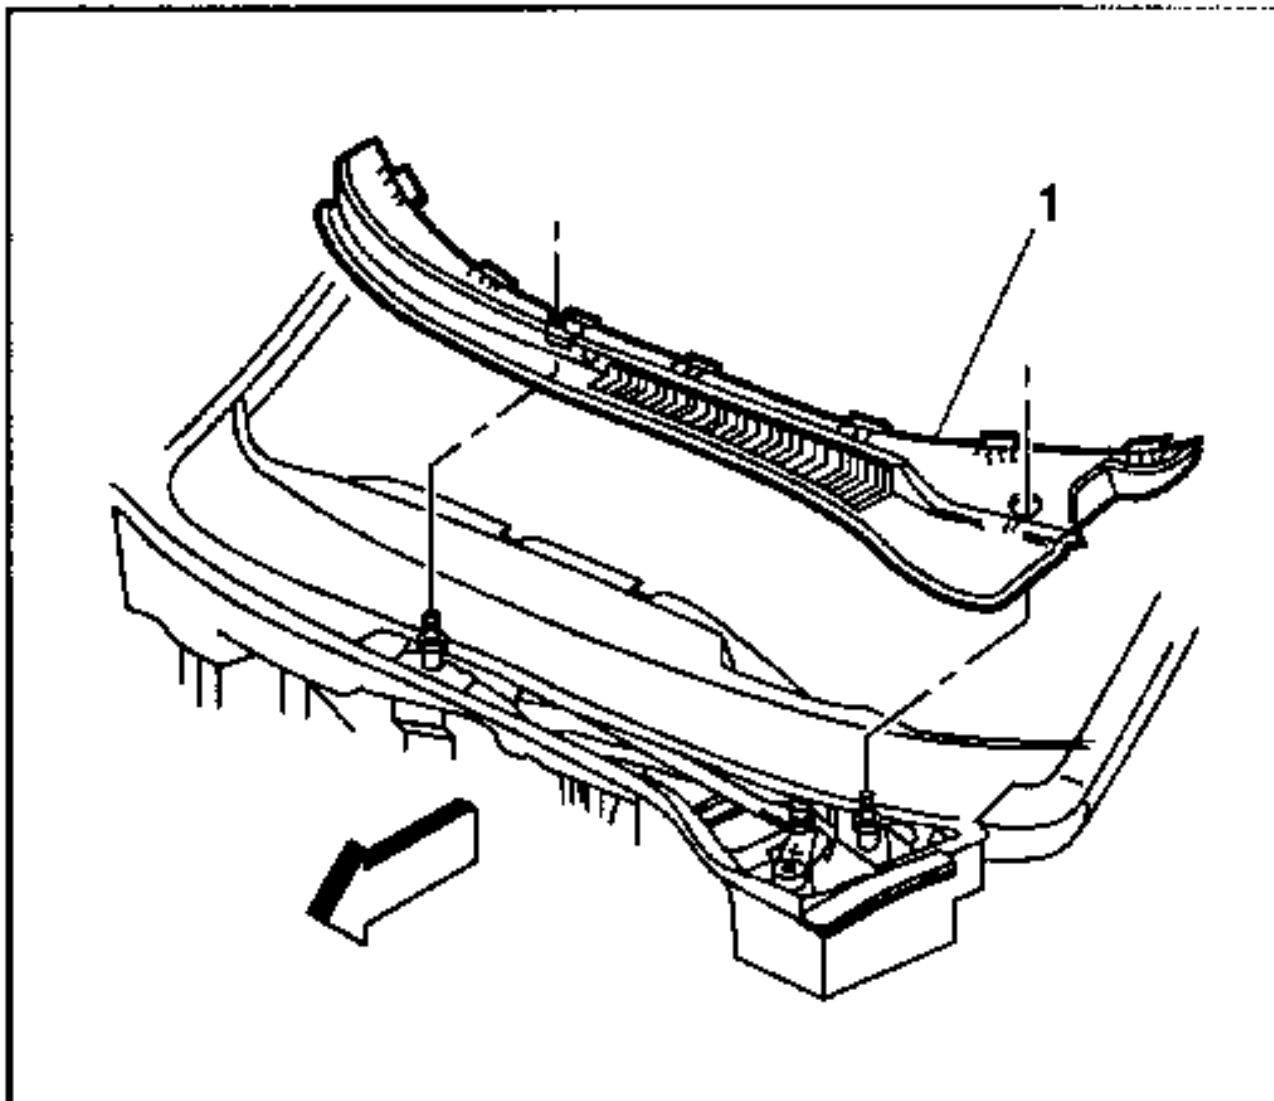
Figure 1

Condition: SOME CUSTOMERS MAY COMMENT THAT THERE ARE WHITISH SPOTS OR STAINS ON THE PLENUM AIR INLET SCREEN AT THE BASE OF THE WINDSHIELD. THESE SPOTS OR STAINS ARE USUALLY FOUND IN THE AREAS AROUND AND BELOW THE WINDSHIELD WIPER ARMS AND BLADES.

THIS CONDITION MAY BE CAUSED BY A CHEMICAL RESIDUE USED IN THE MANUFACTURING PROCESS OF THE WINDSHIELD WIPER WASHER NOZZLES. RESIDUE IS WASHED OUT FROM INSIDE THE NOZZLES DURING THE FIRST FEW USAGES OF THE WINDSHIELD WIPER WASHERS.

INSTALL NEW AIR INLET SCREEN (P/N 10418245), USING THE PROCEDURES IN THE APPROPRIATE SERVICE MANUAL
