1992 Corvette ZR-1: Service Bulletin: Lack of Wide Open Throttle Engine Underpower

Subject: LACK OF WOT-LOW ENGINE POWER REVISED CABLE ADJUSTMENT PROC.

Model and Year: 1992 CORVETTE ZR-1 WITH 5.7L ENGINE AND MANUAL TRANSMISSION

Bulletin Number: 92-214A-7B - (07/01/1992)

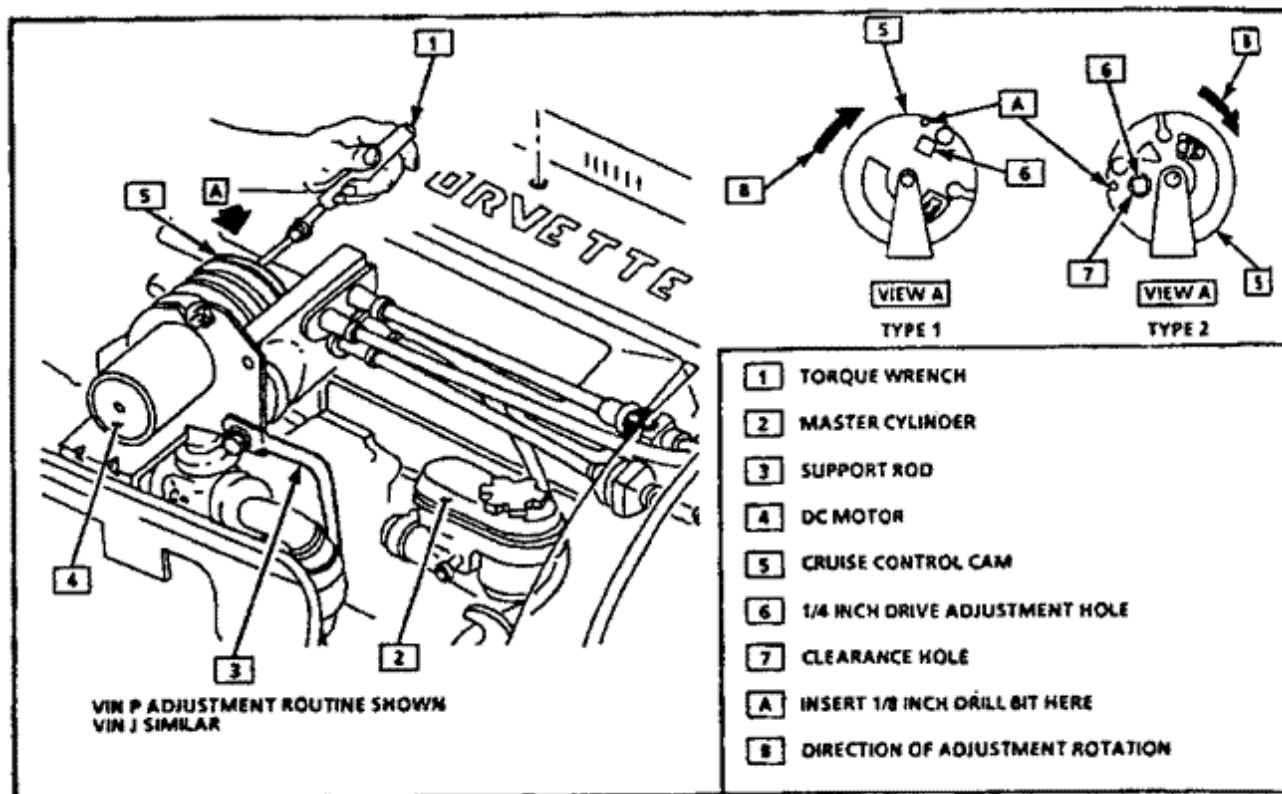
Cable Adjustment Mechanism

Customers with VIN up to 800227 may comment about lack of wide open throttle or low engine power for their 1992 model year Corvette ZR-1.

Adjustment procedures revised at assembly plant.

1. Remove adjuster cam assembly splash cover, foam shield, and cable cam cover.
2. Disconnect cruise control cable from the cruise control servo.
3. Depress reset button on the throttle control cable and fully extend cable sheaths (see figure).
4. Insert a 1/8 inch drill bit into adjuster assembly alignment hole (see figure, item A).

5. Insert a torque wrench with a 1/4 inch drive extension into square hole on the cruise control cam (type 1) or through the cruise control cam into the accelerator cam (type 2) (see figure, item 6).
6. Turn the torque wrench clockwise until obtaining a torque of 4 N.m (35 lbs. in.). During adjustment, several clicks of the adjuster should be heard. If not, repeat step 3.
7. Remove the torque wrench AND drill bit.

• ALWAYS MAKE SURE CABLE SHEATHS ARE AT THEIR FULLY EXTENDED POSITION BEFORE PERFORMING ADJUSTMENT PROCEDURE
