1992 Corvette ZR-1: Service Bulletin: Lack of Wide Open Throttle Engine Underpower

Subject: LACK OF WOT-LOW ENGINE POWER REVISED CABLE ADJUSTMENT PROC.

Model and Year: 1992 CORVETTE ZR-1 WITH 5.7L ENGINE AND MANUAL TRANSMISSION

Bulletin Number: 92-214A-7B - (07/01/1992)

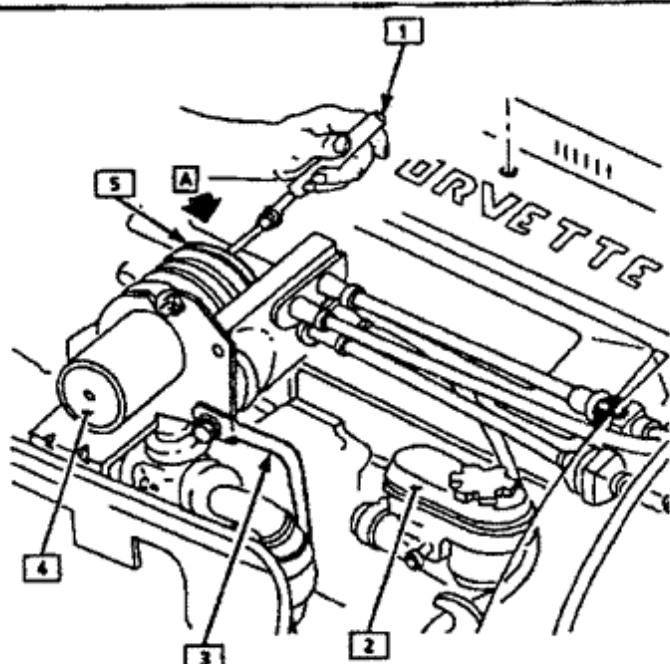
Cable Adjustment Mechanism

* ALWAYS MAKE SURE CABLE SHEATHS ARE AT THEIR FULLY EXTENDED POSITION BEFORE PERFORMING ADJUSTMENT PROCEDURE

1. Remove adjuster cam assembly splash cover, foam shield, and cable cam cover.
2. Disconnect cruise control cable from the cruise control servo.
3. Depress reset button on the throttle control cable and fully extend cable sheaths (see figure).
4. Insert a 1/8 inch drill bit into adjuster assembly alignment hole (see figure, item A).

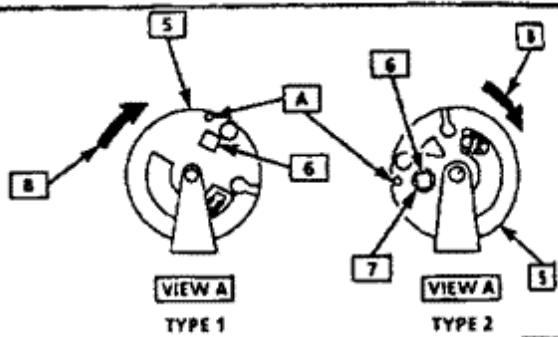
Adjusting Throttle Cable

VIN P ADJUSTMENT ROUTINE SHOWN
VIN J SIMILAR

5. Insert a torque wrench with a 1/4 inch drive extension into square hole on the cruise control cam (type 1) or through the cruise control cam into the accelerator cam (type 2) (see figure, item 6).
6. Turn the torque wrench clockwise until obtaining a torque of 4 N.m (35 lbs. in.). During adjustment, several clicks of the adjuster should be heard. If not, repeat step 3.
7. Remove the torque wrench AND drill bit.
