1992 Corvette ZR-1: Service Bulletin: Lack of Wide Open Throttle Engine Underpower

Subject: LACK OF WOT-LOW ENGINE POWER REVISED CABLE ADJUSTMENT PROC.

Model and Year: 1992 CORVETTE ZR-1 WITH 5.7L ENGINE AND MANUAL TRANSMISSION

Bulletin Number: 92-214A-7B - (07/01/1992)

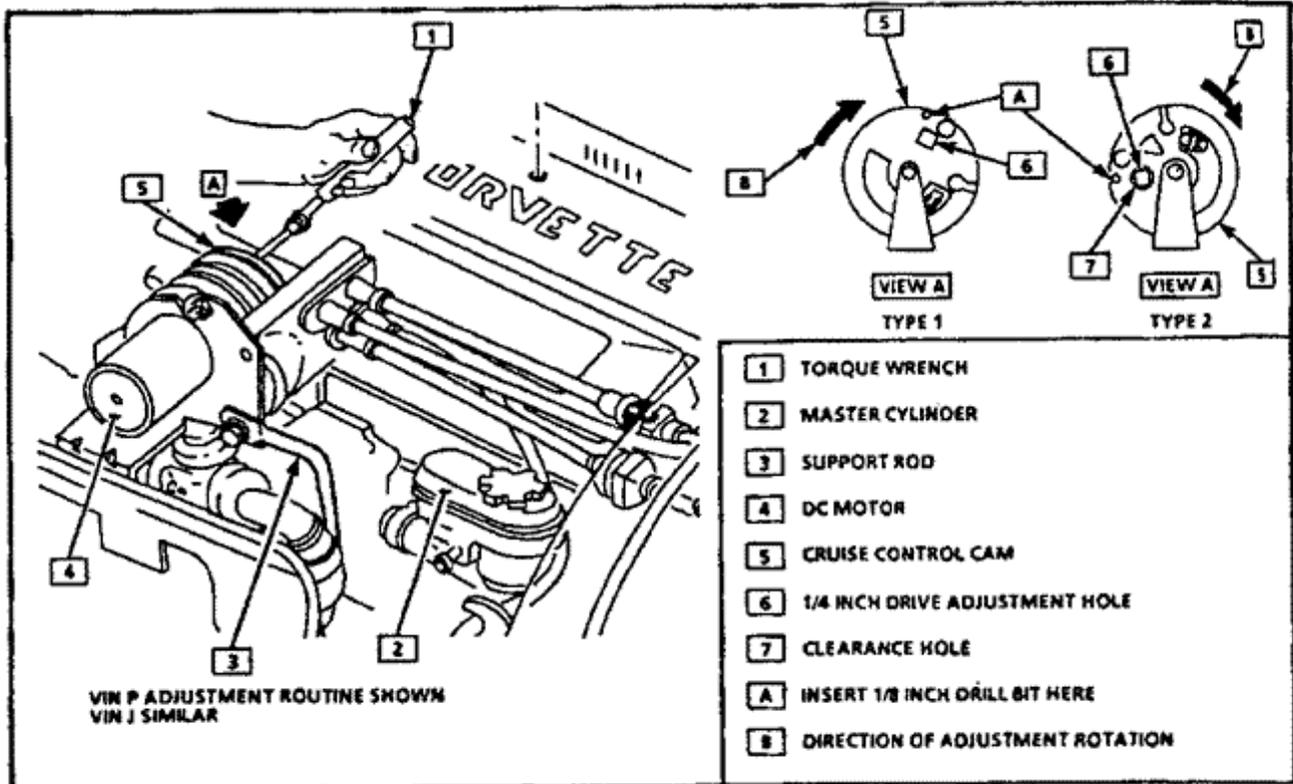
Cable Adjustment Mechanism

Customers with VIN up to 800227 may comment about lack of wide open throttle or low engine power for their 1992 model year Corvette ZR-1.

Adjustment procedures revised at assembly plant.

• ALWAYS MAKE SURE CABLE SHEATHS ARE AT THEIR FULLY EXTENDED POSITION BEFORE PERFORMING ADJUSTMENT PROCEDURE

1. Remove adjuster cam assembly splash cover, foam shield, and cable cam cover.
2. Disconnect cruise control cable from the cruise control servo.
3. Depress reset button on the throttle control cable and fully extend cable sheaths (see figure).
4. Insert a 1/8 inch drill bit into adjuster assembly alignment hole (see figure, item A).

5. Insert a torque wrench with a 1/4 inch drive extension into square hole on the cruise control cam (type 1) or through the cruise control cam into the accelerator cam (type 2) (see figure, item 6).
6. Turn the torque wrench clockwise until obtaining a torque of 4 N.m (35 lbs. in.). During adjustment, several clicks of the adjuster should be heard. If not, repeat step 3.
7. Remove the torque wrench AND drill bit.
