1991 Corvette: Service Bulletin: Squeak and Rattle Diagnosis Guide

Subject: SQUEAK AND RATTLE DIAG. GUIDE DIAGNOSTIC AID/CORRECTION

Model and Year: 1991 CORVETTE

Bulletin Number: 91-264-10 - (03/25/1991)

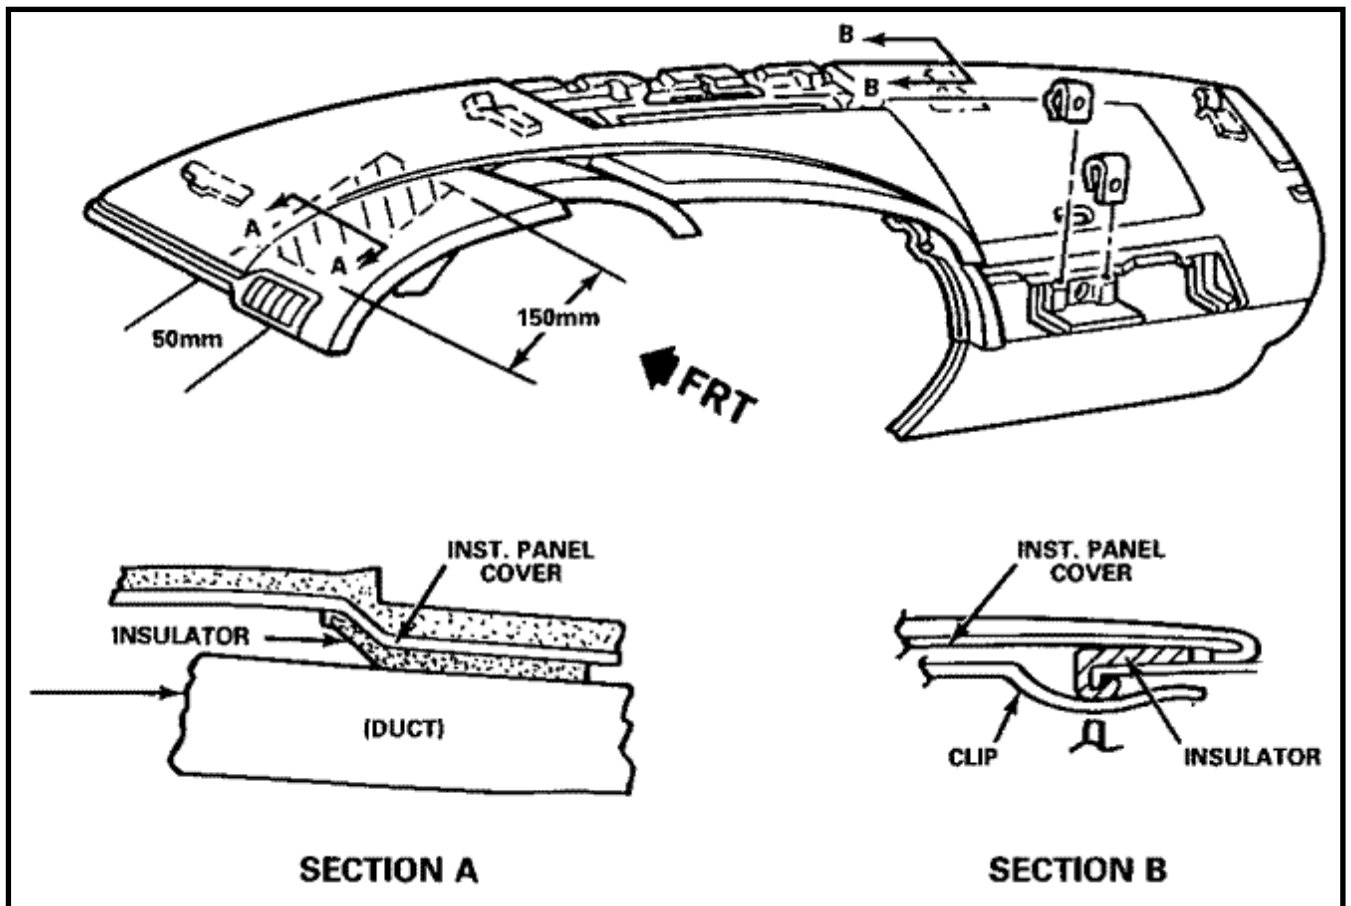
FIGURE 1

1. Rattle forward of gages cluster 1. Insulate area shown in Figure at A/C cross car duct. 1 and Figure 1, Section A (felt material).

2. Rattle at front edge of cover 2. Reposition existing, or near windshield. install felt insulators on metal opening at all retainers, (see Figure 1, Section B). - Left defogger outlet

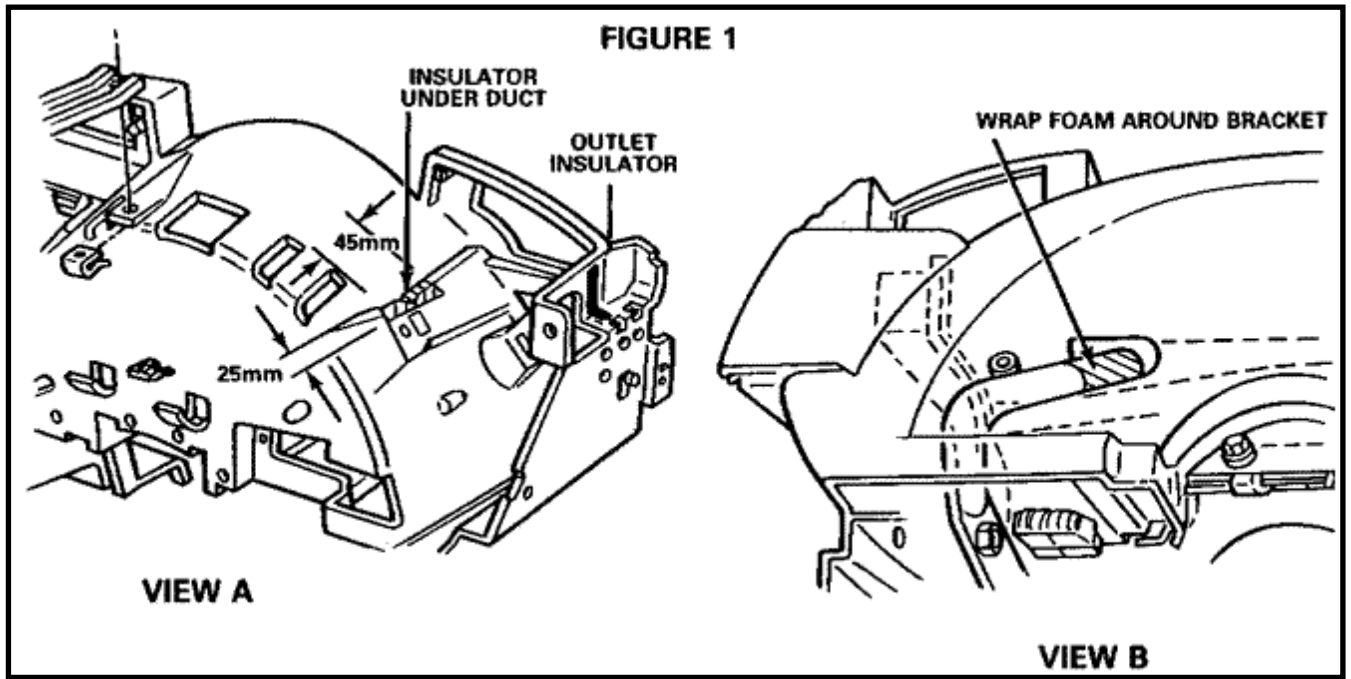
1. Buzzing against instrument 1. Apply felt insulator (1/2" X panel housing. 3"

as shown in Figure 2, view A). - A/C cross car duct

1. Rattle at top of instrument 1. Apply foam insulator (1/8") panel housing. to housing as shown in Figure 2, view A.

2. Rattle at left side SIR 2. Apply foam insulator (1/8") bracket. around bracket as shown in Figure 2 view B. - Instrumentation area

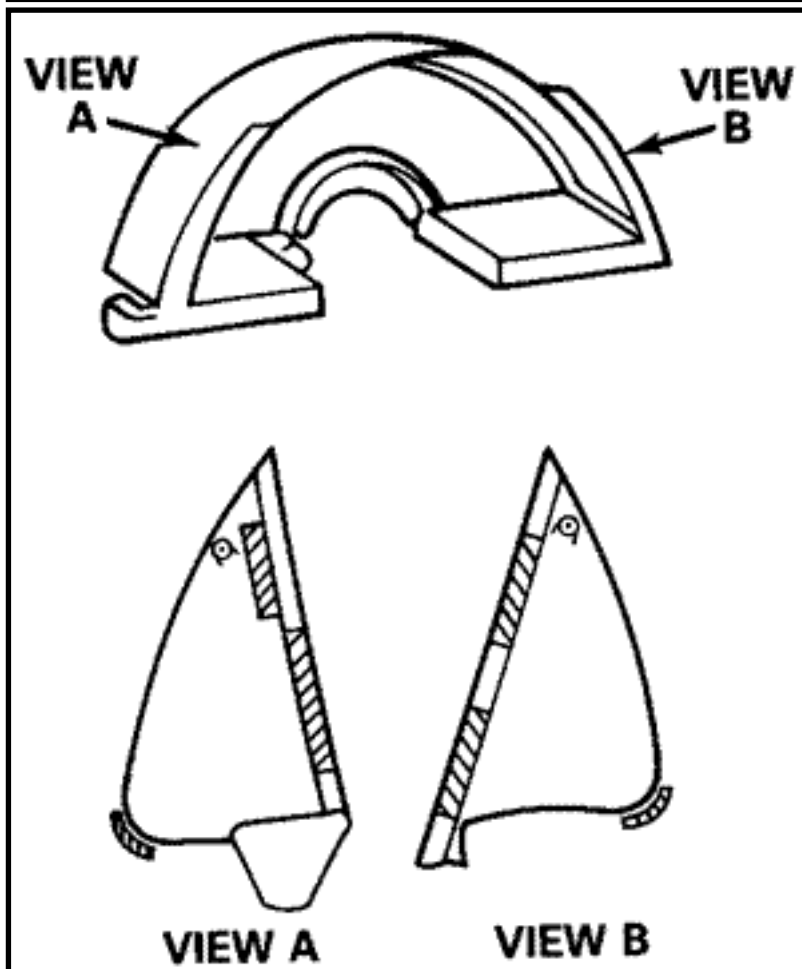
FIGURE 3

1. Squeak in instrument cluster 1. Apply felt insulators to bezel to cover. bezel edges and surfaces in locations as shown in Figure 3, views A and B.

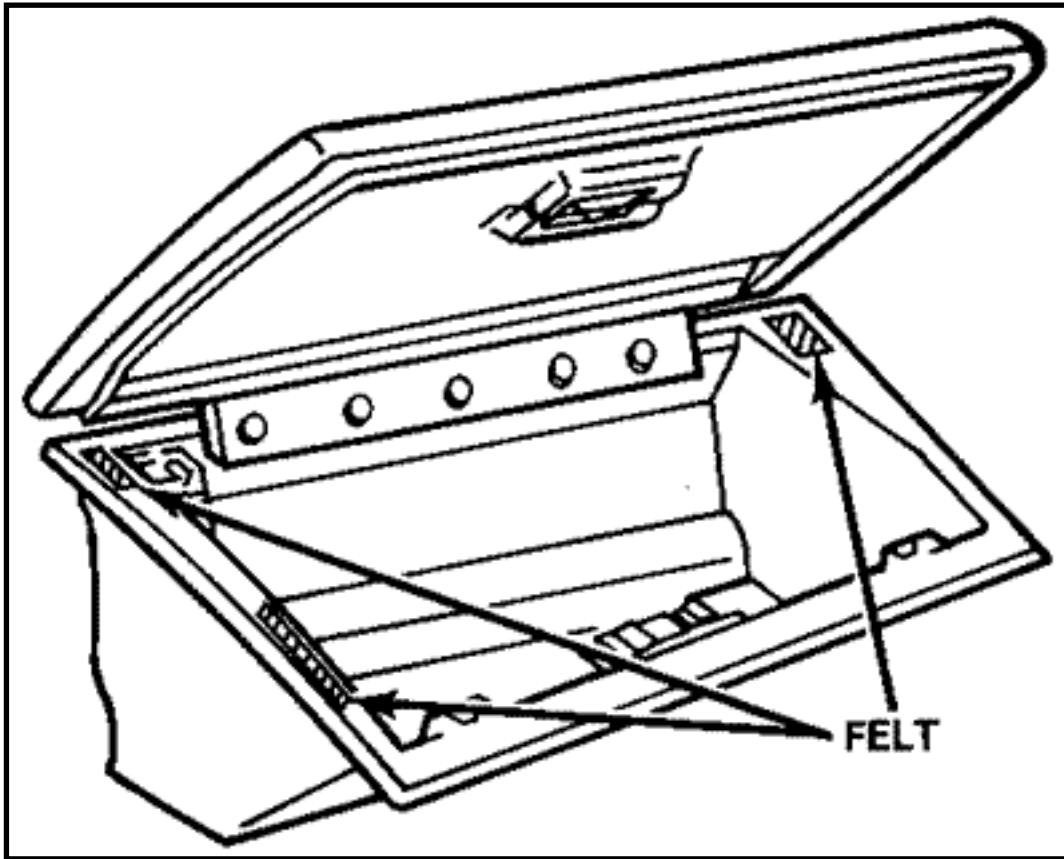
1. Rattle in glove box door to 1. Apply felt insulators as shown glove housing. in Figure 4, or in any contact area.

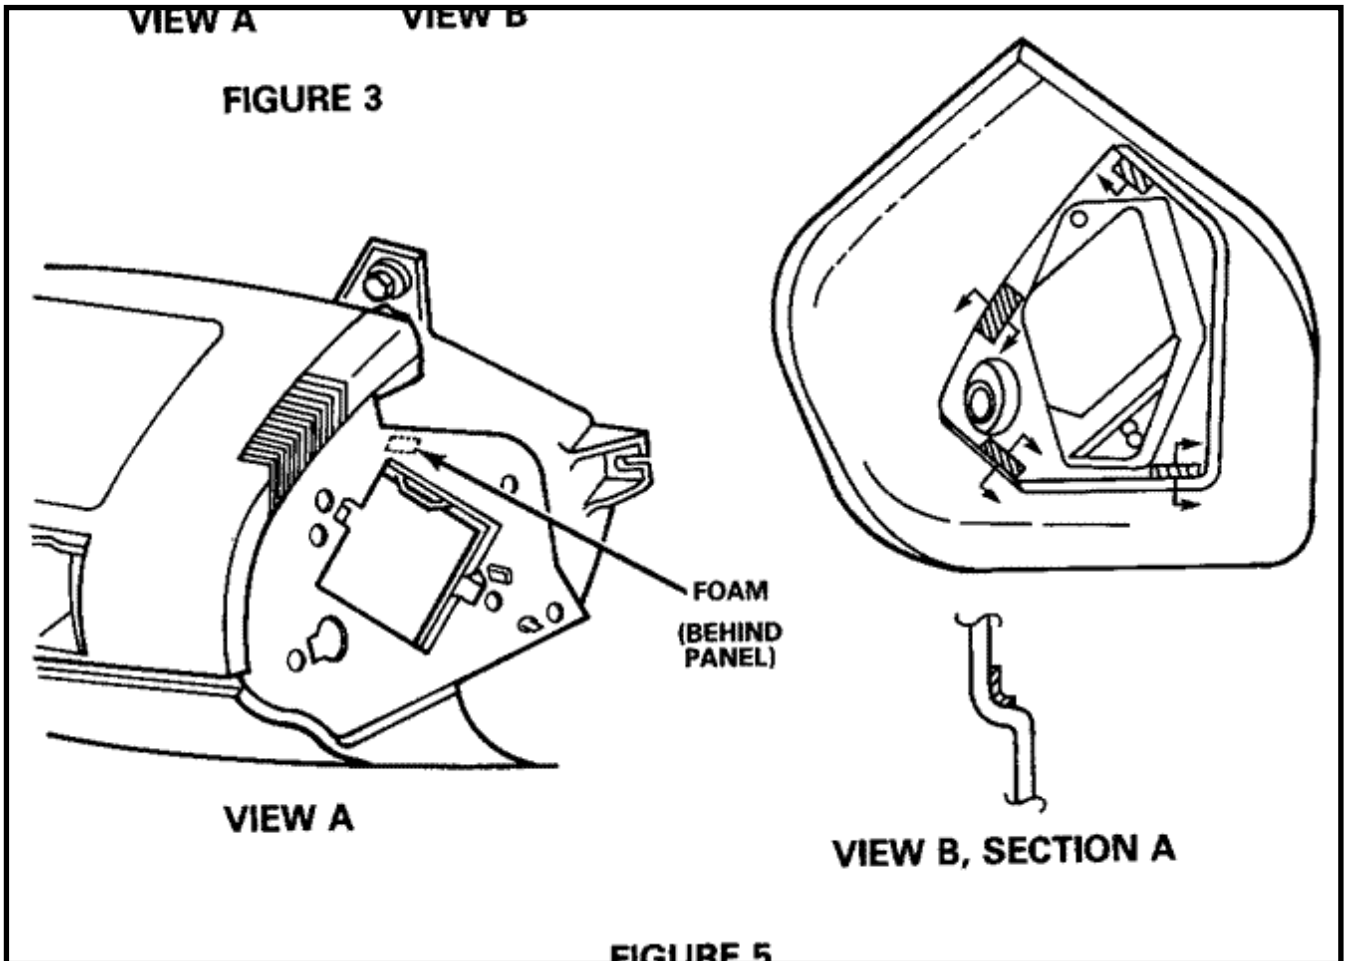
FIGURE 5

2. Buzzing of fuse box rivet 2. Apply small 1/4" foam heads to instrument panel insulator between rivet head cover. and cover as shown and cover as shown in Figure 5, view A.

3. Buzzing of fuse box door 3. Apply felt insulators (1/4" X in the opening. 1") as shown in Figure 5, view B. Position felt into the radius of the opening.

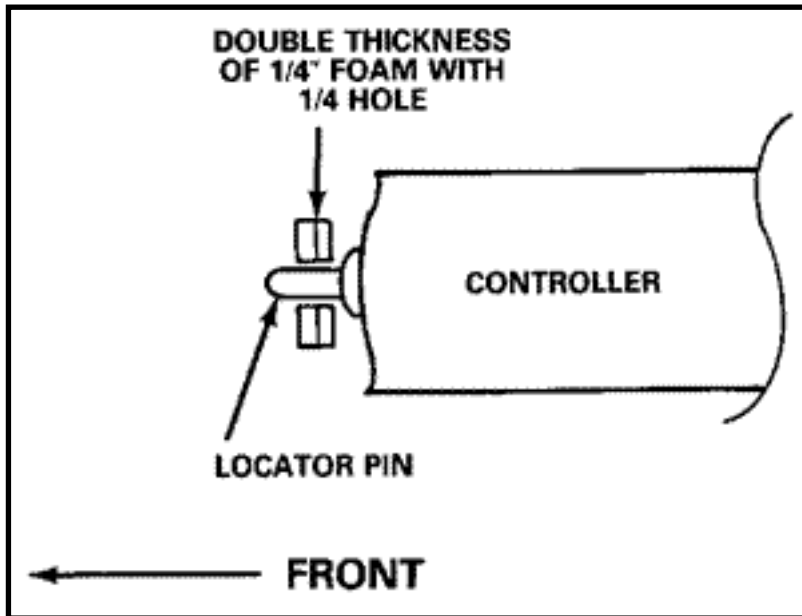
1. Buzzing of A/C controller to 1. Apply double thick 1/4" foam instrument panel housing. with 1/4" hole around forward locator pin of controller and reinstall, see Figure 6.

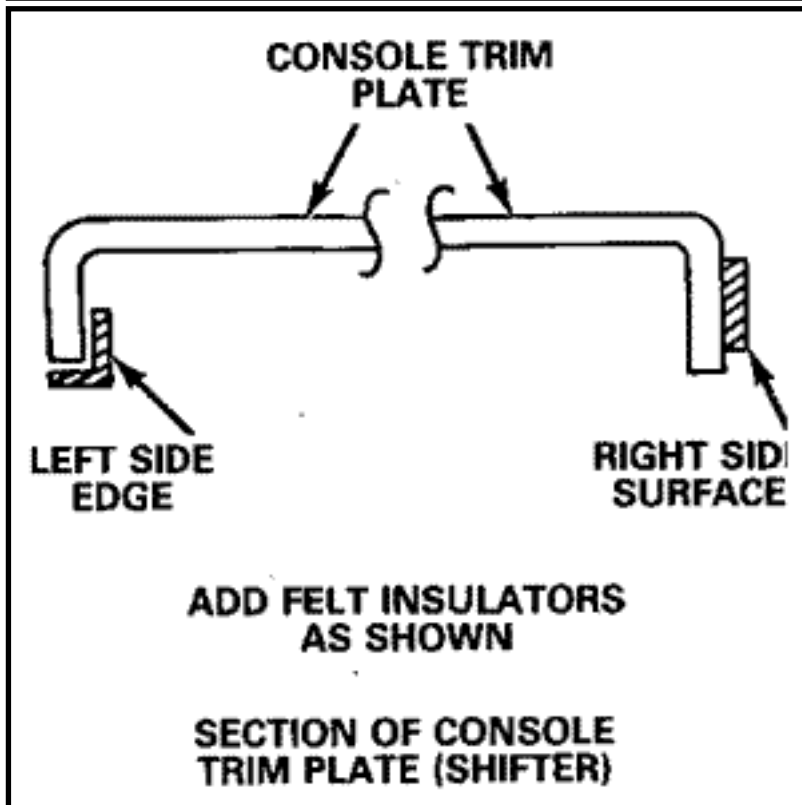
2. Squeak of console shift trim 2. Apply felt to right side and plate to console

surfaces. left edge of trim plate, see Figure 7.

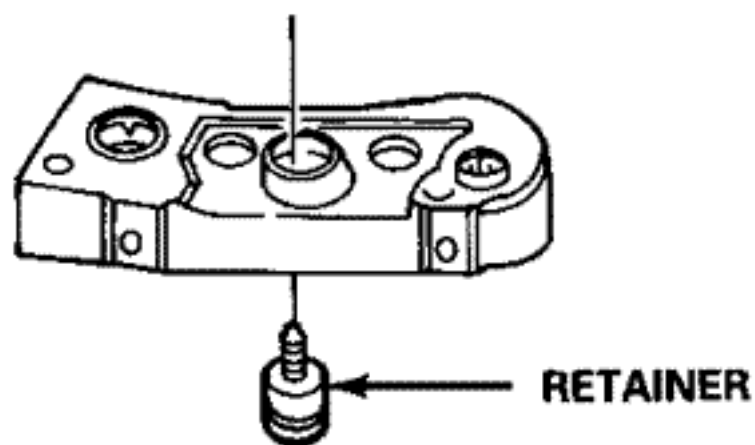
**REMOVABLE ROOF, FRONT
BOLT AND RETAINER**

1. Rattle of front attaching bolts 1. Install new bolt retainers, when panel is stowed in rear. P/N 10 1 75804, see Figure 8.

1. Soak new retainers in warm water to aid in installation.
2. Remove roof panel and stow.
3. Remove upper trim covers at right and left latch areas.
4. Remove right and left sun visors, inside mirror and center garnish molding.
5. Carefully pry original retainer and bolt out of housing using a flat blade screwdriver or other suitable tool.
6. Install bolt in new retainer, align locating rib on retainer with notch in housing and press into place with a "C" clamp and socket.
7. Reinstall garnish molding, inside mirror, sun visors and upper trim covers.

- **PRY BOLT & RETAINER OUT
OF HOUSING WITH FLAT
BLADED SCREWDRIVER**
- **ALIGN LOCATING RIB WITH
NOTCH IN HOUSING**
- **PRESS INTO PLACE WITH
'C' CLAMP**

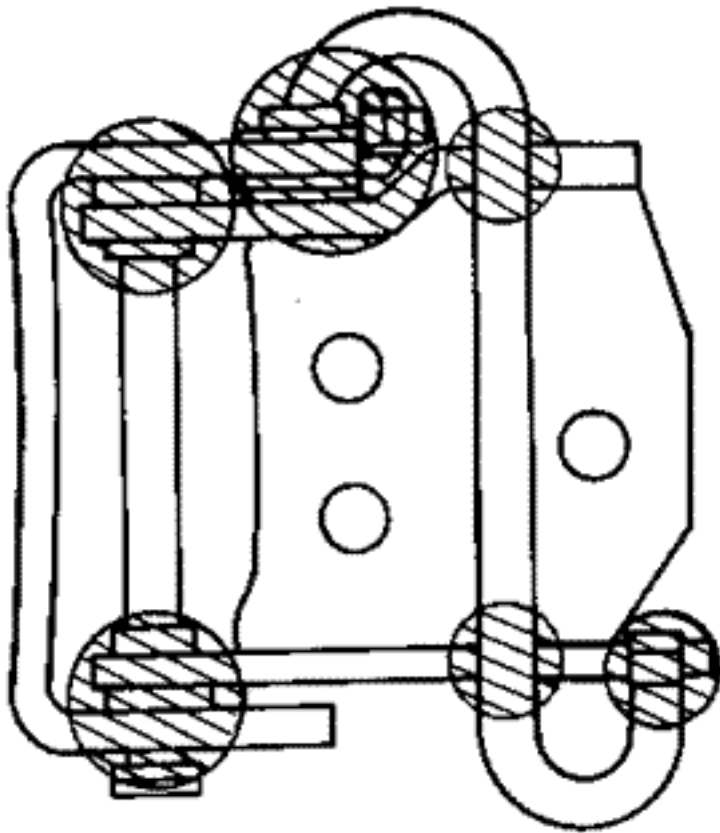
1. Squeaks when opening doors at 1. Lubricate ALL hinge torque hinge torque rod contact areas. rod contact areas with 30 wt. motor oil or grease, see Figure 9. UNDER THE HOOD ----- COMPONENT

**LUBE AT SHADED AREAS
DOOR UPPER HINGE**

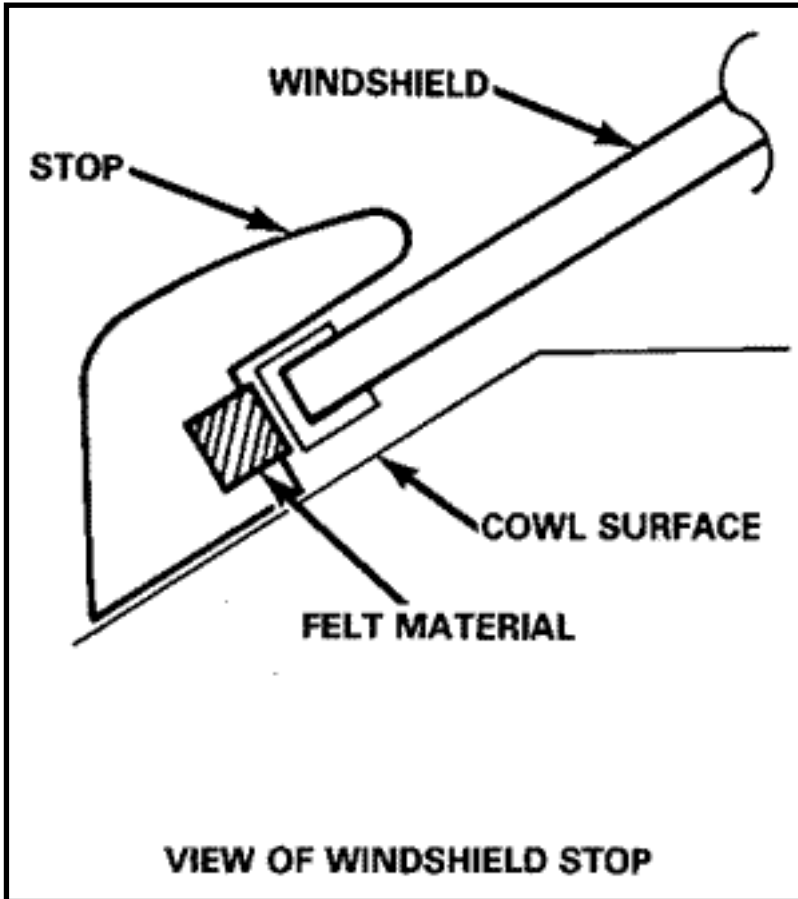
Popping/clicking at left 1. Apply felt to windshield front of windshield area. stop at area contacting windshield edge, see Figure 10.

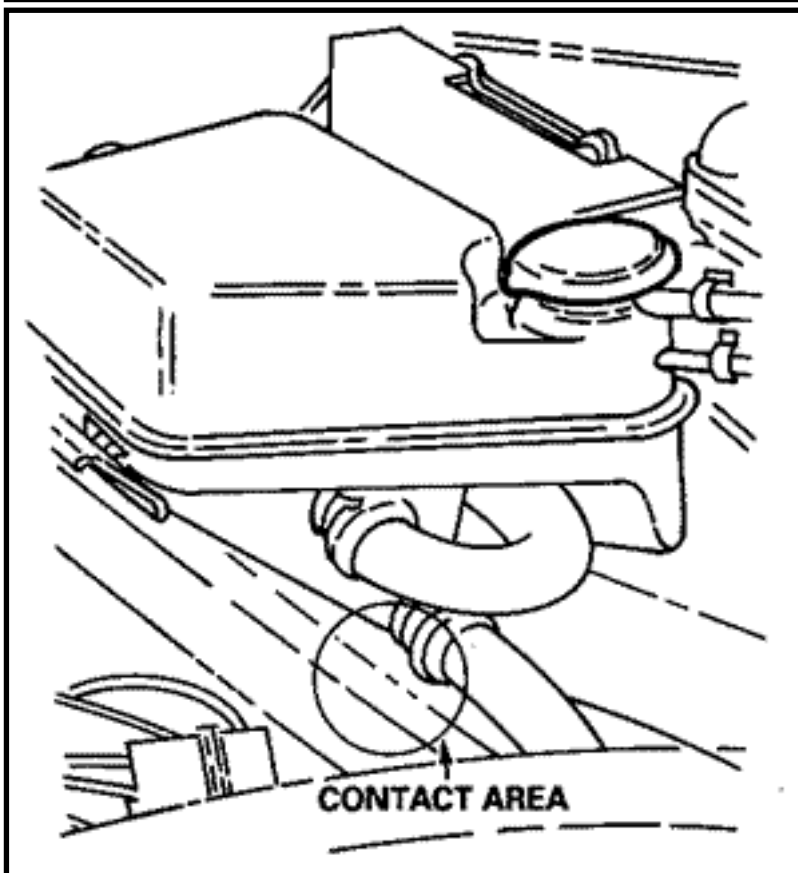
4. Squeak at right side 4. Reposition hose clamps to of vehicle. Hose clamps provide clearance to right for high fill container diagonal brace, see Figure contacting diagonal brace. 11.
