1991 Corvette: Service Bulletin: Squeak and Rattle Diagnosis Guide

Subject: SQUEAK AND RATTLE DIAG. GUIDE DIAGNOSTIC AID/CORRECTION

Model and Year: 1991 CORVETTE

Bulletin Number: 91-264-10 - (03/25/1991)

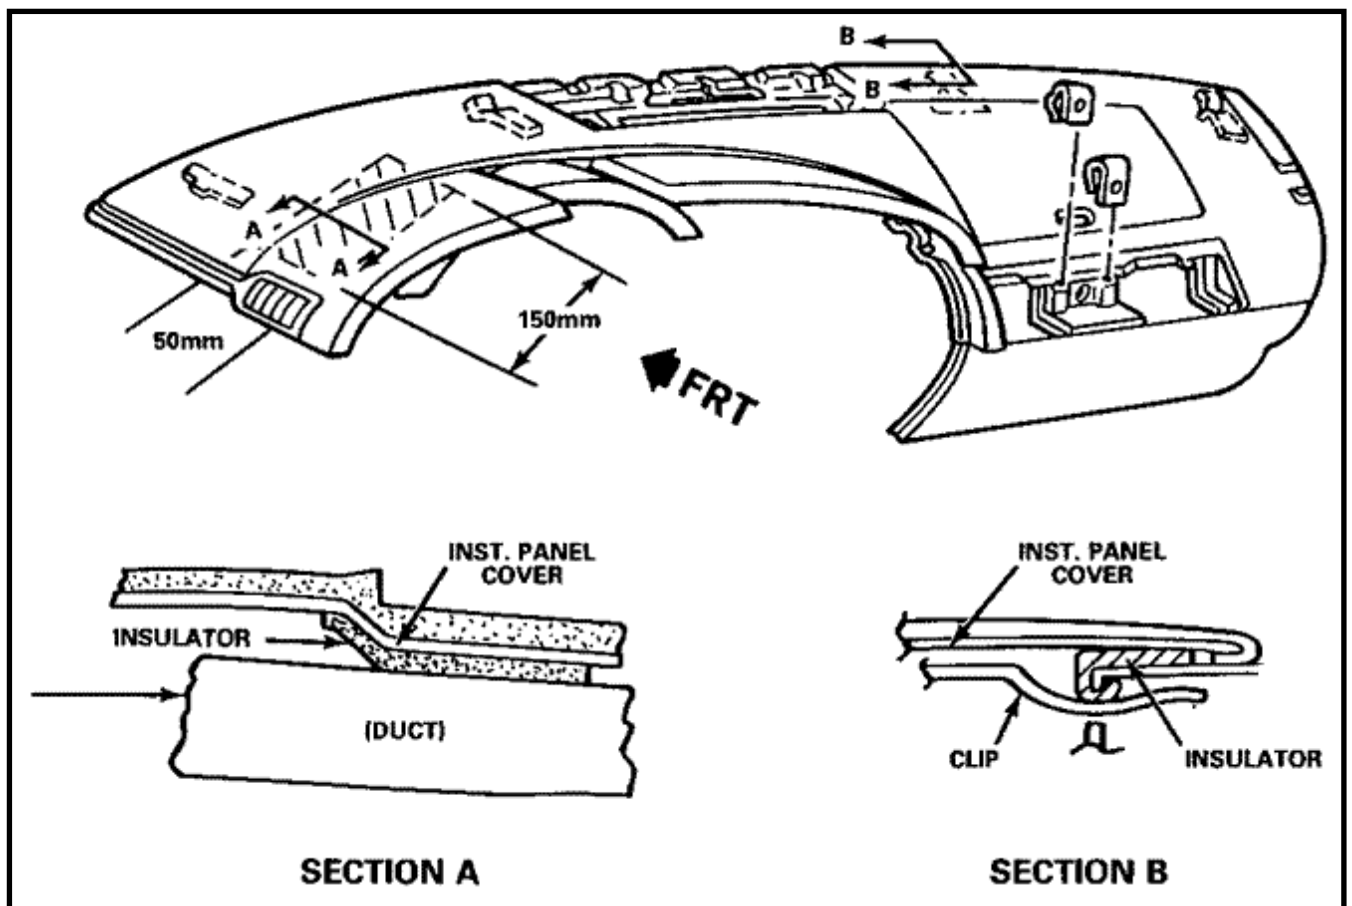
FIGURE 1

1. Rattle forward of gages cluster 1. Insulate area shown in Figure at A/C cross car duct. 1 and Figure 1, Section A (felt material).

2. Rattle at front edge of cover 2. Reposition existing, or near windshield. install felt insulators on metal opening at all retainers, (see Figure 1, Section B). - Left defogger outlet

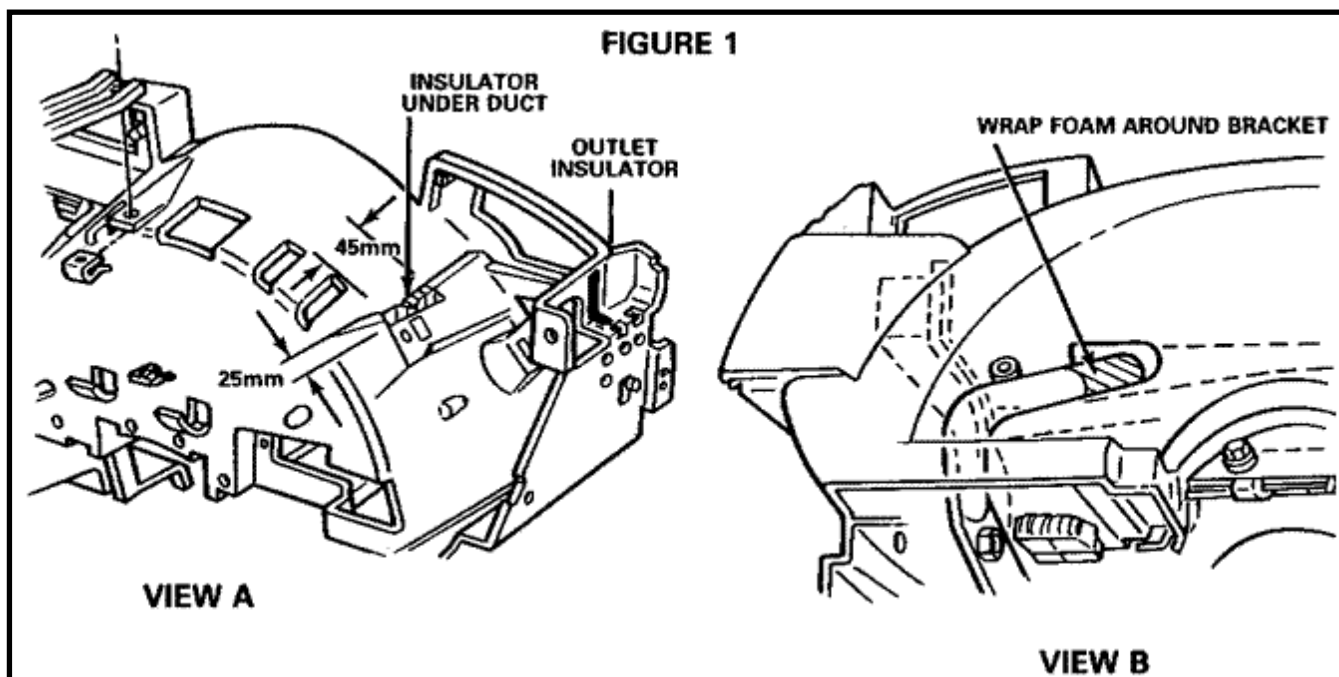
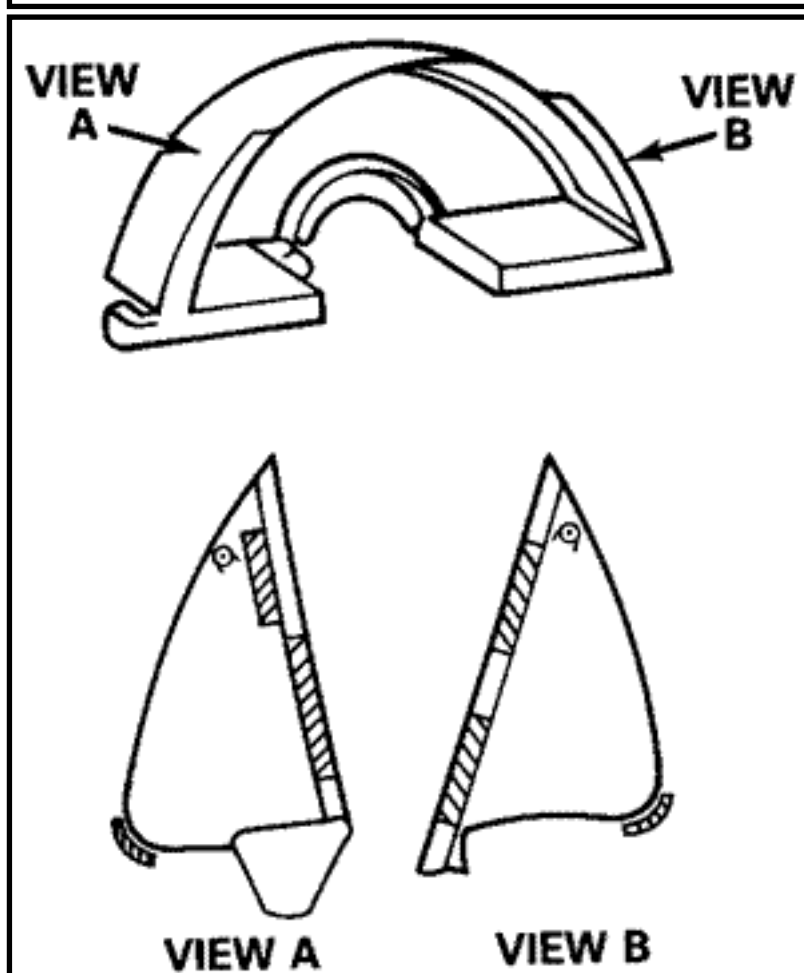
1. Buzzing against instrument 1. Apply felt insulator (1/2" X panel housing. 3"

as shown in Figure 2, view A). - A/C cross car duct

1. Rattle at top of instrument 1. Apply foam insulator (1/8") panel housing. to housing as shown in Figure 2, view A.

2. Rattle at left side SIR 2. Apply foam insulator (1/8") bracket. around bracket as shown in Figure 2 view B. - Instrumentation area

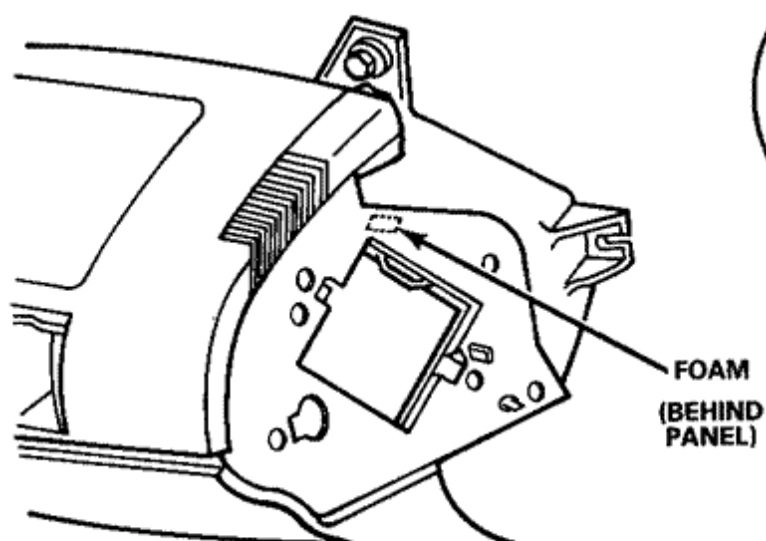
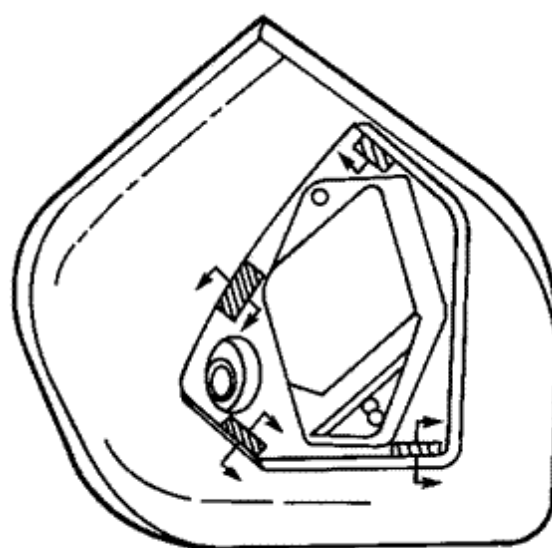
FIGURE 5

2. Buzzing of fuse box rivet 2. Apply small 1/4" foam heads to instrument panel insulator between rivet head cover. and cover as shown and cover as shown in Figure 5, view A.

3. Buzzing of fuse box door 3. Apply felt insulators (1/4" X in the opening. 1") as shown in Figure 5, view B. Position felt into the radius of the opening.

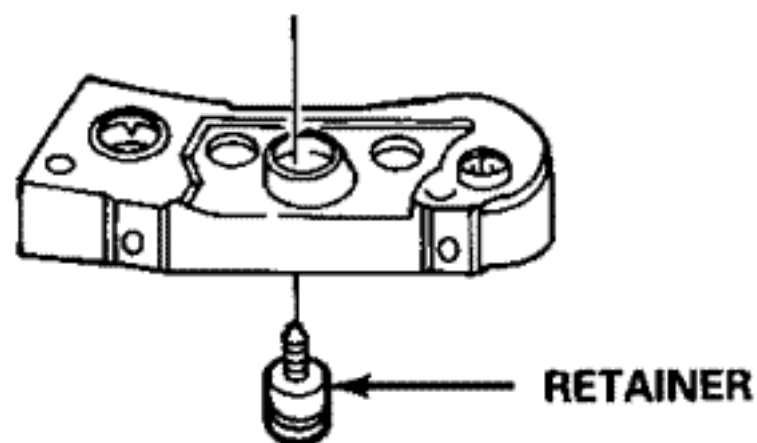
**REMOVABLE ROOF, FRONT
BOLT AND RETAINER**

1. Rattle of front attaching bolts 1. Install new bolt retainers, when panel is stowed in rear. P/N 10 1 75804, see Figure 8.

1. Soak new retainers in warm water to aid in installation.
2. Remove roof panel and stow.
3. Remove upper trim covers at right and left latch areas.
4. Remove right and left sun visors, inside mirror and center garnish molding.
5. Carefully pry original retainer and bolt out of housing using a flat blade screwdriver or other suitable tool.
6. Install bolt in new retainer, align locating rib on retainer with notch in housing and press into place with a "C" clamp and socket.
7. Reinstall garnish molding, inside mirror, sun visors and upper trim covers.

- **PRY BOLT & RETAINER OUT
OF HOUSING WITH FLAT
BLADED SCREWDRIVER**
- **ALIGN LOCATING RIB WITH
NOTCH IN HOUSING**
- **PRESS INTO PLACE WITH
'C' CLAMP**

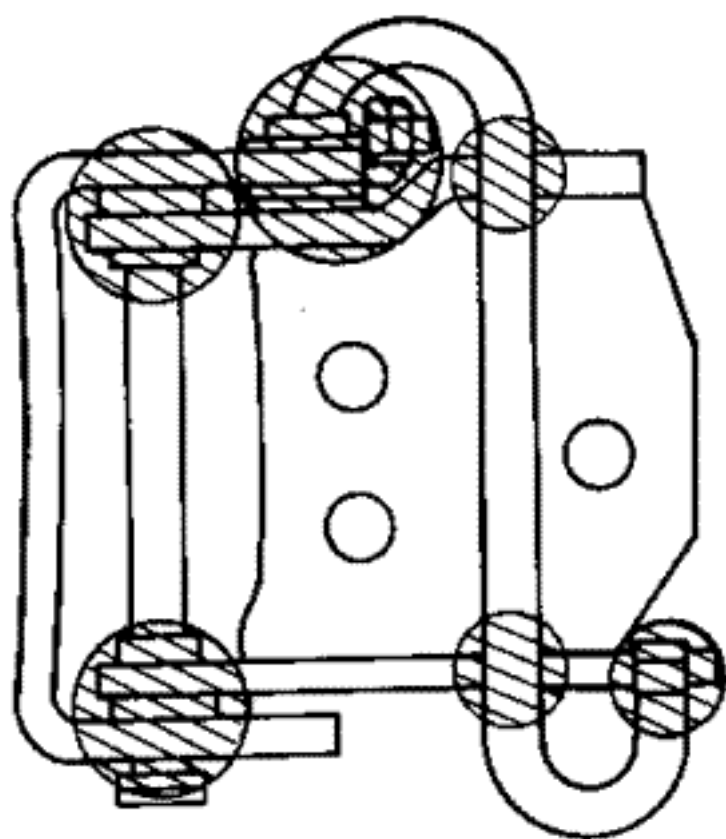
1. Squeaks when opening doors at 1. Lubricate ALL hinge torque hinge torque rod contact areas. rod contact areas with 30 wt. motor oil or grease, see Figure 9. UNDER THE HOOD ----- COMPONENT

LUBE AT SHADED AREAS
DOOR UPPER HINGE
