1991 Corvette: Service Bulletin: Squeak and Rattle Diagnosis Guide

Subject: SQUEAK AND RATTLE DIAG. GUIDE DIAGNOSTIC AID/CORRECTION

Model and Year: 1991 CORVETTE

Bulletin Number: 91-264-10 - (03/25/1991)

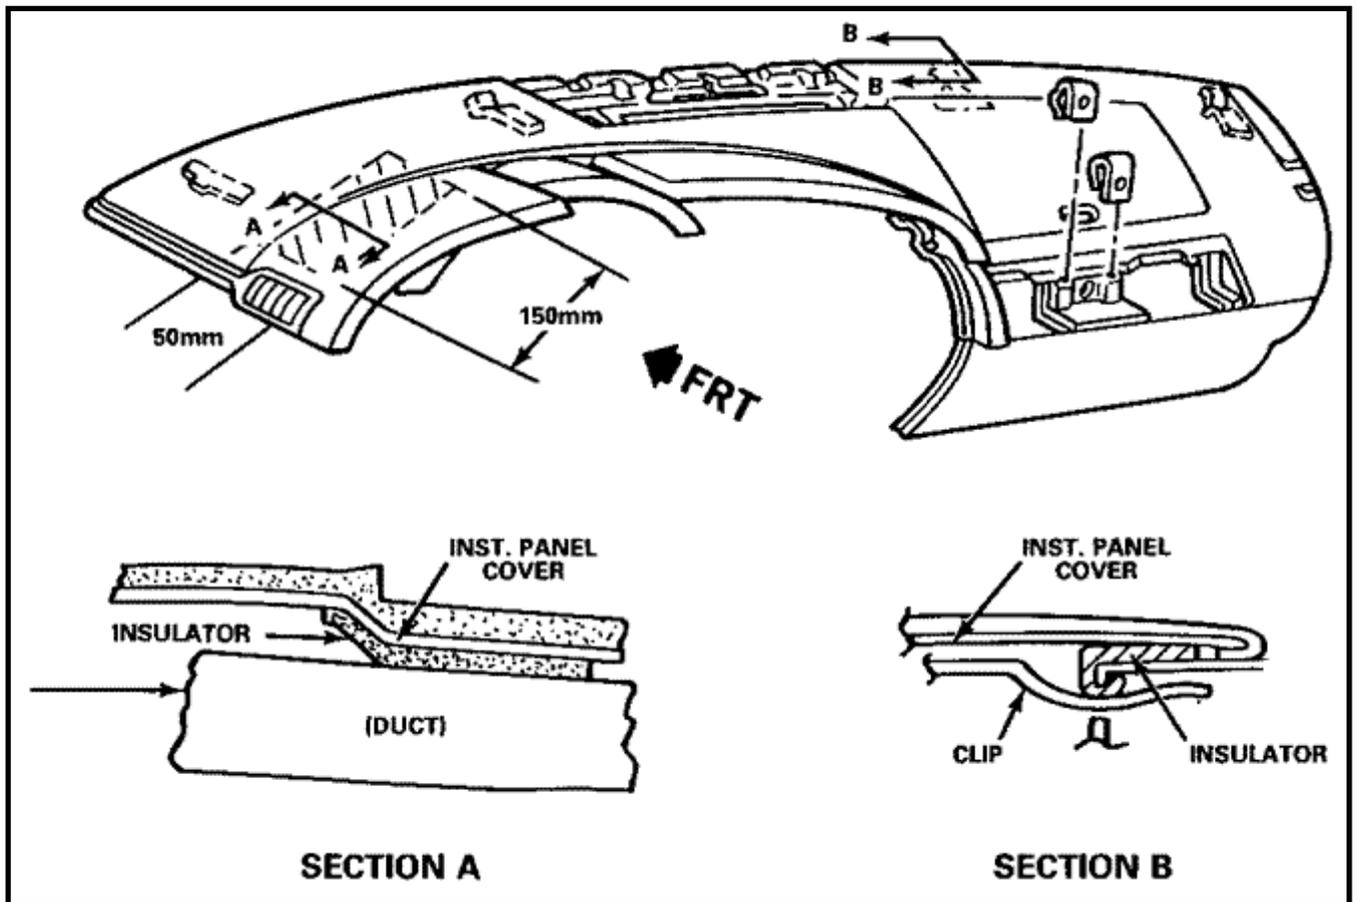
FIGURE 1

1. Rattle forward of gages cluster 1. Insulate area shown in Figure at A/C cross car duct. 1 and Figure 1, Section A (felt material).

2. Rattle at front edge of cover 2. Reposition existing, or near windshield. install felt insulators on metal opening at all retainers, (see Figure 1, Section B). - Left defogger outlet

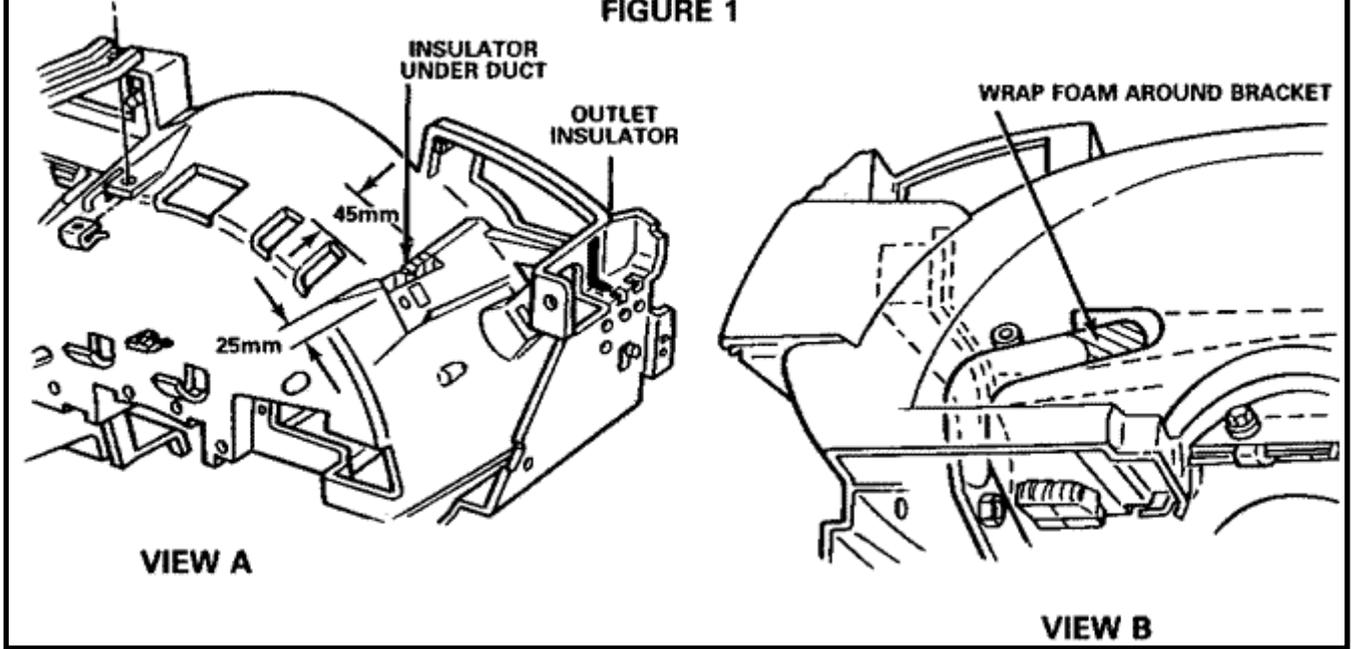
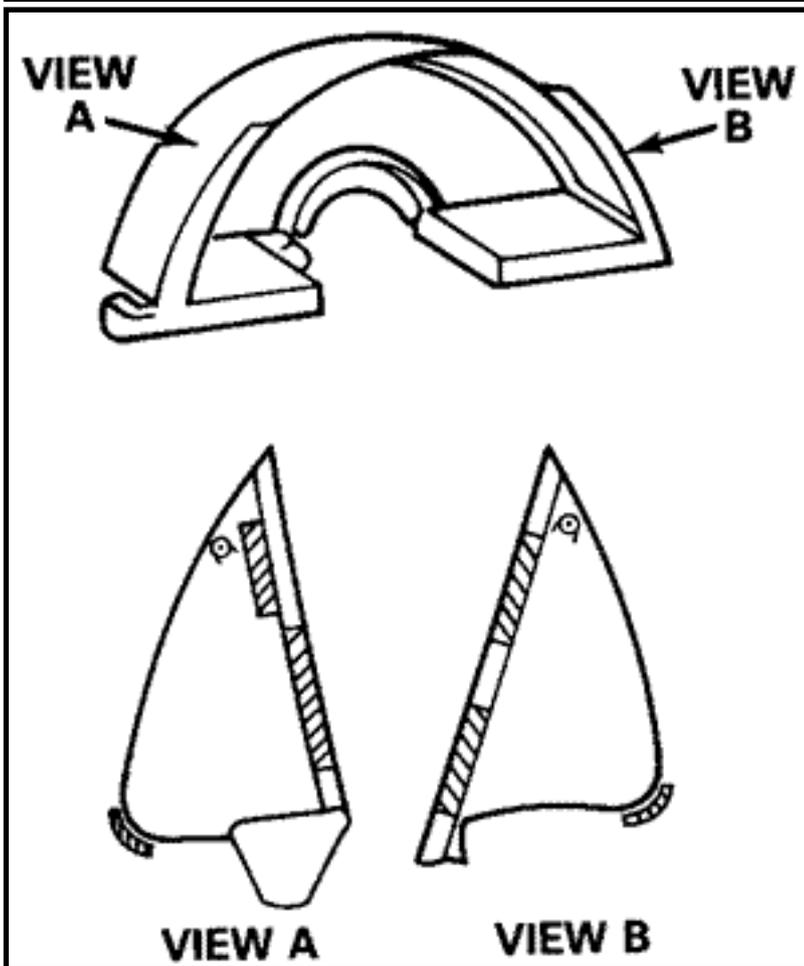
1. Buzzing against instrument 1. Apply felt insulator (1/2" X panel housing. 3"

as shown in Figure 2, view A). - A/C cross car duct

1. Rattle at top of instrument 1. Apply foam insulator (1/8") panel housing. to housing as shown in Figure 2, view A.

2. Rattle at left side SIR 2. Apply foam insulator (1/8") bracket. around bracket as shown in Figure 2 view B. - Instrumentation area

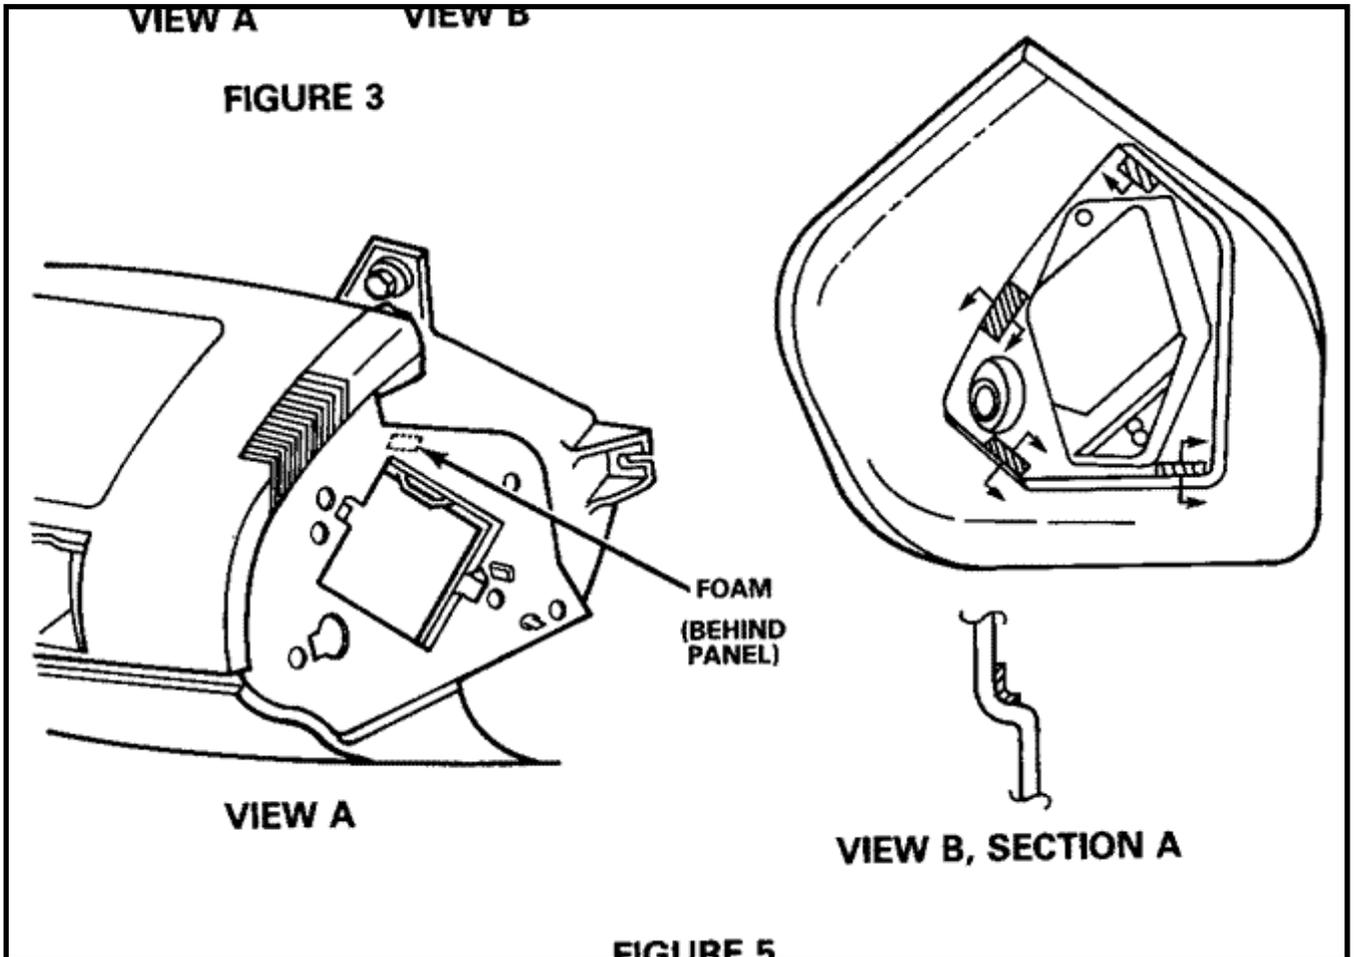
FIGURE 5

2. Buzzing of fuse box rivet 2. Apply small 1/4" foam heads to instrument panel insulator between rivet head cover. and cover as shown and cover as shown in Figure 5, view A.

3. Buzzing of fuse box door 3. Apply felt insulators (1/4" X in the opening. 1") as shown in Figure 5, view B. Position felt into the radius of the opening.

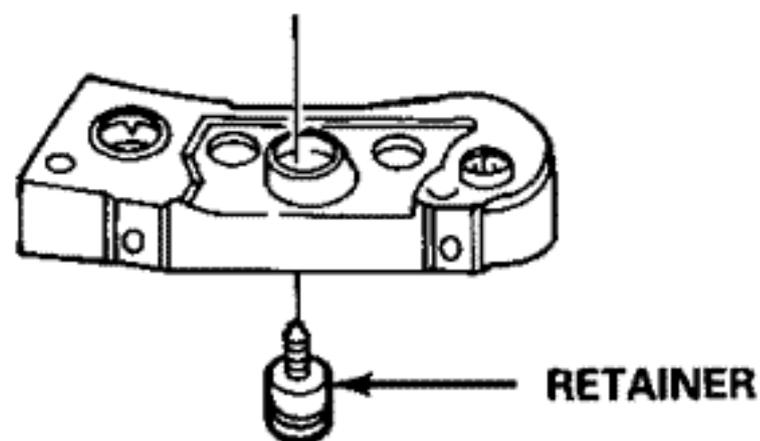
**REMOVABLE ROOF, FRONT
BOLT AND RETAINER**

1. Rattle of front attaching bolts 1. Install new bolt retainers, when panel is stowed in rear. P/N 10 1 75804, see Figure 8.

1. Soak new retainers in warm water to aid in installation.
2. Remove roof panel and stow.
3. Remove upper trim covers at right and left latch areas.
4. Remove right and left sun visors, inside mirror and center garnish molding.
5. Carefully pry original retainer and bolt out of housing using a flat blade screwdriver or other suitable tool.
6. Install bolt in new retainer, align locating rib on retainer with notch in housing and press into place with a "C" clamp and socket.
7. Reinstall garnish molding, inside mirror, sun visors and upper trim covers.

- **PRY BOLT & RETAINER OUT
OF HOUSING WITH FLAT
BLADED SCREWDRIVER**
- **ALIGN LOCATING RIB WITH
NOTCH IN HOUSING**
- **PRESS INTO PLACE WITH
'C' CLAMP**

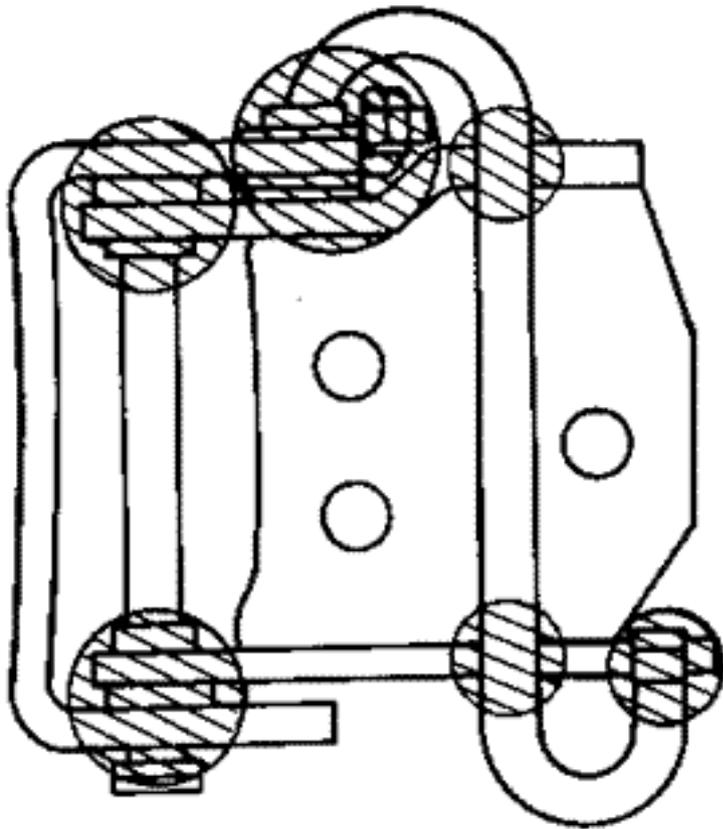
**LUBE AT SHADED AREAS
DOOR UPPER HINGE**

1. Squeaks when opening doors at 1. Lubricate ALL hinge torque hinge torque rod contact areas. rod contact areas with 30 wt. motor oil or grease, see Figure 9. UNDER THE HOOD ----- COMPONENT
