1991 Corvette: Service Bulletin: Squeak and Rattle Diagnosis Guide

Subject: SQUEAK AND RATTLE DIAG. GUIDE DIAGNOSTIC AID/CORRECTION

Model and Year: 1991 CORVETTE

Bulletin Number: 91-264-10 - (03/25/1991)

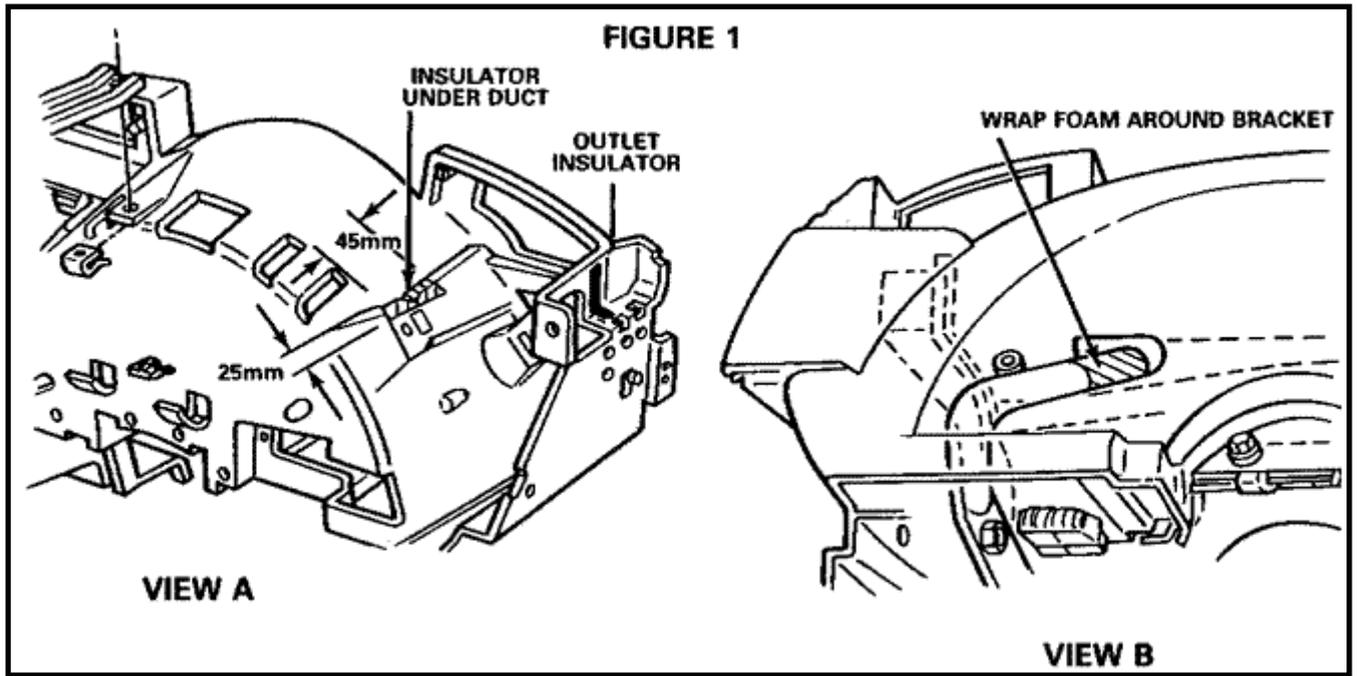
1. Buzzing against instrument 1. Apply felt insulator (1/2" X panel housing. 3"

as shown in Figure 2, view A). - A/C cross car duct

1. Rattle at top of instrument 1. Apply foam insulator (1/8") panel housing. to housing as shown in Figure 2, view A.

2. Rattle at left side SIR 2. Apply foam insulator (1/8") bracket. around bracket as shown in Figure 2 view B. - Instrumentation area

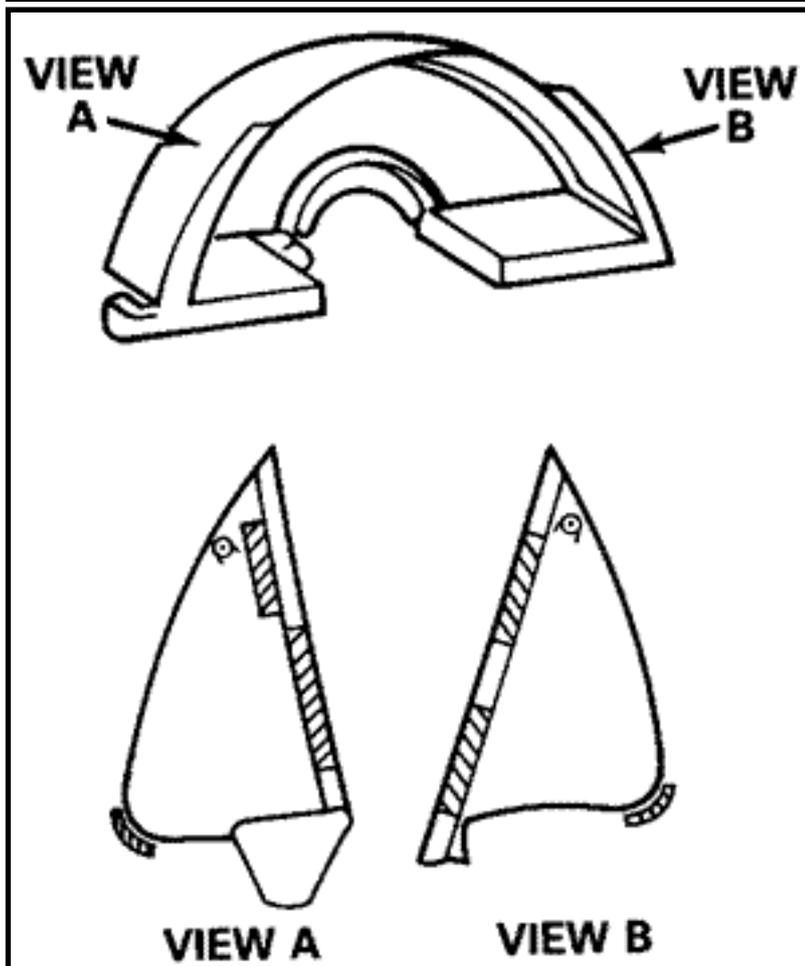
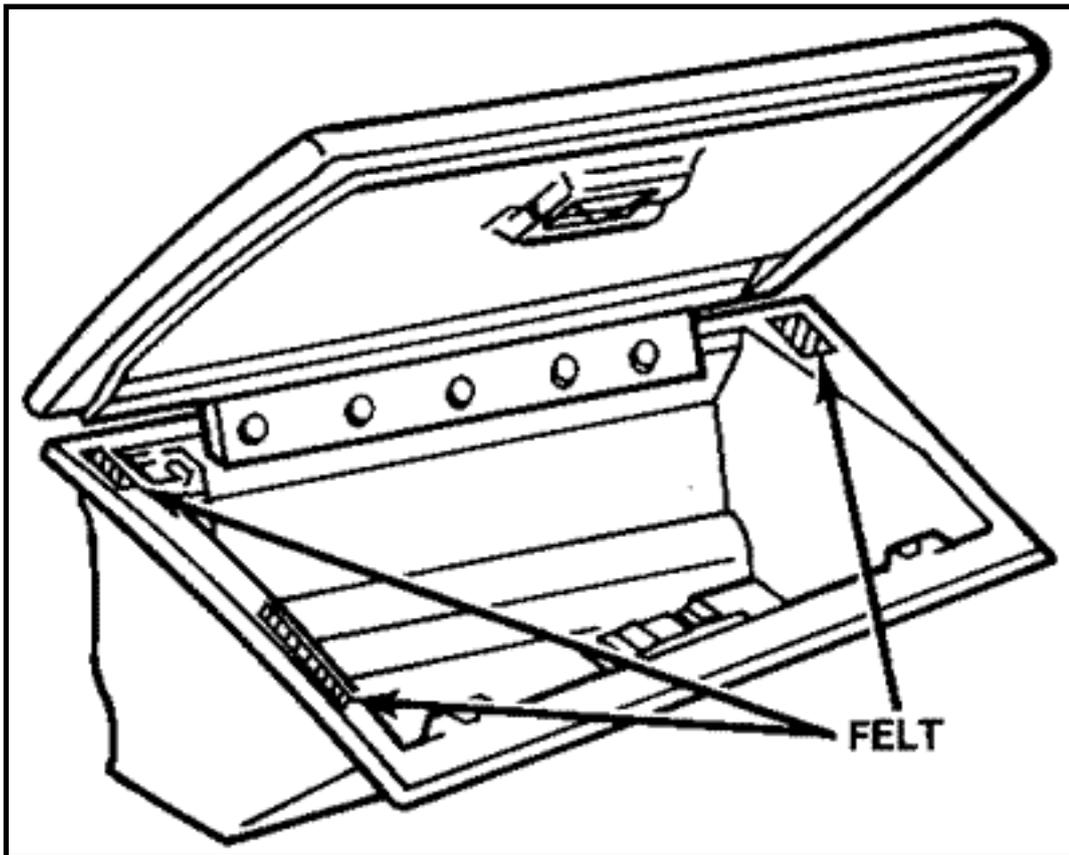
FIGURE 3

1. Squeak in instrument cluster 1. Apply felt insulators to bezel to cover. bezel edges and surfaces in locations as shown in Figure 3, views A and B.

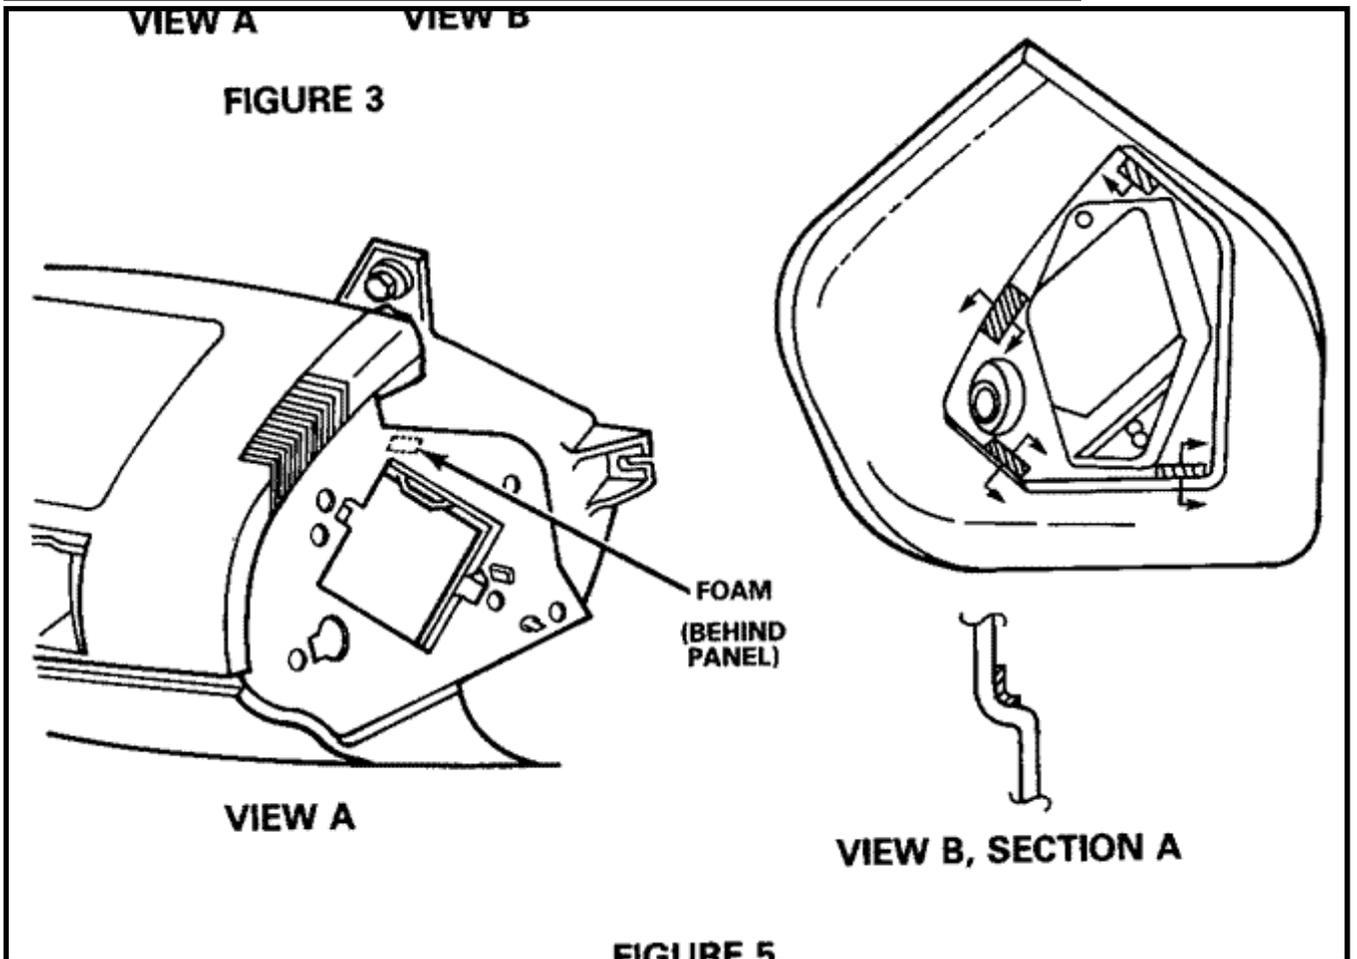
FIGURE 5

2. Buzzing of fuse box rivet 2. Apply small 1/4" foam heads to instrument panel insulator between rivet head cover. and cover as shown and cover as shown in Figure 5, view A.

3. Buzzing of fuse box door 3. Apply felt insulators (1/4" X in the opening. 1") as shown in Figure 5, view B. Position felt into the radius of the opening.

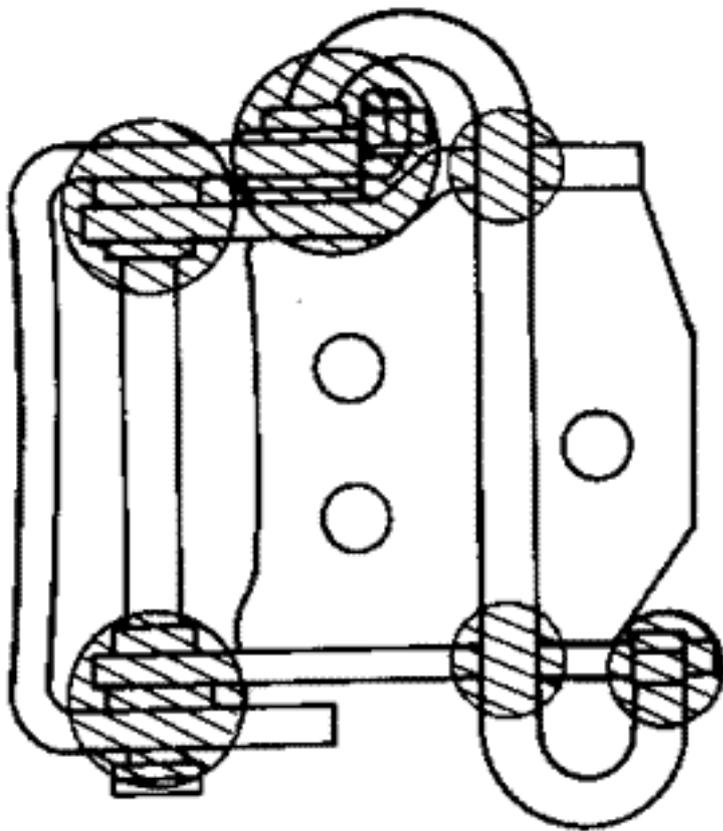
1. Squeaks when opening doors at 1. Lubricate ALL hinge torque hinge torque rod contact areas. rod contact areas with 30 wt. motor oil or grease, see Figure 9.

**LUBE AT SHADED AREAS
DOOR UPPER HINGE**

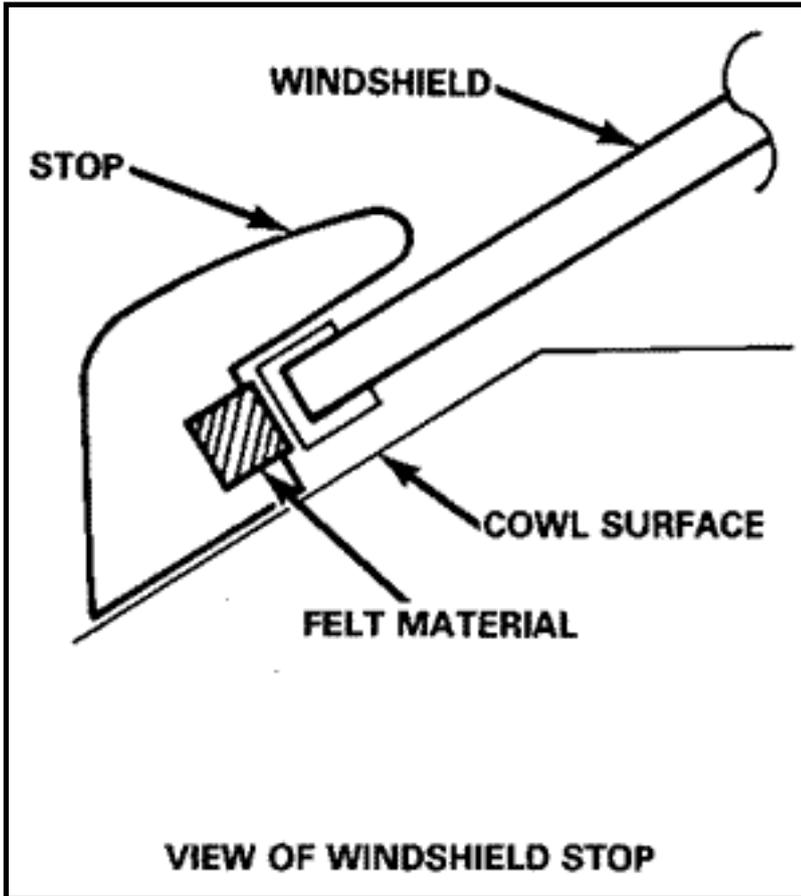
Popping/clicking at left 1. Apply felt to windshield front of windshield area. stop at area contacting windshield edge, see Figure 10.

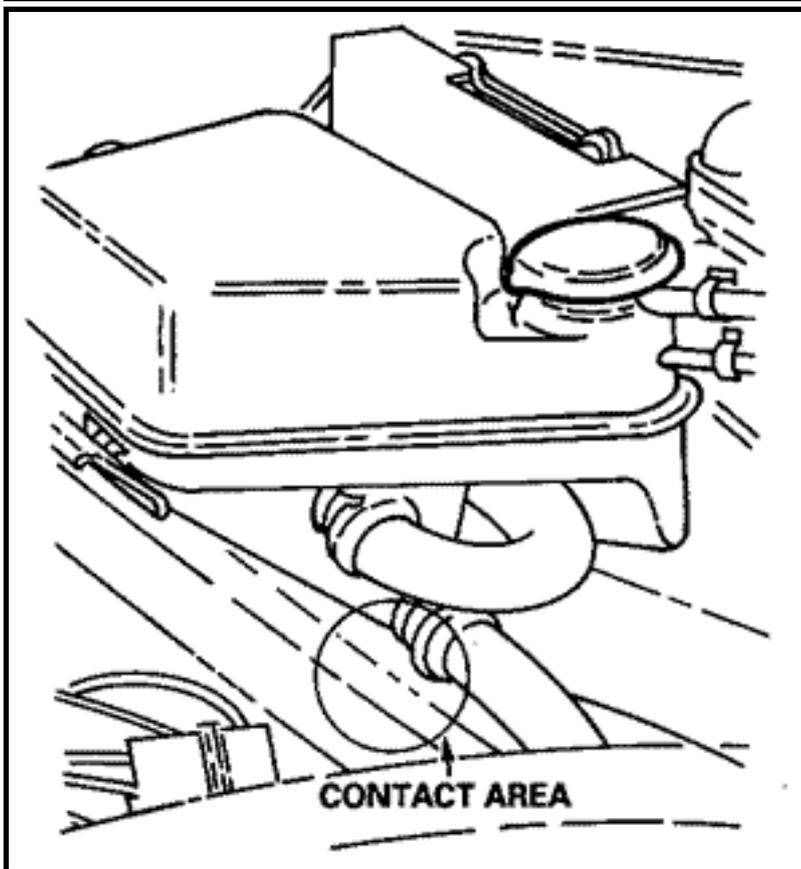
4. Squeak at right side 4. Reposition hose clamps to of vehicle. Hose clamps provide clearance to right for high fill container diagonal brace, see Figure contacting diagonal brace. 11.
