1990 Corvette: Service Bulletin: SIR Revised Code 42 Chart

Number: 90-229-9

Subject: Service Manual Update - SIR Revised Code 42 Chart

Model Year: 1990 Y Car

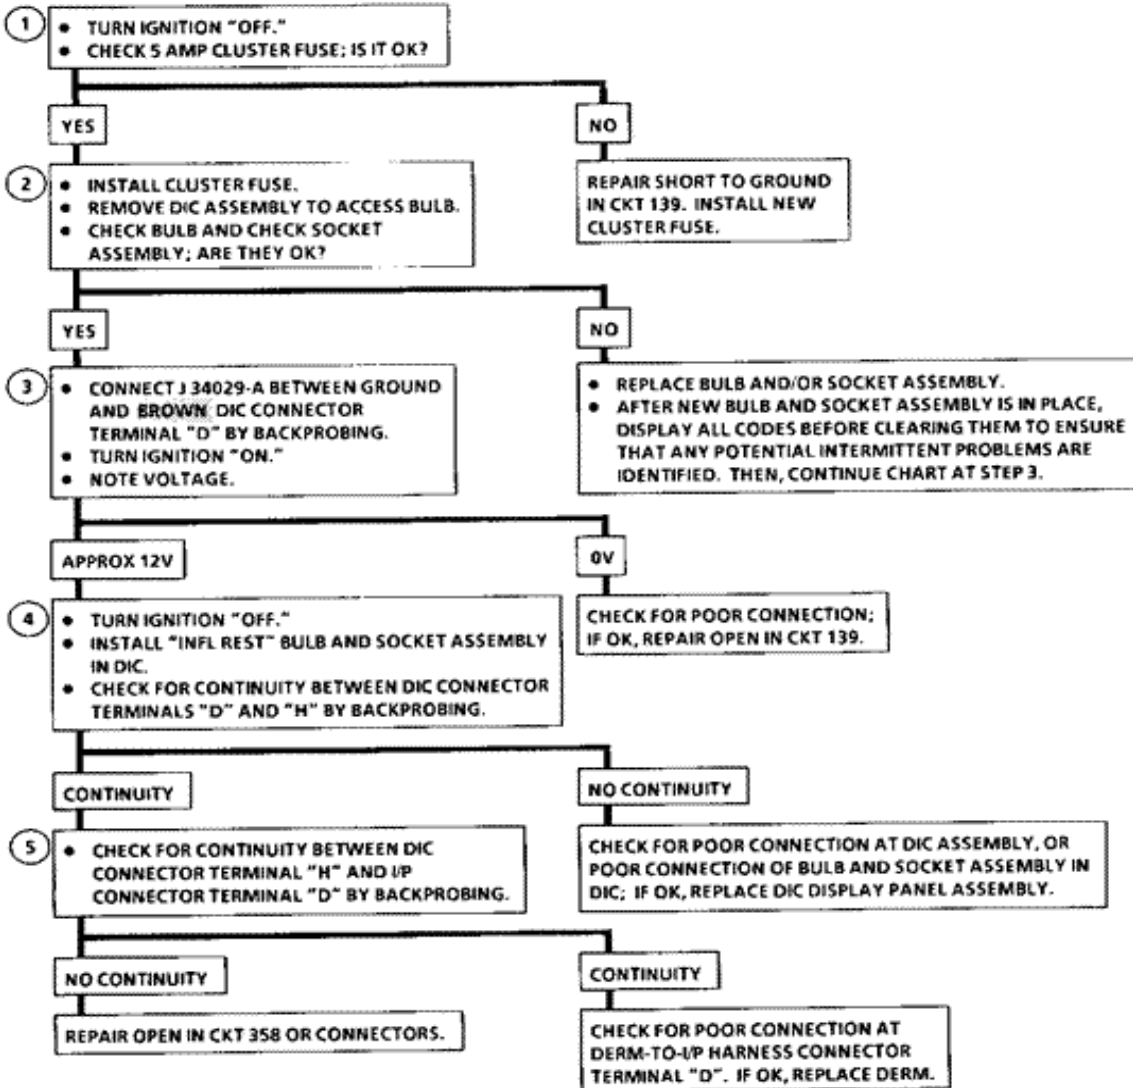
CODE 42 INDICATOR LAMP CIRCUIT (OPEN CIRCUIT)

The blue connector referenced in the chart, step 3, should be a brown connector.

NOTE: IF IGNITION IS TURNED "ON," WHEN CLUSTER FUSE IS REMOVED OR BLOWN, THIS CODE WILL SET. ALSO, AN INTERMITTENT OPEN IN THE "INFL REST" INDICATOR CIRCUIT OR A DISCONNECTED DIC CONNECTOR WILL SET THIS CODE.

IMPORTANT
WHEN ALL DIAGNOSIS AND REPAIRS ARE COMPLETED, CLEAR CODES AND PERFORM "SIR DIAGNOSTIC SYSTEM CHECK" IN THIS SECTION.
