1989 - 1991 Corvette: Service Bulletin: Proper Installation and Seating of the SIR Coil Assembly

Subject: PROPER INSTALLATION AND SEATING OF THE SIR COIL ASSEMBLY

Model and Year: 1989-91 CAPRICE, CAMARO, CORVETTE, CORSICA AND BERETTA

Bulletin Number: 91-204-3B - (01/23/1991)

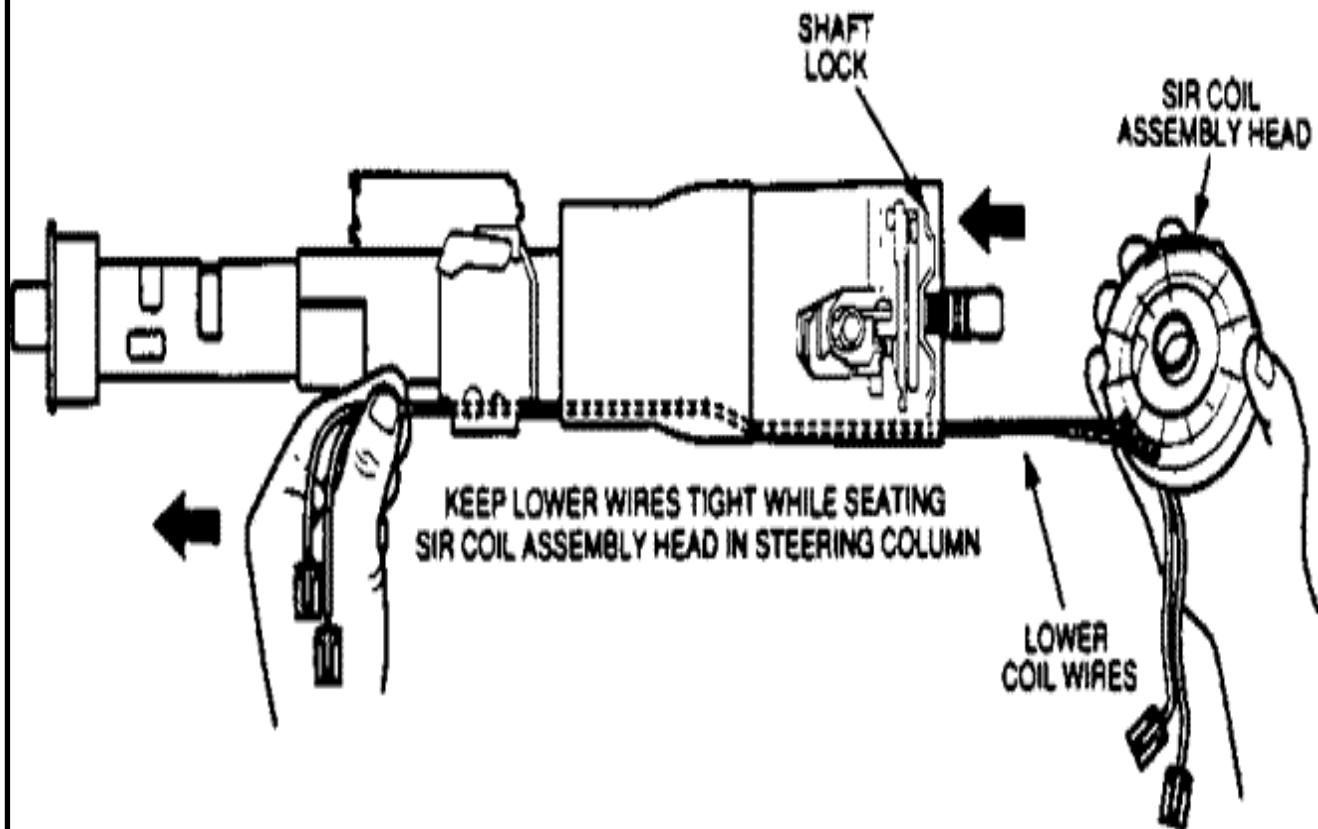
Figure 3 SIR Coil Assembly Installation Procedure

The lower SIR coil assembly wires can be kinked near the shaft lock mechanism after service of the steering column. The improperly located wires interfere with the shaft lock and can be cut when the steering wheel is turned. The SIR coil must be reassembled correctly. During reassembly, do not force the coil down, and do not allow the lower coil wires to be trapped between the shaft lock and the coil assembly.

After the steering column has been serviced, the SIR coil assembly may be improperly seated with slack in the lower SIR coil wires in the shaft lock area.

1. Grasp the ends of all the lower SIR coil wires below the I.P. bracket (See Figure 3).
2. Grasp the SIR coil head with the other hand. Position the head assembly with the lower wires in the down position (See Figure 3).
3. Stretch the SIR coil head and lower wires so that they are straight and tight with no slack.
4. Pull on the lower wires to keep them straight while positioning the SIR coil head over the end of the upper steering shaft assembly.
5. Continue to pull on the lower coil wires while moving the coil head down on the steering shaft.
