1989 - 1991 Corvette: Service Bulletin: Proper Installation and Seating of the SIR Coil Assembly

Subject: PROPER INSTALLATION AND SEATING OF THE SIR COIL ASSEMBLY

Model and Year: 1989-91 CAPRICE, CAMARO, CORVETTE, CORSICA AND BERETTA

Bulletin Number: 91-204-3B - (01/23/1991)

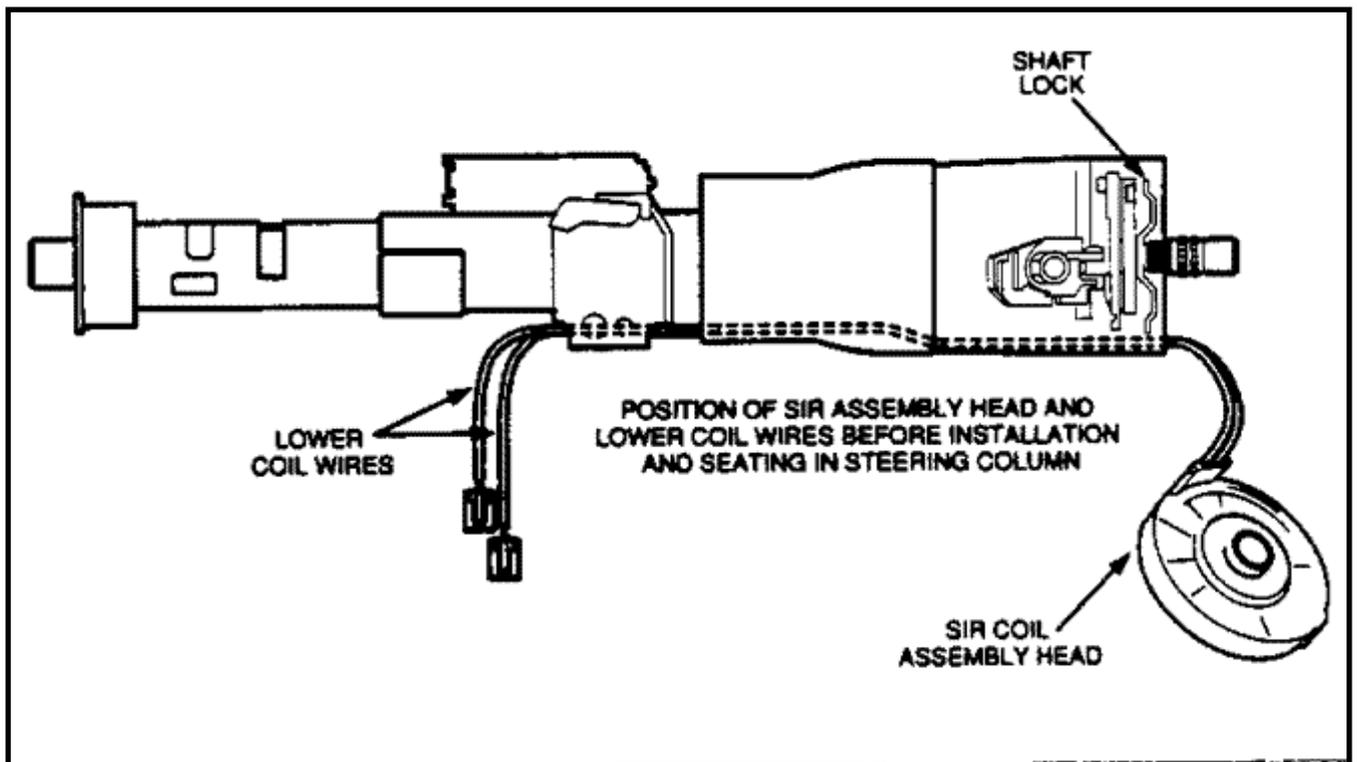
Figure 2 SIR Coil Assembly Before Seating

Begin this procedure with lower SIR coil wires routed through the column shift bowl exiting the I.P. bracket on the jacket assembly (wire protector removed) with the coil head hanging freely from the top of the column (See Figure 2).
