# 1989 - 1990 Corvette: Service Bulletin: Improved Access to Inboard Seat Belt Buckle / New Extender

**Model and Year:** 1989-90 CORVETTE WITH AQ9 SEATS

**Bulletin Number:** 90-291-10 - (06/22/1990)

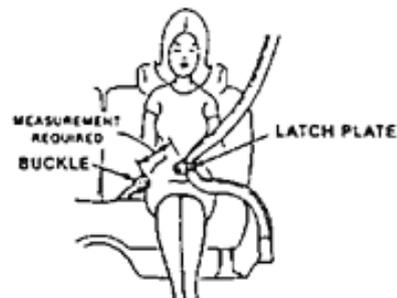
- 0 MEASURE FROM THE LEADING EDGE OF THE LATCH PLATE WITH THE BELT FULLY EXTENDED TO THE FRONT EDGE OF THE BUCKLE (FIGURE 1) AND NOTE DIMENSION BELOW:
