1989 - 1990 Corvette: Service Bulletin: Improved Access to Inboard Seat Belt Buckle / New Extender

Model and Year: 1989-90 CORVETTE WITH AQ9 SEATS

Bulletin Number: 90-291-10 - (06/22/1990)

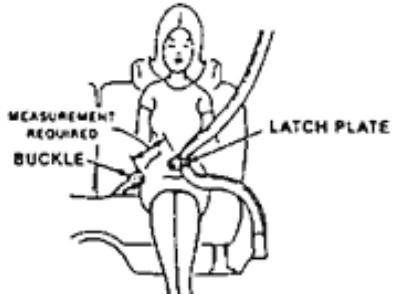
0 MEASURE FROM THE LEADING EDGE OF THE LATCH PLATE WITH THE BELT FULLY EXTENDED TO THE FRONT EDGE OF THE BUCKLE (FIGURE 1) AND NOTE DIMENSION BELOW:
