1984 - 1990 Corvette: Service Bulletin: Power Seat Inoperative and/or Blows Fuses

Subject: POWER SEAT INOP/BLOWS FUSES REPAIR/REPLACE HARNESS

Model and Year: 1984-90 CORVETTE

Bulletin Number: 90-412-10 - (03/18/1991)

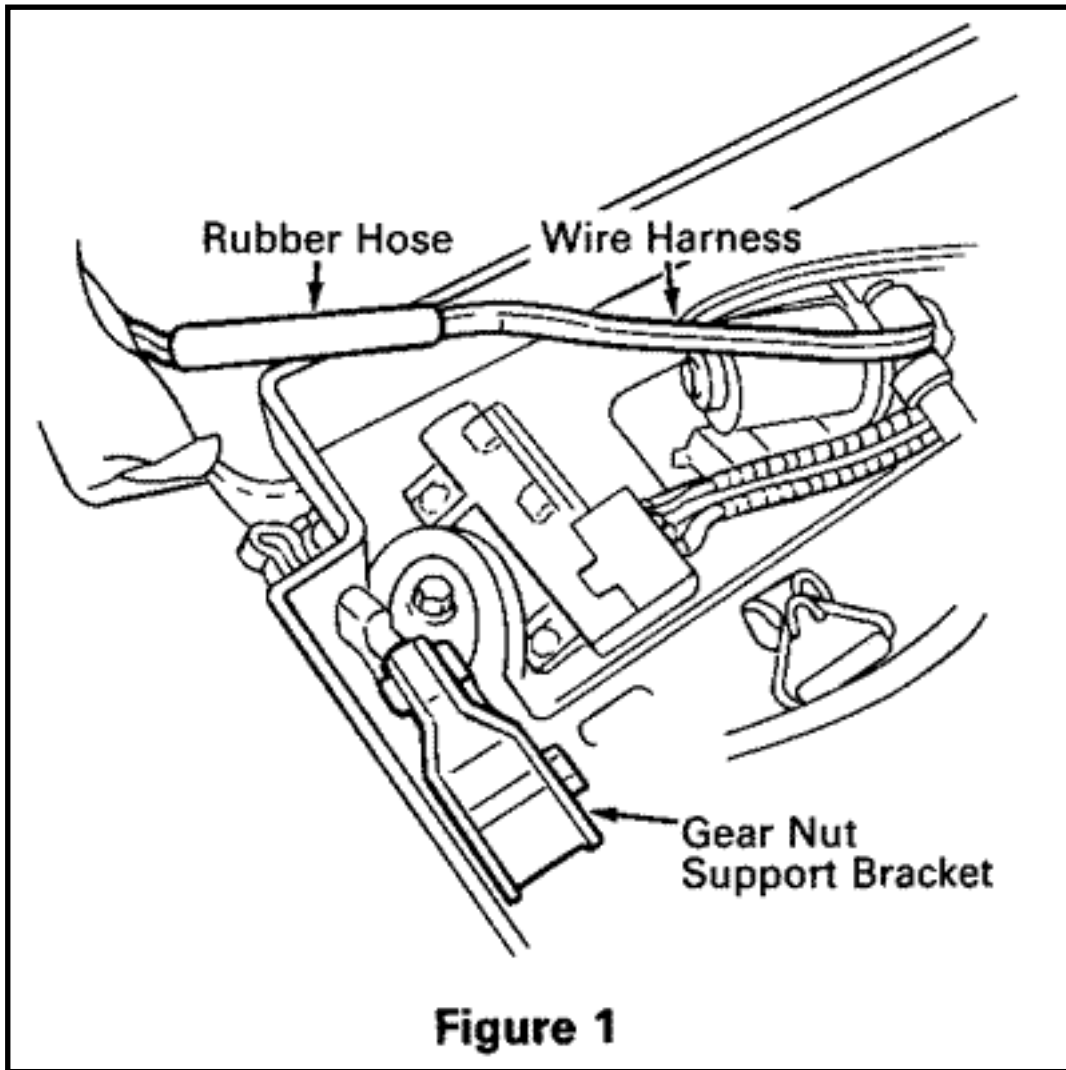
Seat Control Switch Wire Harness may be shorted at gearnut support bracket. (See Illustration) With seat cushion installed, harness contacts gearnut support bracket and may become shorted with weight of driver/passenger.

Repair and/or replace harness as required. Using a section of rubber hose (gas line) about (4) inches long (split), cover harness as illustrated taping both ends.
