1984 - 1990 Corvette: Service Bulletin: Power Seat Inoperative and/or Blows Fuses

Subject: POWER SEAT INOP/BLOWS FUSES REPAIR/REPLACE HARNESS

Model and Year: 1984-90 CORVETTE

Bulletin Number: 90-412-10 - (03/18/1991)

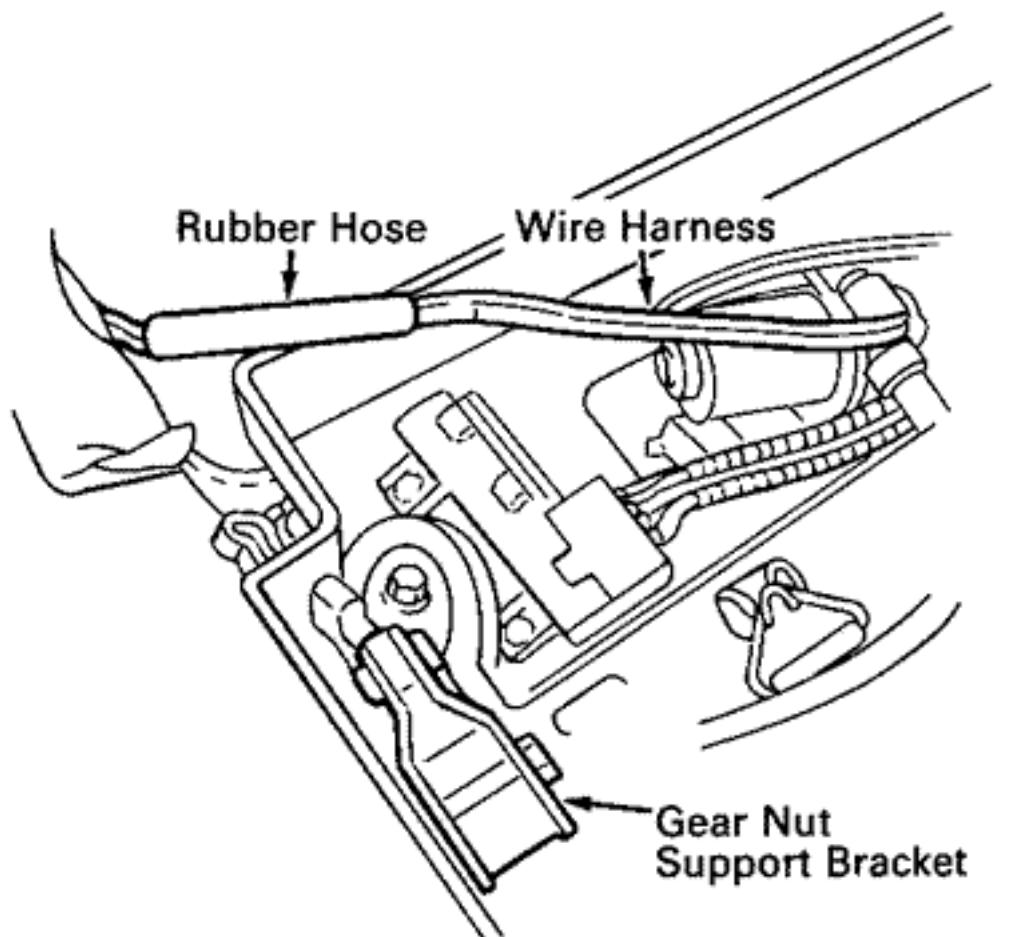
Figure 1

Power Seat (AQ9) inoperative and/or blows fuse.

Seat Control Switch Wire Harness may be shorted at gearnut support bracket. (See Illustration) With seat cushion installed, harness contacts gearnut support bracket and may become shorted with weight of driver/passenger.

Repair and/or replace harness as required. Using a section of rubber hose (gas line) about (4) inches long (split), cover harness as illustrated taping both ends.
