# 1984 - 1987 Corvette: Service Bulletin: Loose Corvette Door Trim Panel

**Subject:** Loose Corvette Door Trim Panel

**Bulletin Number:** 87-116, Number 10

**Date:** April, 1987

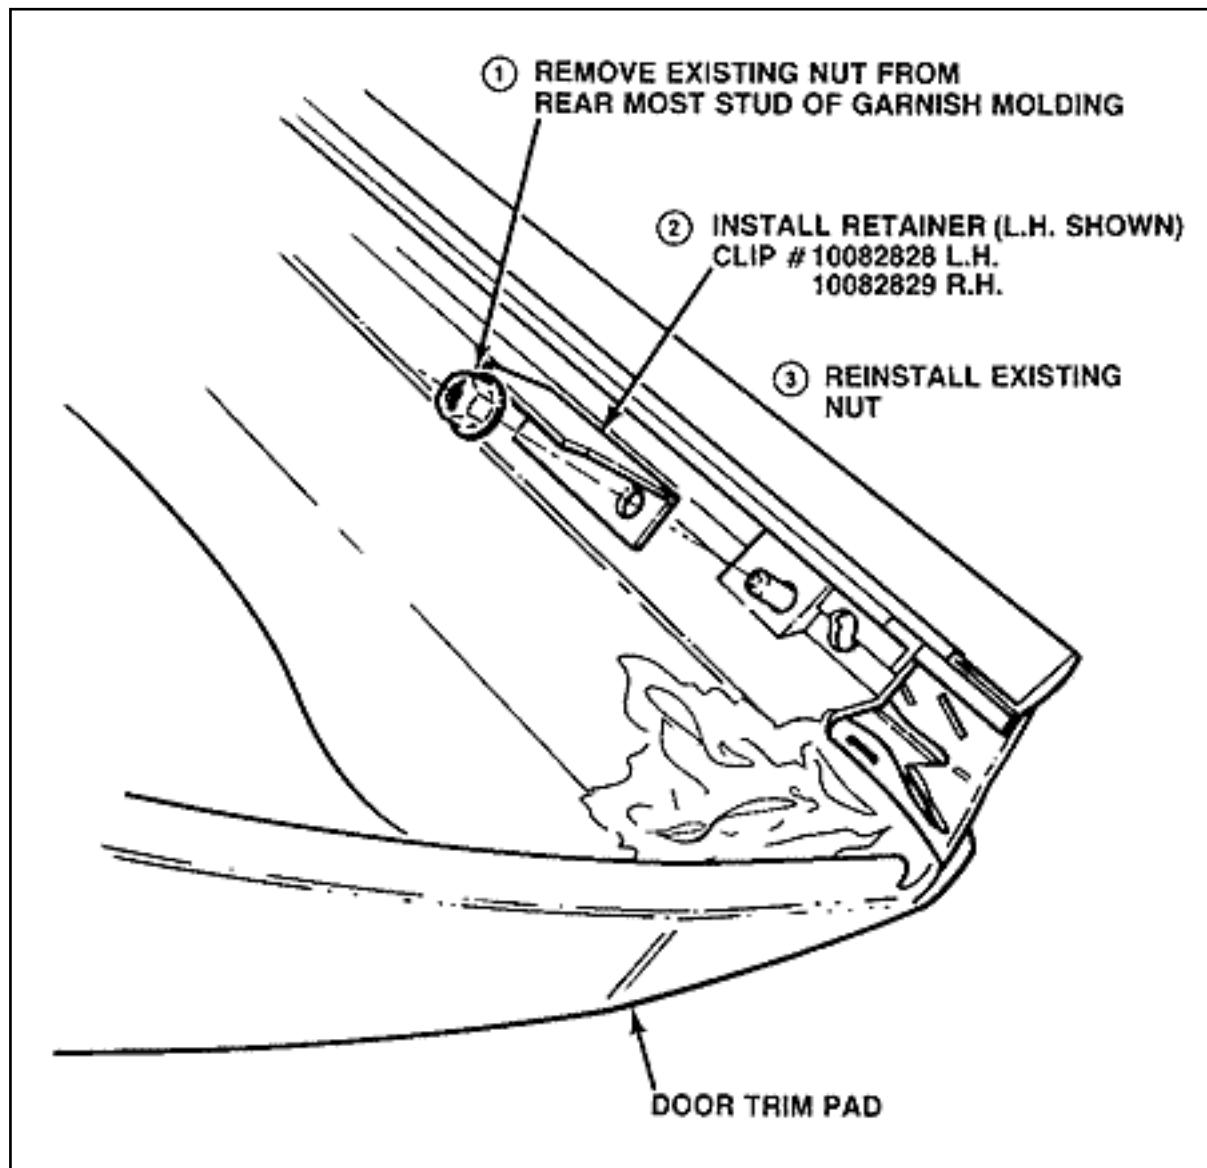
Some 1984-87 Corvette door trim pads may be loose from the door inner panel at the rear upper edge of the door.

If this condition is found it may be repaired by adding a retainer to the door trim panel using the following procedure.

1. Remove door trim panel per instructions in the Corvette Shop Manual.
2. Install retainer, P/N 10082828-9, L.H./R.H. as illustrated, to the trim pads rear upper garnish molding stud using spin nut. (See Illustration)
3. To remove a trim panel with a retainer, push trim panel upward and outboard to disengage clip from door inner panel at beltline.
