# 1984 - 1987 Corvette: Service Bulletin: Loose Corvette Door Trim Panel

**Subject:** Loose Corvette Door Trim Panel

**Source:** Chevrolet Dealer Service Bulletin

**Bulletin Number:** 87-116, Number 10

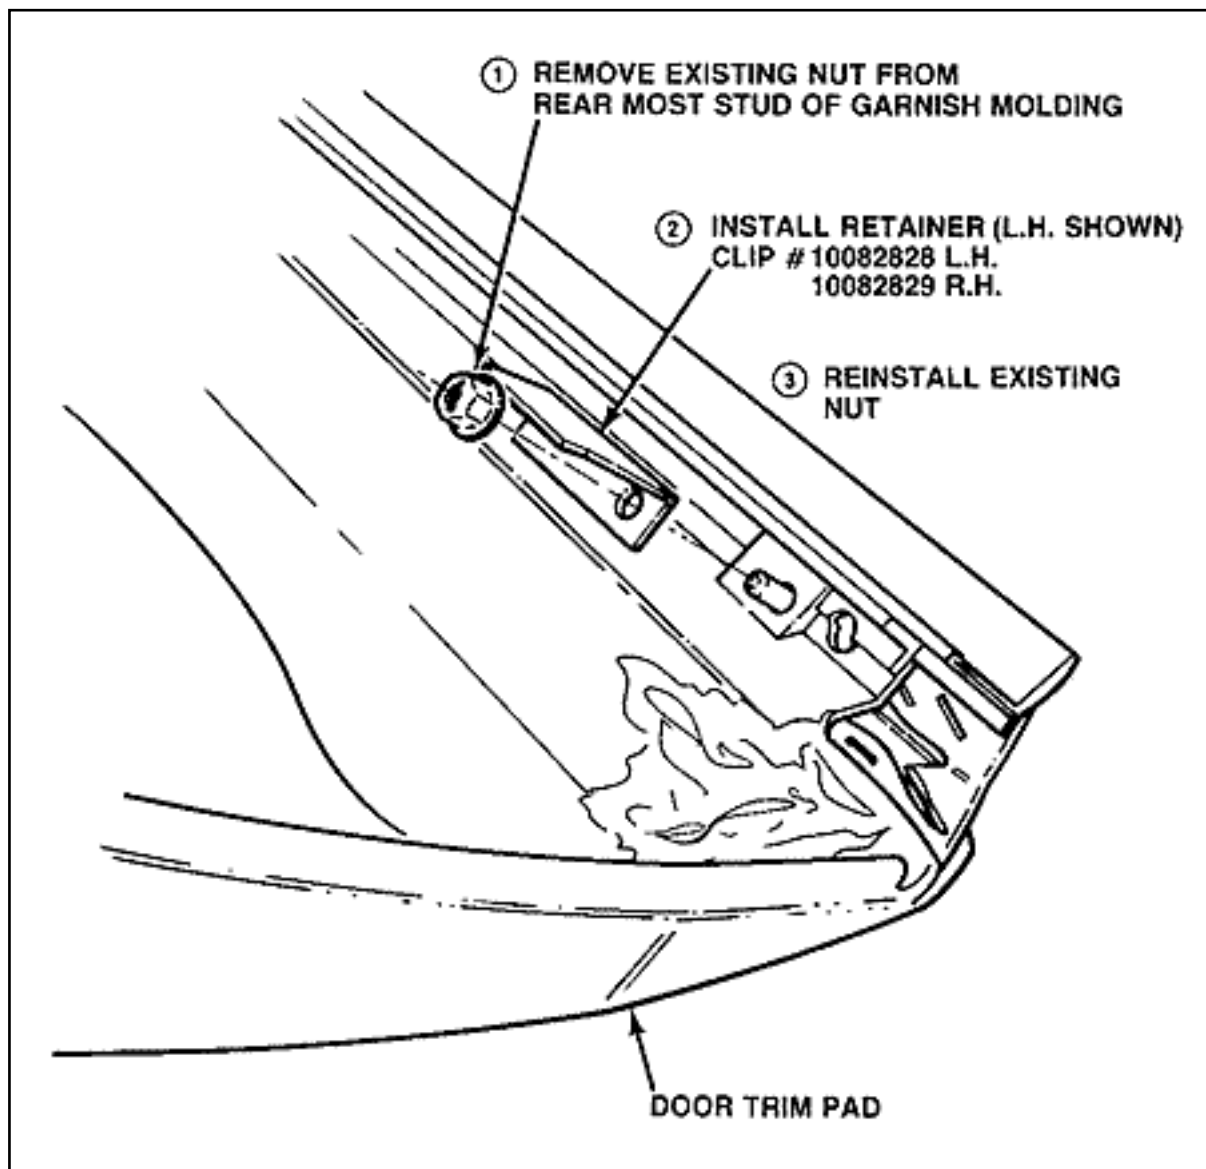
Some 1984-87 Corvette door trim pads may be loose from the door inner panel at the rear upper edge of the door.

If this condition is found it may be repaired by adding a retainer to the door trim panel using the following procedure.

1. Remove door trim panel per instructions in the Corvette Shop Manual.
2. Install retainer, P/N 10082828-9, L.H./R.H. as illustrated, to the trim pads rear upper garnish molding stud using spin nut. (See Illustration)
3. To remove a trim panel with a retainer, push trim panel upward and outboard to disengage clip from door inner panel at beltline.
