1992 - 1993 Corvette: Service Bulletin: Noisy/Fraying Accessory Drive Belt

Subject: NOISY/FRAYING ACCESSORY DRIVE BELT (INST. SINGLE-SIDED BELT)

Model and Year: 1992-93 CORVETTE WITH 5.7L (LT1) ENGINE

Bulletin Number: 93-273-6A

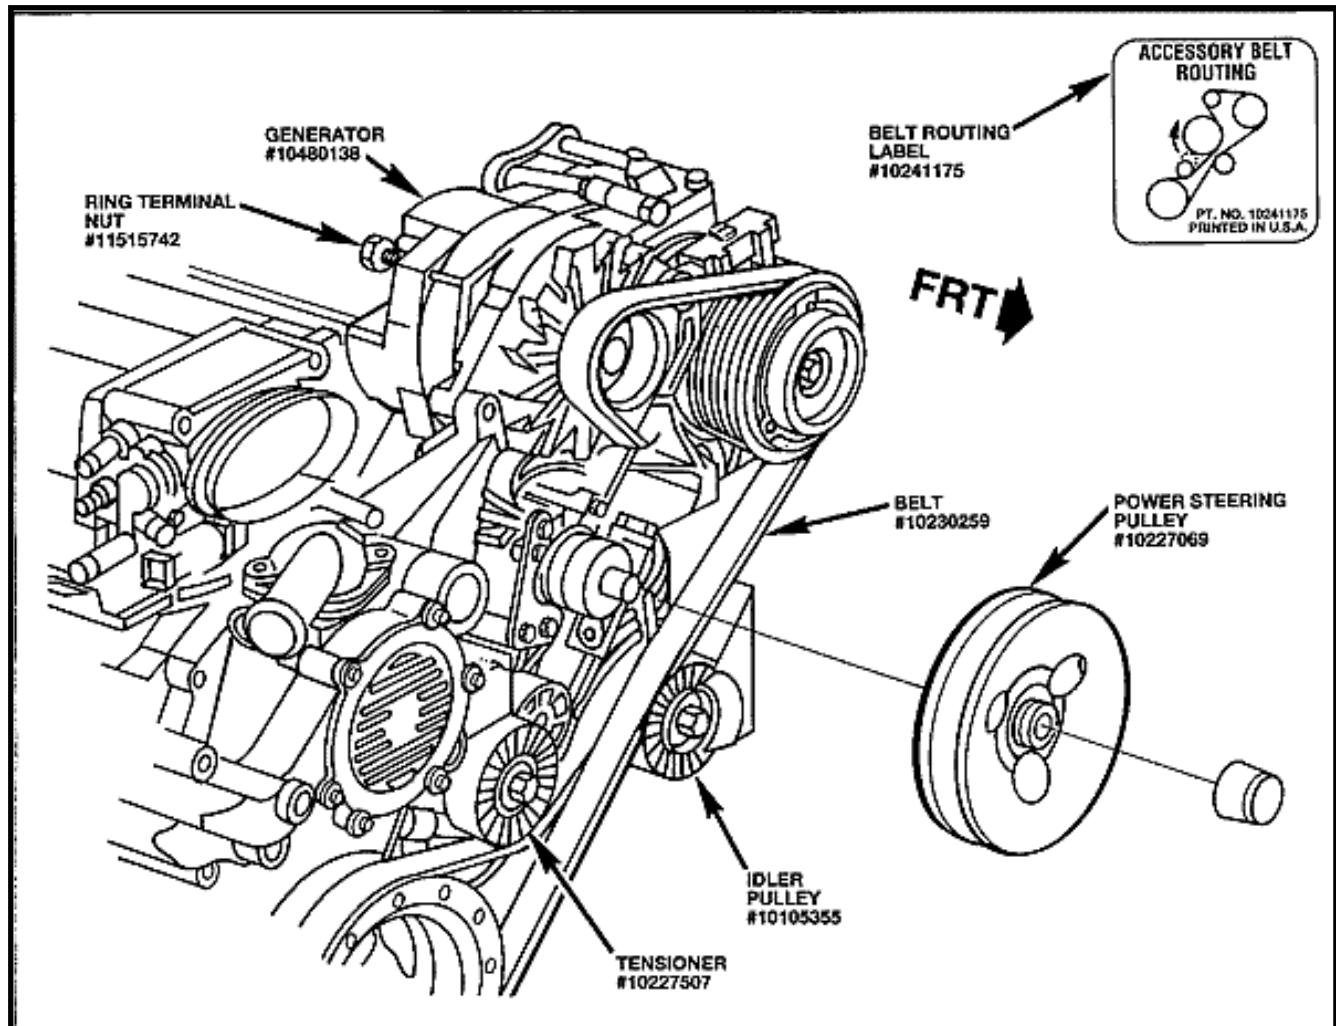
Some owners of 1992 and early 1993 model year Corvettes with 5.7L (LT1, VIN P) engines using the double-sided accessory drive belt may experience a noisy or fraying belt condition.

Inherent stresses and/or processing of the double-sided belt.

To correct this condition a change was made from the double-sided belt system to a new single-sided belt system. Starting the week of March 22, 1993, VIN breakpoint #1G1YY23P4P5113150 Corvettes with LT1 engines were built with the new single-sided belt. To repair older units with the double-sided belt to a single-sided belt, the following parts must be installed:

NOTE: When replacing the new generator, the ring terminal on the wire harness will have to be opened up the 8.5mm to accommodate the larger stud on the back of the new generator.
