1992 - 1993 Corvette: Service Bulletin: Noisy/Fraying Accessory Drive Belt

Subject: NOISY/FRAYING ACCESSORY DRIVE BELT (INST. SINGLE-SIDED BELT)

Model and Year: 1992-93 CORVETTE WITH 5.7L (LT1) ENGINE

Bulletin Number: 93-273-6A

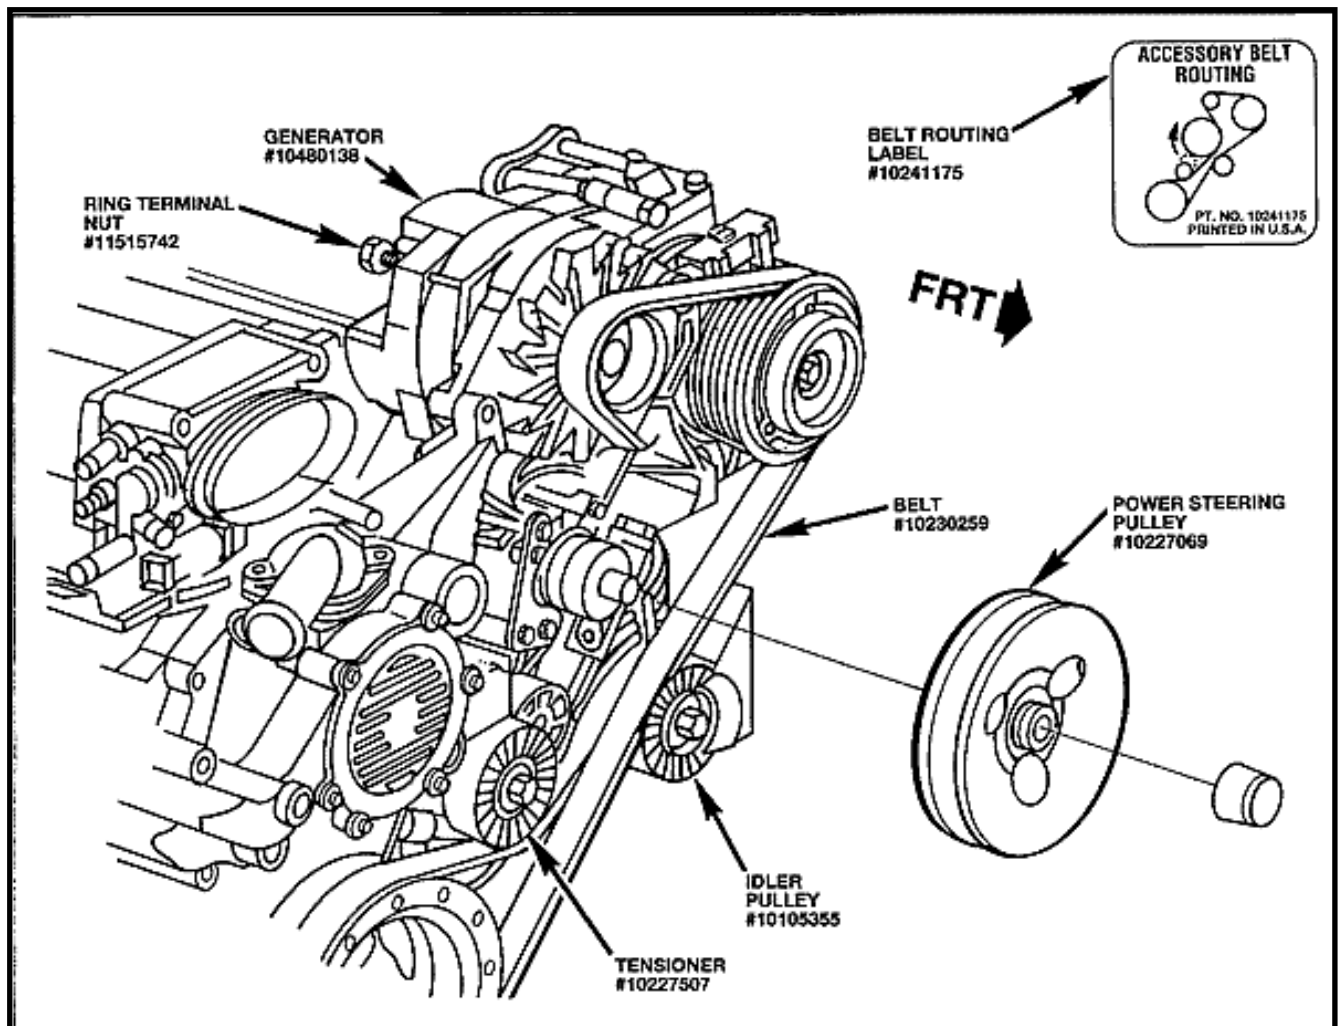
Some owners of 1992 and early 1993 model year Corvettes with 5.7L (LT1, VIN P) engines using the double-sided accessory drive belt may experience a noisy or fraying belt condition.

Inherent stresses and/or processing of the double-sided belt.

To correct this condition a change was made from the double-sided belt system to a new single-sided belt system. Starting the week of March 22,1993, VIN breakpoint #1G1YY23P4P5113150 Corvettes with LT1 engines were built with the new single-sided belt. To repair older units with the double-sided belt to a single-sided belt, the following parts must be installed:

NOTE: When replacing the new generator, the ring terminal on the wire harness will have to be opened up the 8.5mm to accommodate the larger stud on the back of the new generator.
