1992 Corvette: Recall: Optispark Distributor

Subject: OPTI-SPARK DIST. (REPLACE WITH NEW P/N)

Model and Year: 1992 CHEVROLET CORVETTE W/ LT1 ENGINE

Bulletin Number: 92C11 - (06/15/1992)

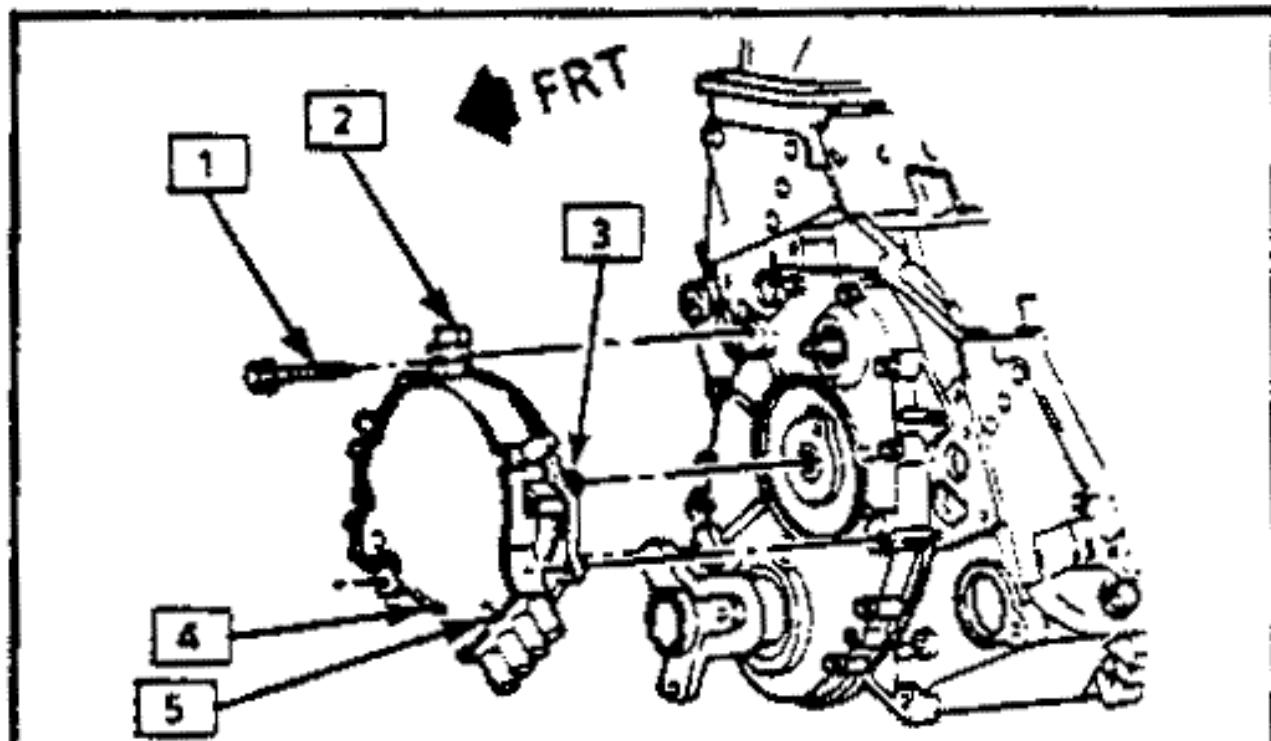
Figure 3 - Distributor - (VIN P)

General Motors has determined that certain 1992 Chevrolet Corvettes with LT1 engines (VIN code "P") have been equipped with Opti-Spark distributors which may develop a faulty low-resolution pulse signal. This condition may cause a "no-start" engine stall condition, along with a "Service Engine Soon" light (Code 16).

12. Disconnect four-terminal connector from distributor.
13. Remove three distributor mounting bolts. Pull distributor forward until drive shaft disengages from engine. Mark top surface of shaft to denote location during re-assembly (refer to Figure 3, page 6).

1. Install distributor shaft into distributor. Turn shaft until mark is on top.
2. Install distributor and shaft assembly into engine. Tighten distributor bolts to 11 Nm (8 lb. ft.).
3. Connect four-terminal ECM connector to distributor.
4. Connect spark plug cables to distributor.
5. Install torsional damper to engine. Tighten damper bolts to 81 Nm (60 lb. ft.).
6. Install pump to engine (DO NOT FORCE PUMP ONTO ENGINE):
 - A. Clean engine block and coolant pump thoroughly.
 - B. Inspect O-rings on both pump shaft and drive assembly front cover for cracks and replace O-rings if damaged.
 - C. Apply light coat of grease to seals and splines before assembly of coupling to coolant pump. White band on coupling goes toward engine (refer to Figure 4, page 7).
 - D. Install new gaskets with tabs up.
